ENGINE - HP COMPRESSOR - STAGE 10 CASE ASSEMBLY WITH INTEGRAL FRONT RETAINING ARM FOR  
SEAL RING - CATEGORY CODE 7 - MOD.ENG-72-0185

V2500-ENG-72-0185

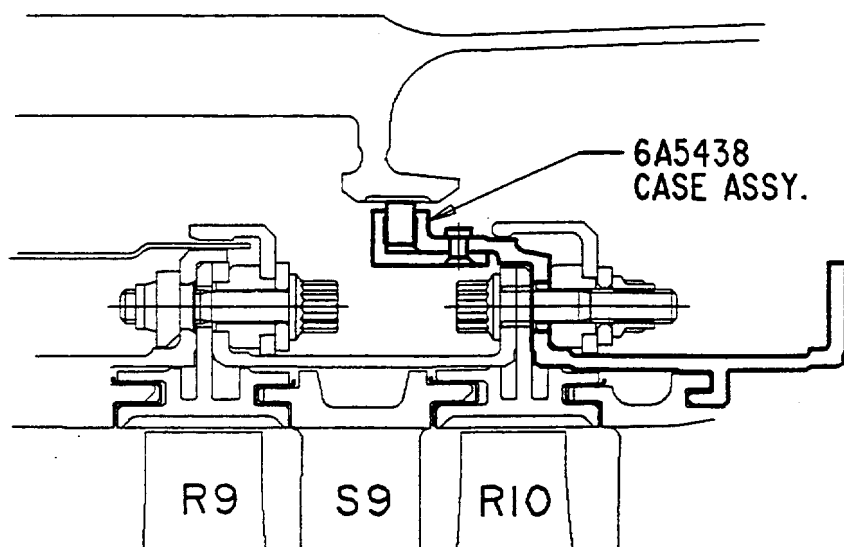
**VIEW ON STAGE 10 CASE ASSEMBLY  
BEFORE ALTERATION**

Instances have occurred where the retainer of the stage 10 case seal ring assembly have been deflected forward following release of a number of its securing rivets.

A review of fitting procedures has established that the rear outer casing can foul the seal assembly if it is not properly aligned during engine assembly and this may cause overstressing of the rivets. Service Bulletin V2500-ENG-72-0154 was subsequently introduced to reduce rivet stresses by increasing the number of securing rivets.

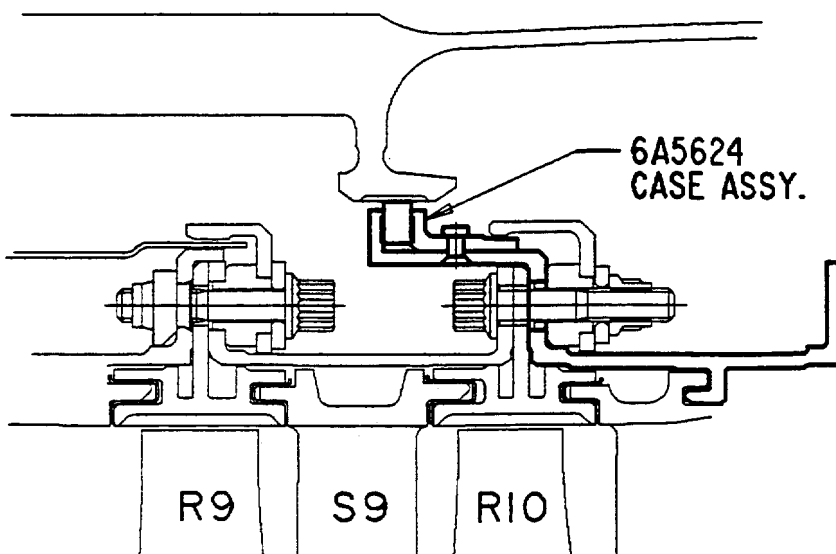
**VIEW ON STAGE 10 CASE ASSEMBLY  
AFTER ALTERATION**

This Service Bulletin instructs a new HP compressor stage 10 case assembly with the integral seal retaining arm extended forwards to support the front face of the seal ring.

The retainer is transferred to the outside of the stage 10 case to support the rear face of the seal ring.

At engine build the integral seal retaining arm supports the ring seal thus lowering build stress levels, enabling a reduction in the number of rivets on the retainer from 96 to 24.

- (1) Assemble the stage 10 case assembly 6A5624 by use of approved procedures, Engine Manual, 72-41-20. (Refer to 1.M.(2) and 1.M.(4)).
