DATE ~~R~~ Oct.31/02**V2500-A1/A5/D5 PROPULSION SYSTEMS SERVICE BULLETIN**

This document transmits Revision 3 to Service Bulletin EV2500-72-0190

ENGINE - HP TURBINE ROTOR AND STATOR ASSEMBLY - INTRODUCE A NEW STAGE 1 HPT AIR SEAL
AND A NEW NO. 4 BEARING REAR COOLING DUCT ASSEMBLY

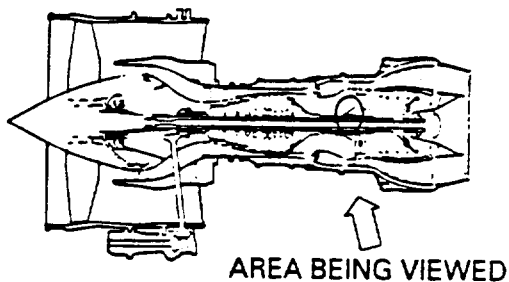
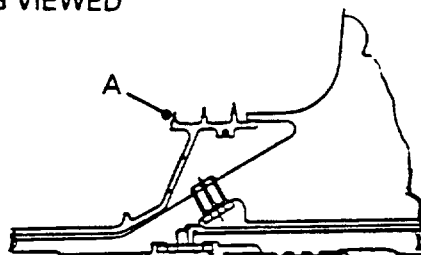
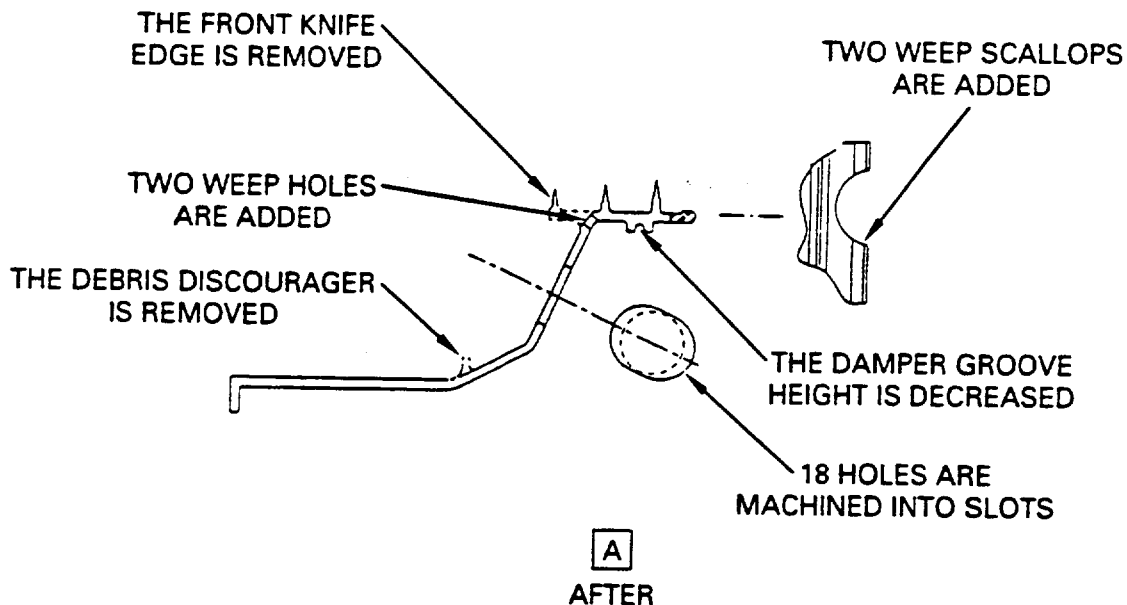
Before and After views of configuration changes that affect the High Pressure Turbine Rotor and Stator Assembly (Stage 1 HPT Air Seal)
Figure 1 (Sheet 1)

It is possible that unwanted oil can collect in the area between the Stage 1 HPT Air Seal and the Stage 1 HPT Turbine Hub.

It was found that the unwanted oil will not drain from the area unless there was a modification to the Stage 1 HPT Air Seal, the No. 4 Bearing Seal Support Assembly, the No. 4 Bearing Rear Cooling Duct Assembly, and the No. 4 Bearing Strainer Element Assembly.

The Stage 1 HPT Air Seal features include: Removal of the front knife-edge, additional drain holes, an elongated cooling air hole and a damper groove with a decreased wall height.

R (1) Improve the features of the parts listed so that more of the unwanted oil will drain from the area between the air seal and the Stage 1 Hub. See Figure 1. The affected parts are:

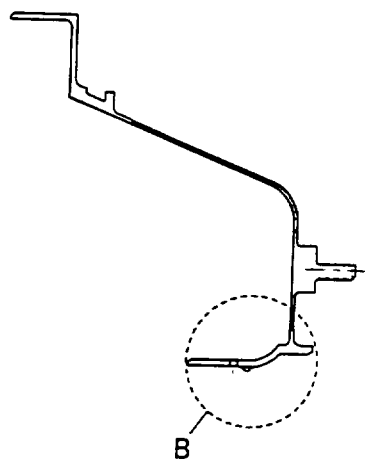
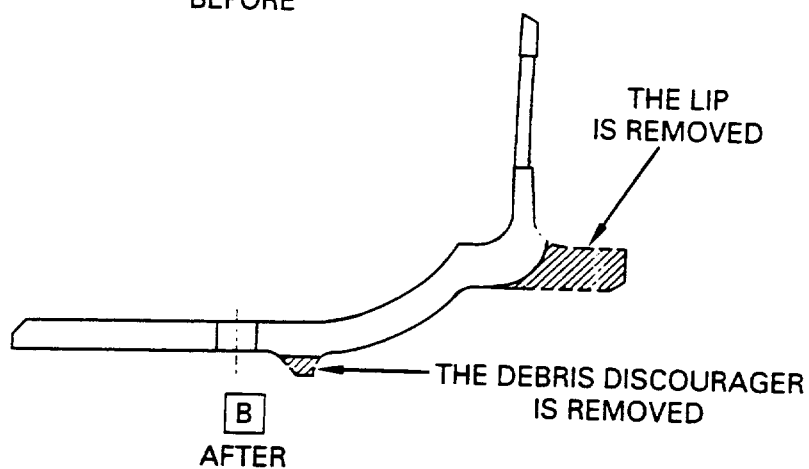
Before and After views of configuration changes that affect the High Pressure Turbine Rotor and Stator Assembly (No.4 Bearing Rear Cooling Duct assembly)
Figure 1 (Sheet 2)

The No. 4 Bearing Rear Cooling Duct Assembly features include: Removal of the debris deflector and the lip adjacent to the Stage 1 Turbine Seal.

THE LIP
IS REMOVED

THE DEBRIS DISCOURAGER
IS REMOVED

(b) No. 4 Bearing Rear Cooling Duct Assembly for all V2500 Engine models.
