ENGINE – ATTACHING PARTS AND FITTINGS – HP SYSTEM MODULE – IMPROVED COOLING AIR
DEFLECTOR FOR CABIN AIR PRESSURE REGULATING VALVE – CATEGORY CODE 6 – MOD.ENG-72-0191

V2500-ENG-72-0191

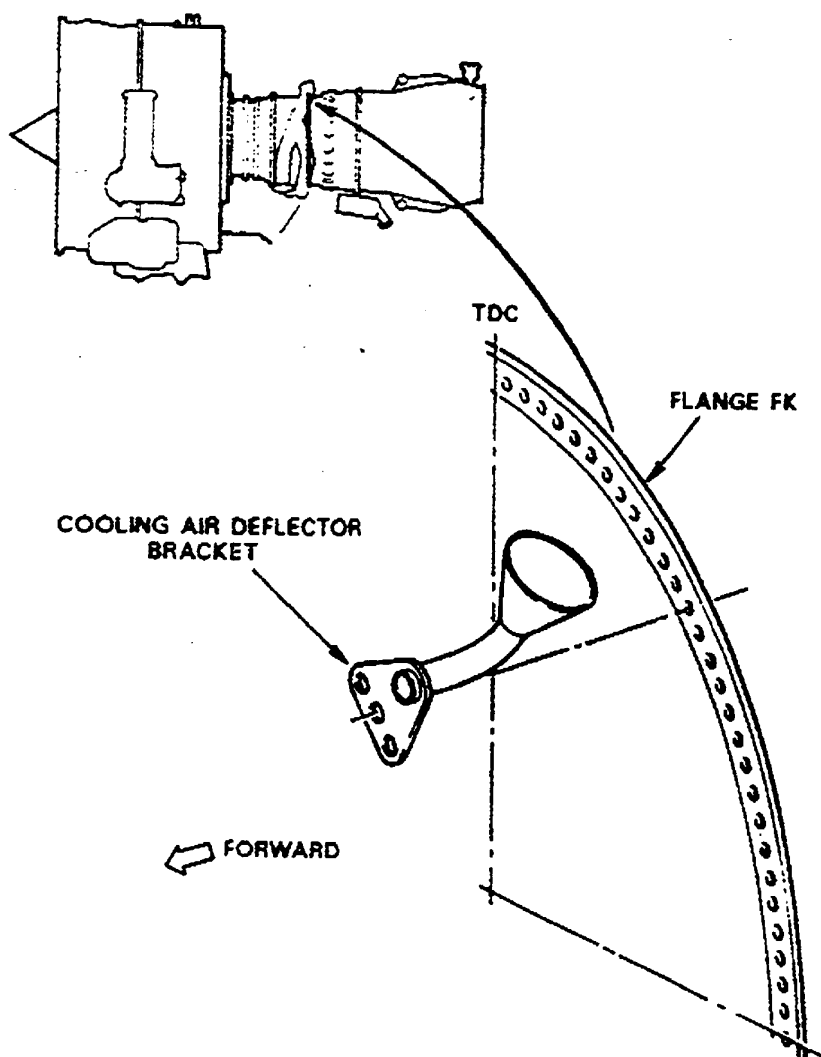
Location of cooling air deflector bracket
Fig.1

The position of the cooling air deflector bracket relative to the cabin air pressure regulating valve (PRV) has resulted in the flow of cooling air to the valve being reduced.

- (1) Find 6A5663 bracket. Refer to Figures 1 and 2.
- (2) Remove the 4W0651 bolts (3 off) and 4W0003 (3 off) retaining the 6A5663 bracket. Remove the 6A5663 bracket. Refer to Figure 2.
- (3) Remove the retaining bolt at flange 'FK' hole position 100. Refer to Figure 2.
- (4) Remove the MS9573-13 bolts (2 off) from the diffuser casing (boss 19) fuel nozzle boss. Refer to Figure 3.

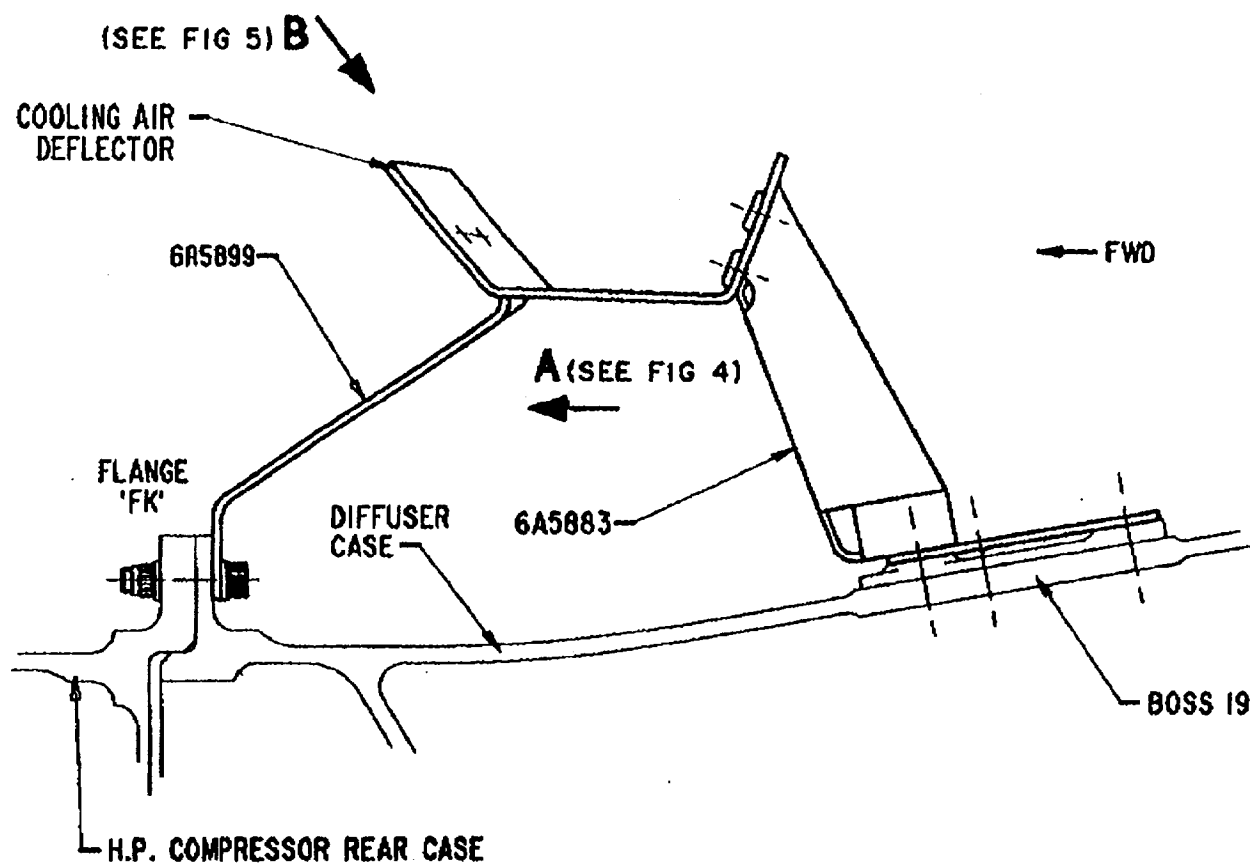
View on nozzle and support assembly showing cooling air deflector/support - After alteration
Fig.3

Incorporation of the modified deflector bracket is designed to increase the flow of cooling air to the valve.

- (1) Install the 6A5899 bracket on to the rear face of flange 'FK' using 4W0649 bolts (3 off) and 4W0003 nuts (3 off). Do not tighten. Refer to Figures 3 and 4.

- (2) Install the 4th 4W0649 bolt (1 off) and 4W0003 nut (1 off) to flange face 'FK' hole position 103. Refer to Figure 4.
- (3) Install the 6A5883 bracket on to the diffuser case (boss 19) fuel nozzle boss using existing MS9575-13 bolts (2 off). Do not tighten. Refer to Figure 3.

- (4) Centralise the 6A5883 and 6A5899 bracket hole positions, install 4W0105 bolts (2 off) 4W2621 washers (2 off) to 6A5883 and 6A5899 brackets, 4W2621 washers (2 off) and 4W0001 nuts (2 off). Refer to Figures 3 and 5.

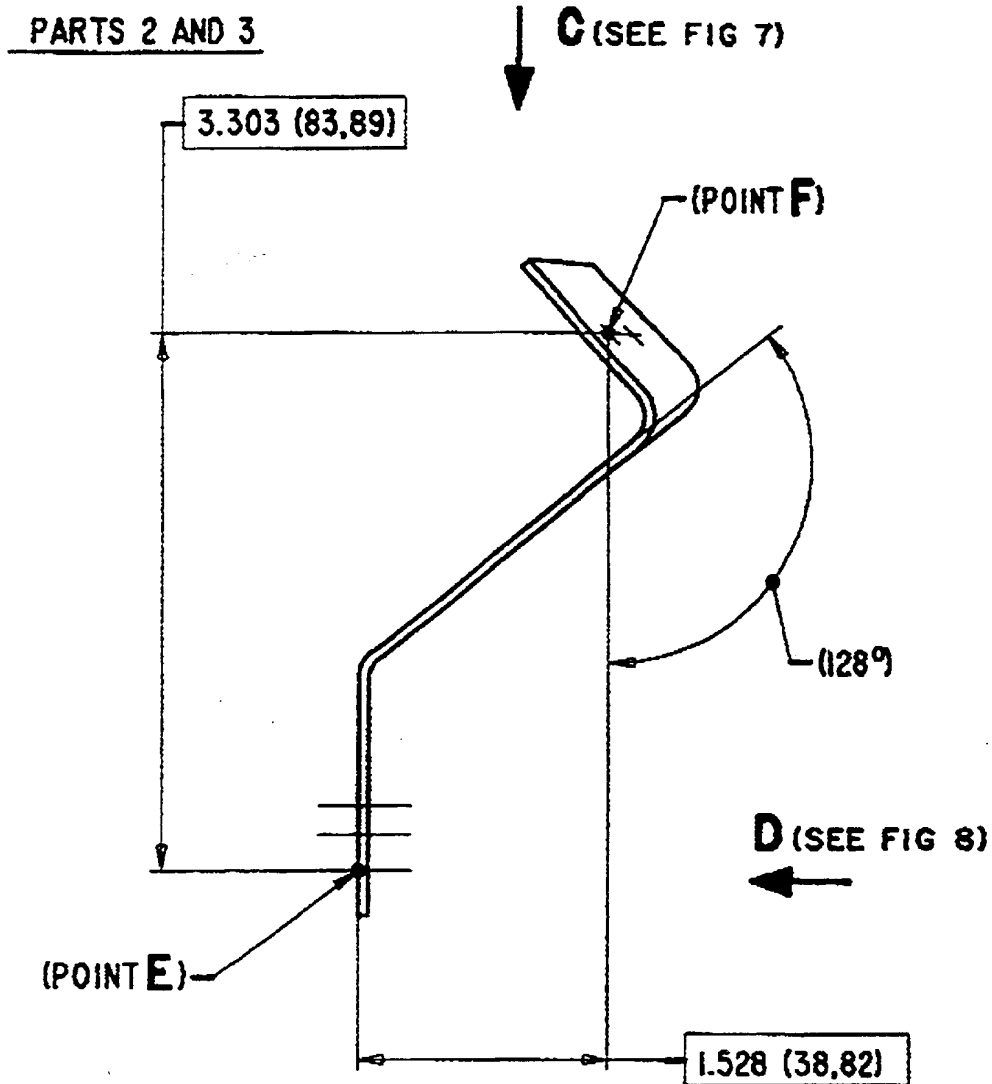
View on support bracket (6A5884) showing reworking required
Fig.6

Several engines were delivered to operators with incorrect support bracket clearance holes.

Procedure	Supplementary Information	
(a) Install the support bracket on to the machine table	Refer to Figures 6,7 and 8. Align the axis of the three existing bolt holes correctly to the table surface. Use jig boring machine with standard workshop equipment.	
(b) Increase the diameter of the three existing holes	Refer to Figure 8. Use a standard 0.348 in. (8,839 mm) diameter letter 'S' drill.	
(c) Remove sharp edges	Use standard workshop equipment.	
(d) Cancel the old part number and identify with the new part number	Old Part No. 6A5884	New Part No. 6A5899
	Refer to SPM TASK 70-09-00-400-501, SUBTASK 70-09-00-400-001. Use vibro-engraving equipment.

- (c) Dimensionally examine the three bolt holes.

If the bolt holes are not the correct size, do Part 2 of this Service Bulletin.
