ENGINE - CORE TO FANCASE INTERFACE SEALING OF BIFURCATION PANEL - CATEGORY CODE 6, 3 -
MOD.ENG-72-0193

V2500-ENG-72-0193

SERVICE BULLETIN

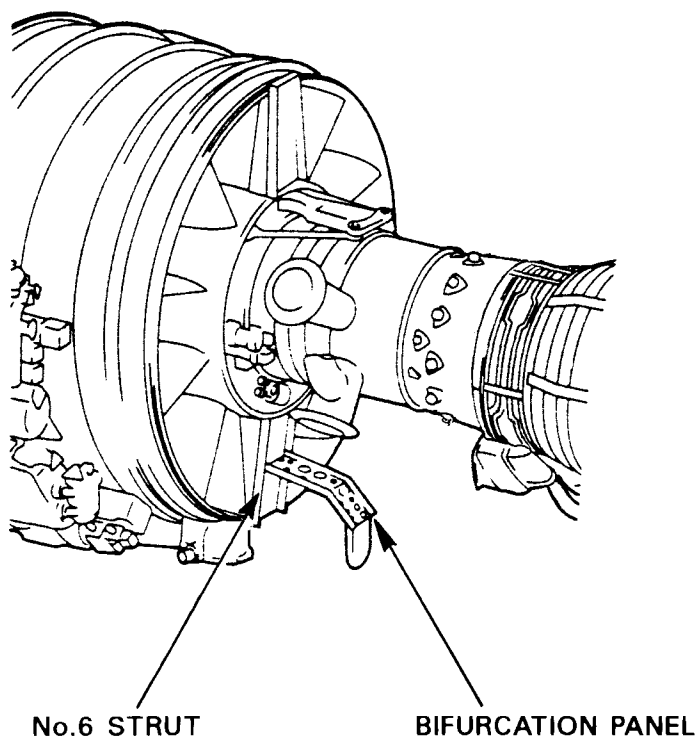
Location of bifurcation panel and No.6 strut
Fig.1

Leakage can occur through the radial gap between tube/harness connectors and bifurcation panel, which is a firewall seal.

- (1) This Service Bulletin introduces sealant (silcoset 152 or RTV 159) around the radial gap between the tube/harness connectors and the bifurcation panel.

The opportunity has also been taken to include sealant at the joint of the bifurcation panel and the No.6 strut.
