SERVICE BULLETIN

ENGINE - HP TURBINE ROTOR AND STATOR ASSEMBLY - INTRODUCE A NEW STAGE 1 HP TURBINE AIR SEAL - CATEGORY CODE 8 - MOD.ENG-72-0194

V2500-ENG-72-0194

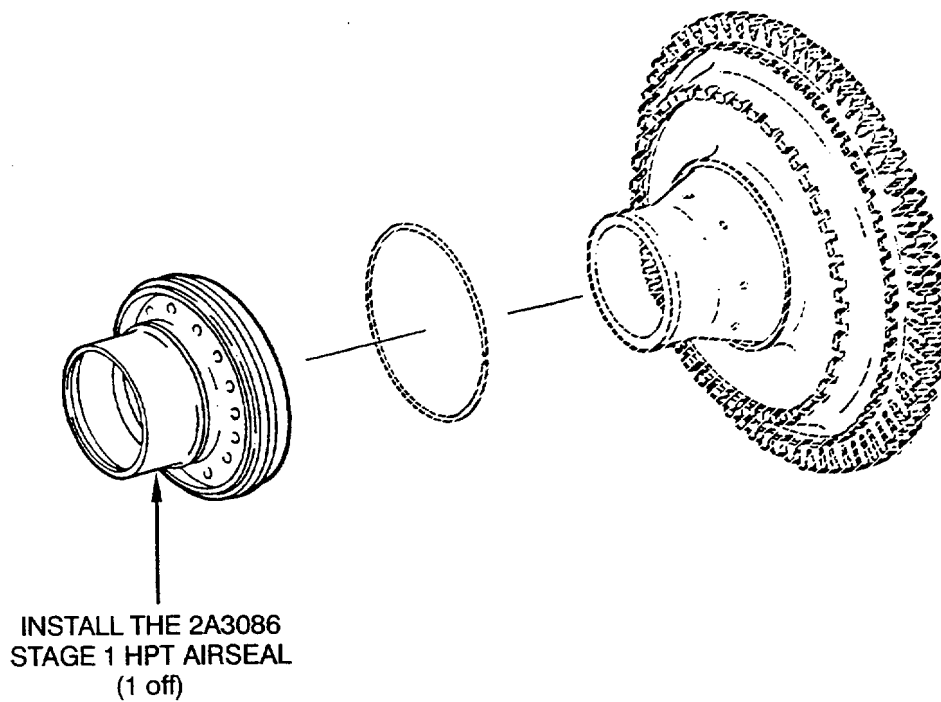
Location of the Stage 1 HPT Air Seal
Fig.1

It is possible that unwanted oil can collect in the area between the Stage 1 HPT Air Seal and the Stage 1 HPT Turbine Hub.

It was found that the unwanted oil will not drain from the area unless there was a modification to the Stage 1 HPT Air Seal.

- (1) Install the 2A3086 Stage 1 HPT Air Seal (1 off) by the approved procedure given in References (3) or (4), Chapter/Section 72-45-10 Assembly. See Figure 1.
- (2) Identify the new Stage 1 Turbine Rotor Assembly as 2A8921 by the procedure given in Reference (7), Chapter/Section 70-09-00, Marking of Parts.
 - (a) Use the vibration peen method.
 - (b) Mark the new part number adjacent to the old part number.
