## SERVICE BULLETIN

ENGINE - ANGLE GEARBOX ASSEMBLY - INTRODUCTION OF MODIFIED BRACKET SUPPORT - VSCF OIL COOLING TUBES - CATEGORY CODE 7 - MOD.ENG-72-0197

V2500-ENG-72-0197

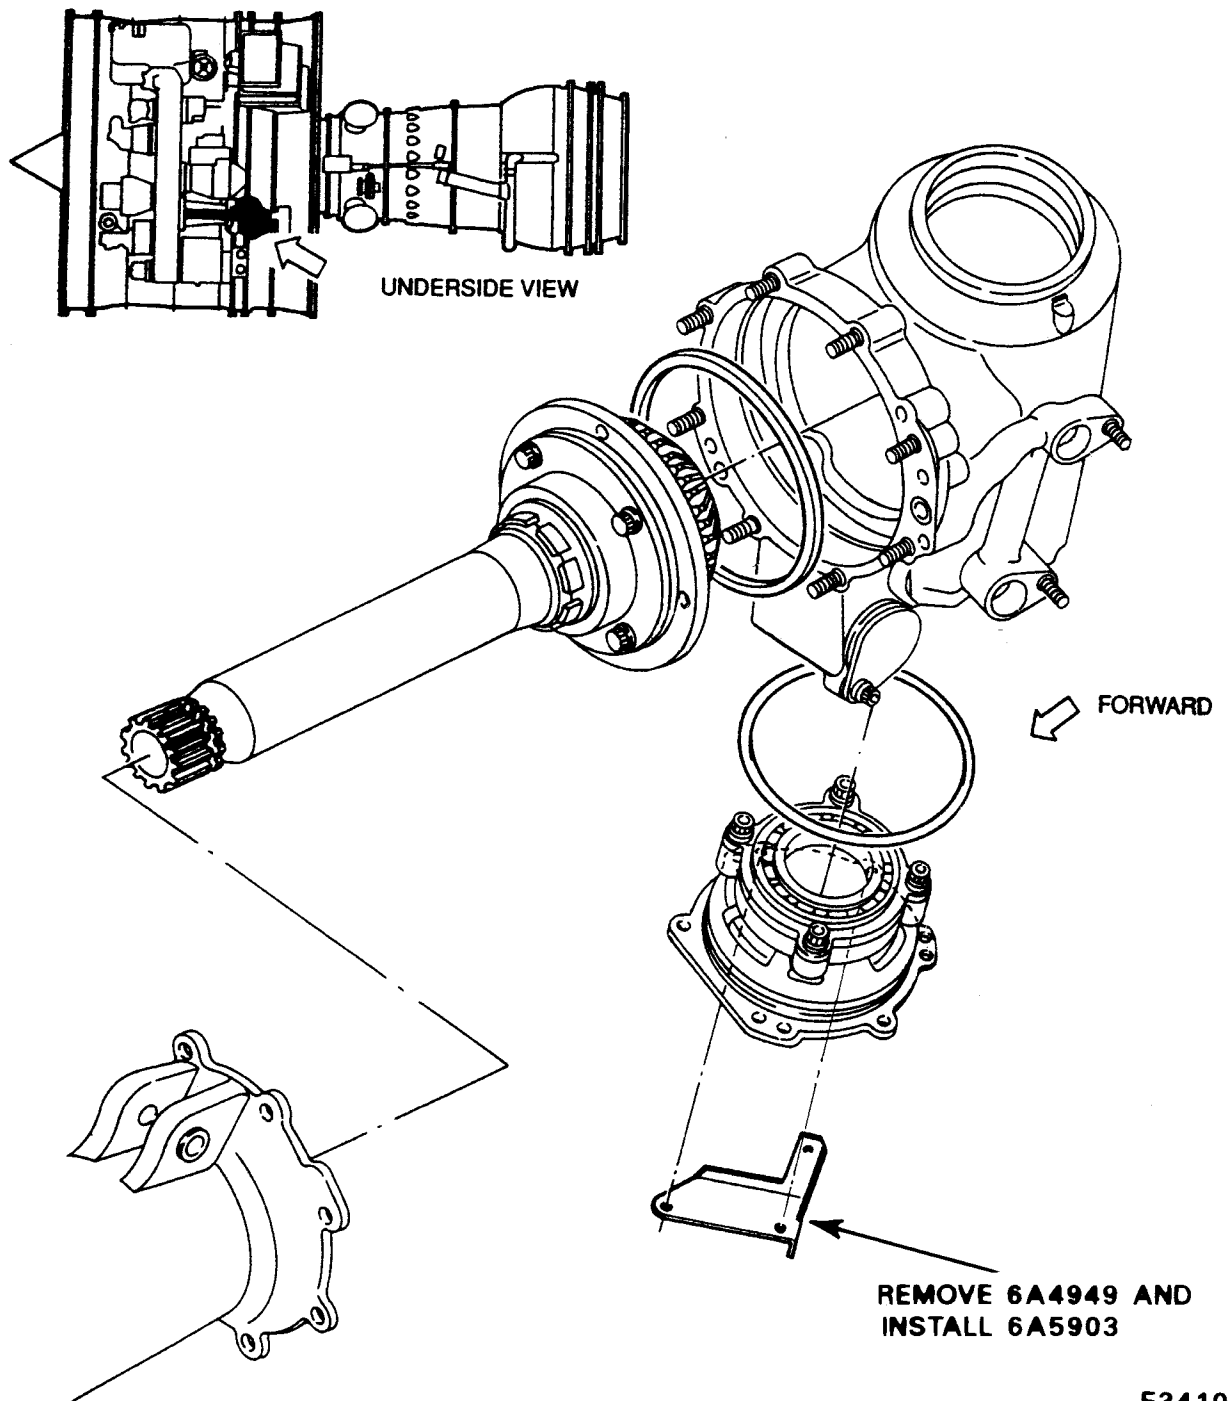
Location of support bracket  
Fig.1

Difficulty has been reported in clipping the variable speed constant frequency generator oil cooling tubes at clipping point 2354. This may result in the tube assembly being prestressed during assembly.

- (1) Find the 6A4949 bracket. Refer to Figures 1, 2 and 3.
- (2) Disassemble clipping point CP2354 sufficiently to allow the removal of 6A4949 bracket.
- (3) Remove the bracket retaining bolts (2 off) and washers (2 off) and remove the 6A4949 bracket.
- (4) Install the new 6A5903 bracket using the retaining bolts (2 off) and washers (2 off) previously removed in step (3).
- (5) Torque the retaining bolts (2 off) to 85 to 105 lbfin (10 to 12 Nm).
- (6) Install clipping point CP2354 using existing parts previously removed at step (2) and torque the bolt to 36 to 45 lbfin (4 to 5 Nm).

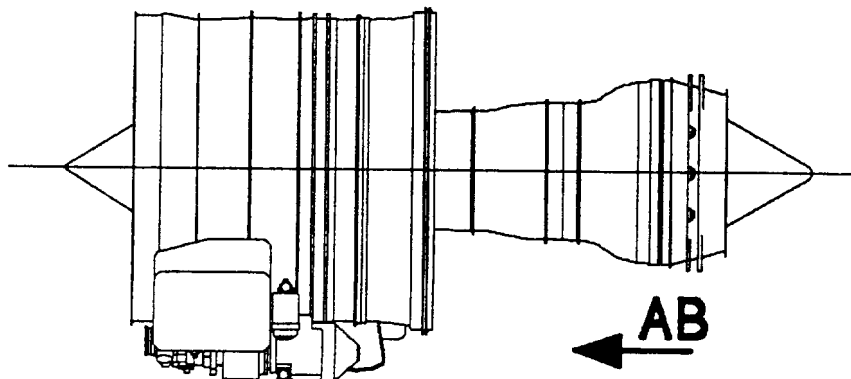
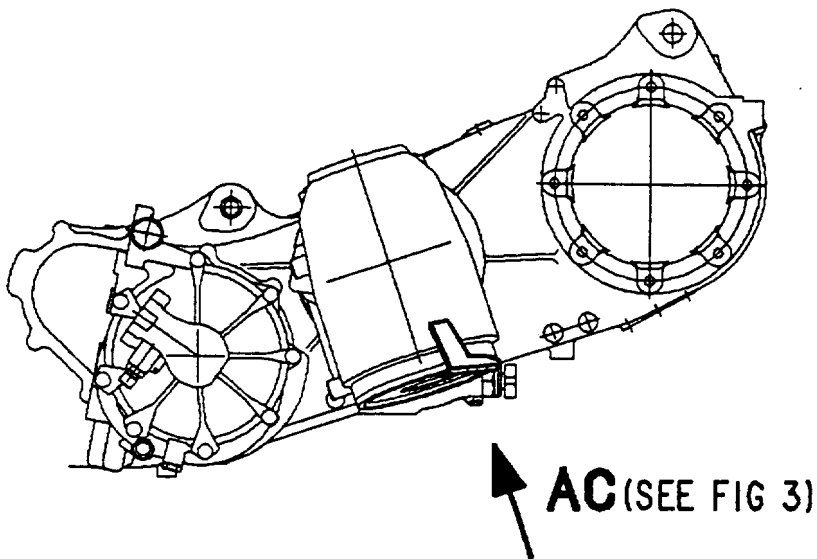
Views showing position of support bracket on angle gearbox  
Fig.2

PART VIEW ON ARROW **AB**  
SHOWING POSITION OF SUPPORT  
BRACKET ON ANGLE GEARBOX

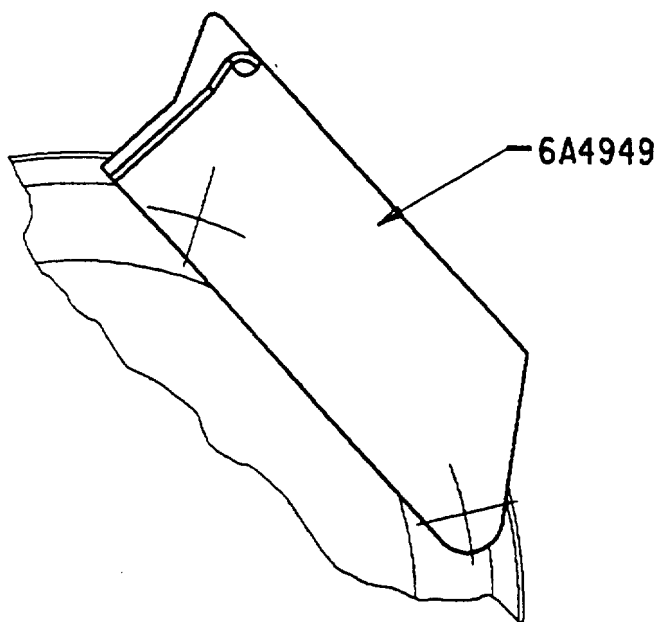
Part view on arrow AC (see Figure 2) - Before and after alteration  
Fig.3

PART VIEW ON ARROW **AC** (SEE FIG 2)  
BEFORE ALTERATION

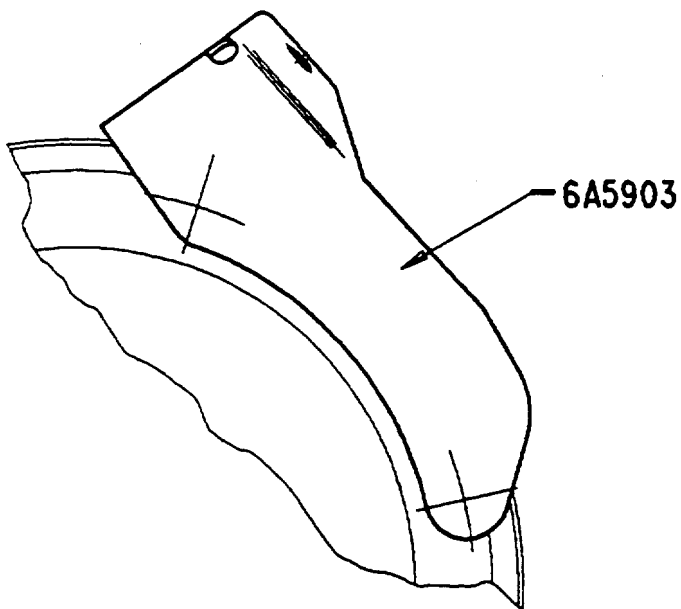
This Bulletin introduces a new bracket similar to the existing bracket except for a repositioned clipping hole and a redesigned stiffening web.

PART VIEW ON ARROW **AC** (SEE FIG 2)  
AFTER ALTERATION
