ENGINE - HP COMPRESSOR - INTRODUCE A NEW STAGE 3 HPC ROTOR BLADE WITH A CUT BACK CLAPPER - CATEGORY CODE 6 - MOD.ENG-72-0201

V2500-ENG-72-0201

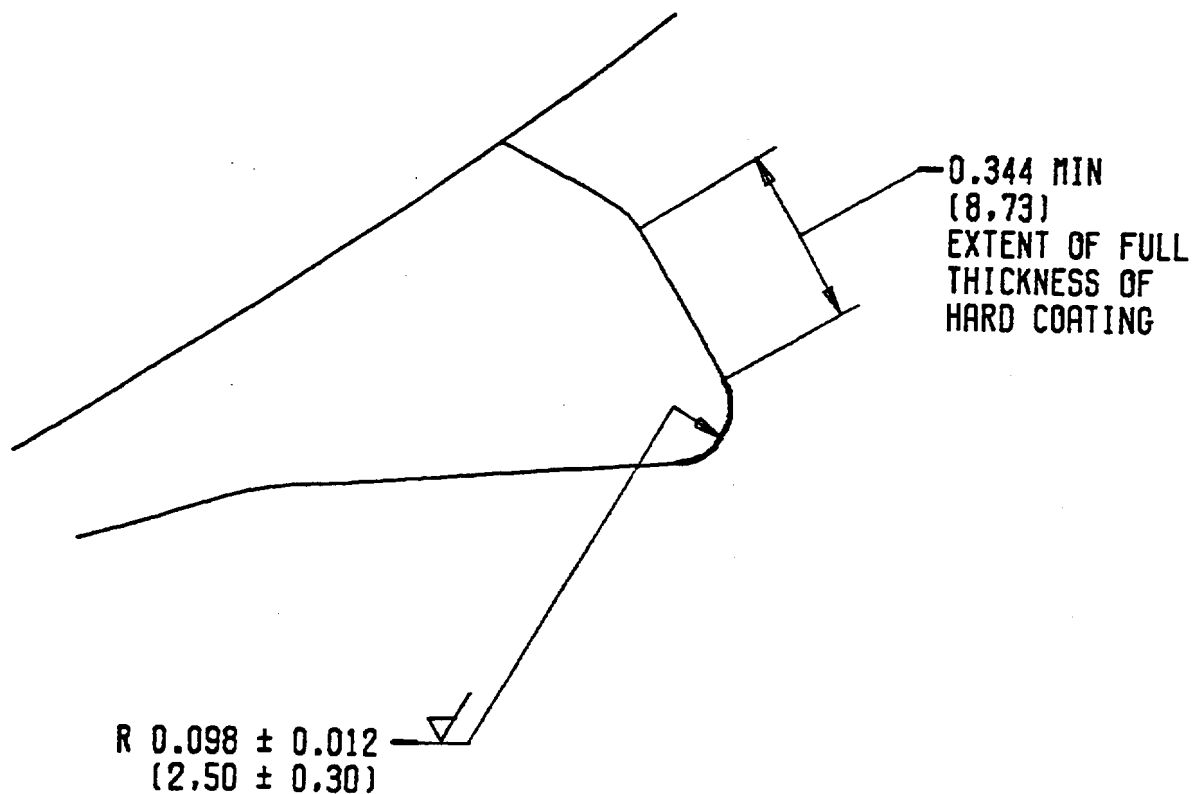
Repeat part view on A (See Figure 3) – Reworking of stage 3 rotor blades
Fig.5

SHARP EDGE CREATED BY MACHINING RADIUS TO BE REMOVED BY BLENDING UNIFORMLY BETWEEN EXISTING LEADING AND TRAILING EDGE CORNER RADII.

Refer to Figure 5. Use a hand file or a portable grinding machine with a locally made inspection template

| (f) Visually examine and measure the dimensions of the new radius | Refer to Figure 5. Use a locally made inspection template |
| (g) Visually examine the clapper coating | Refer to Figure 5. |
