International Aero Engines SERVICE BULLETIN

ENGINE - HP COMPRESSOR - INTRODUCE A NEW
STAGE 12 LH LOCKING BLADE WITH AN
INCREASED PLATFORM CROP

72-41-00

V2500-ENG-72-0204

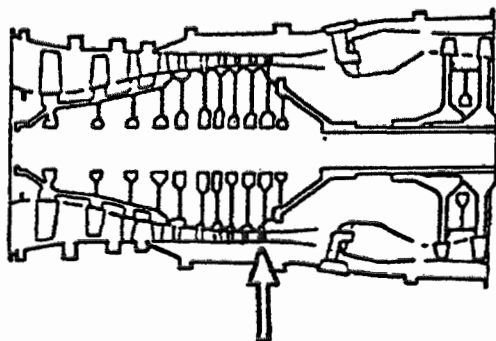
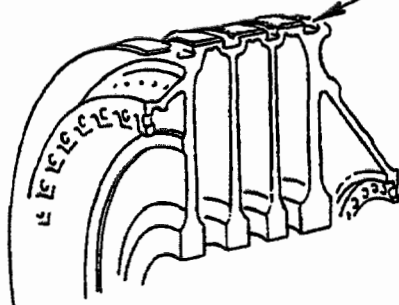
Figure 1

REMOVE 6A4729 STAGE 12
LH LOCKING BLADE AND INSTALL
6A5947 STAGE 12 LH LOCKING
BLADE

Location of Stage 12 HP Compressor Rotor Blade

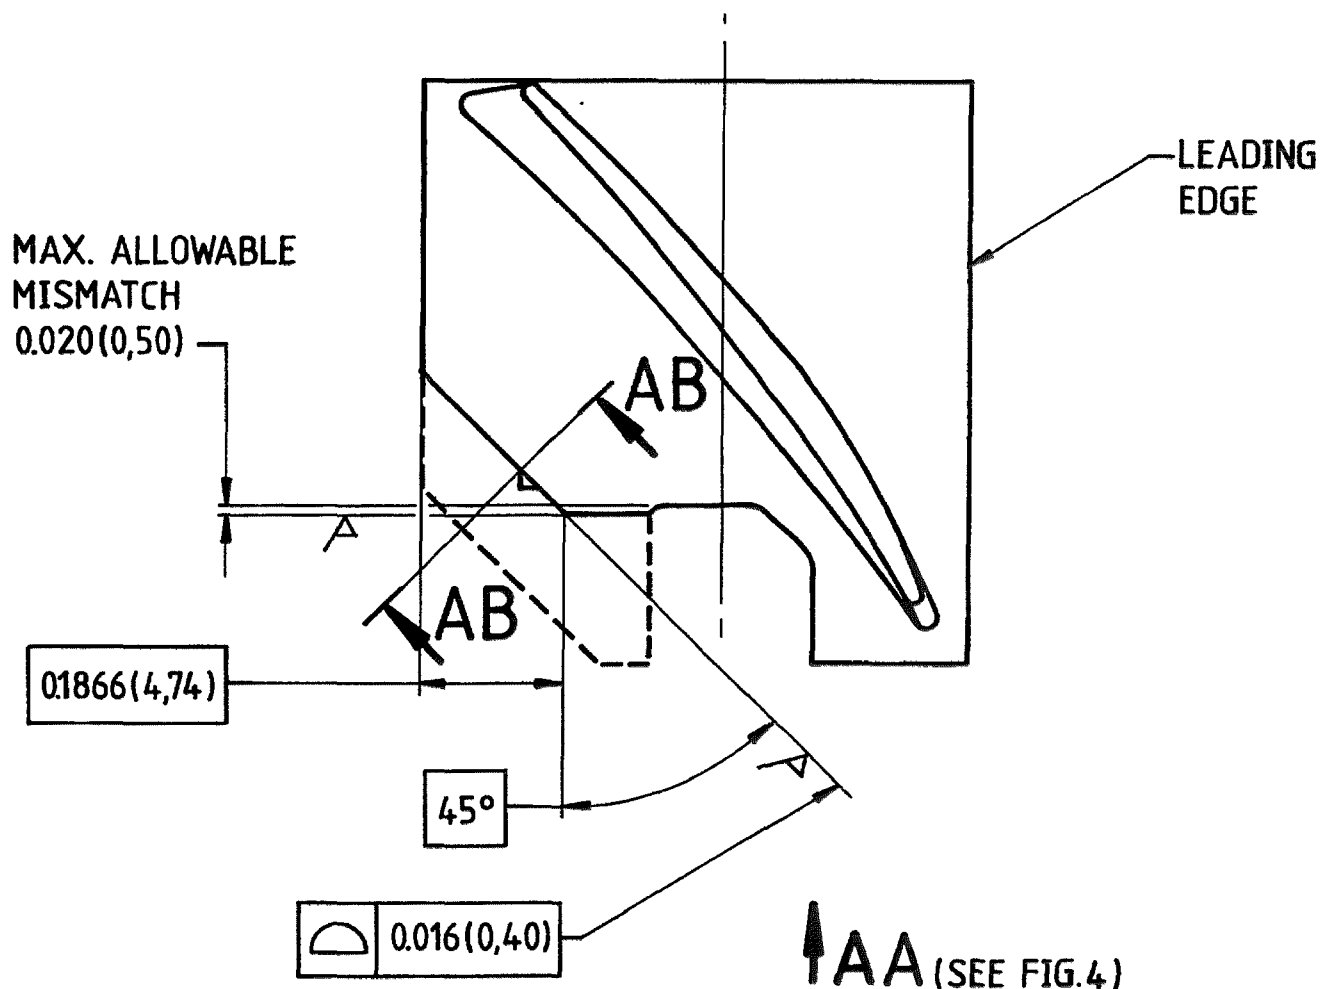
Figure 2

HP compressor stage 12 left hand locking rotor blades have experienced platform corner cracking.

Reworking of Existing HP Compressor
Stage 12 LH Locking Blades

This Bulletin introduces a stage 12 HP compressor left hand locking rotor blade with the platform axially cropped from the root of the locking slot to the rear face.

The platform is further reduced by dressing to remove the rear corner cusp created by machining.

- (e) Grind back the rotor blade(s) platform, where shown
- Refer to Figures 2 and 4.
Use a grinding machine.

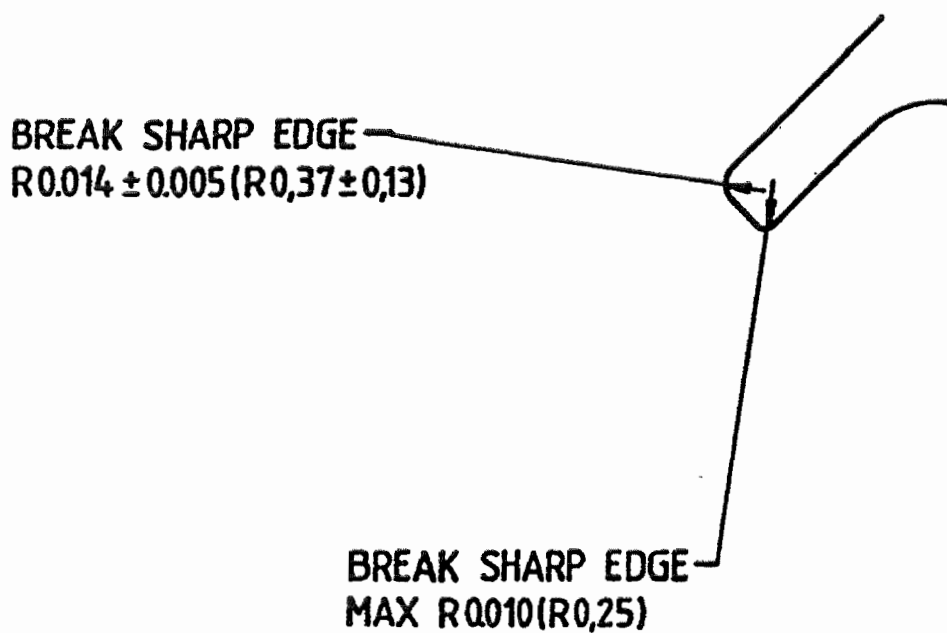
Figure 3

Section AB (See Figure 2)

- | (f) Remove sharp edges | Refer to Figures 2, 3 and 4.
Use standard workshop equipment. | | | | |
|--|---|---|---|---|---|
| (g) Cold ferric chloride etch the repaired area | Refer to SPM TASK 70-11-39-300-503, SUBTASK 70-11-39-300-001.
Use chemical cleaning equipment. | | | | |
| (h) Do a local penetrant crack test on the repaired area | Refer to SPM TASK 70-23-05-230-501.
Use CoMat 06-022 fluorescent penetrant, with penetrant crack test equipment.
Cracks are not permitted | | | | |
| (i) Measure the dimensions | Refer to Figures 2, 3 and 4. | | | | |
| (j) Cancel the old part number and identify with the new part number | <table border="0"> <thead> <tr> <th><u>OLD PART NO.</u></th> <th><u>NEW PART NO.</u></th> </tr> </thead> <tbody> <tr> <td>6A4729</td> <td>6A5947</td> </tr> </tbody> </table> <p>Refer to SPM TASK 70-09-00-400-501, SUBTASK 70-09-00-400-001.
Use vibro-engraving equipment.</p> | <u>OLD PART NO.</u> | <u>NEW PART NO.</u> | 6A4729 | 6A5947 |
| <u>OLD PART NO.</u> | <u>NEW PART NO.</u> | | | | |
| 6A4729 | 6A5947 | | | | |

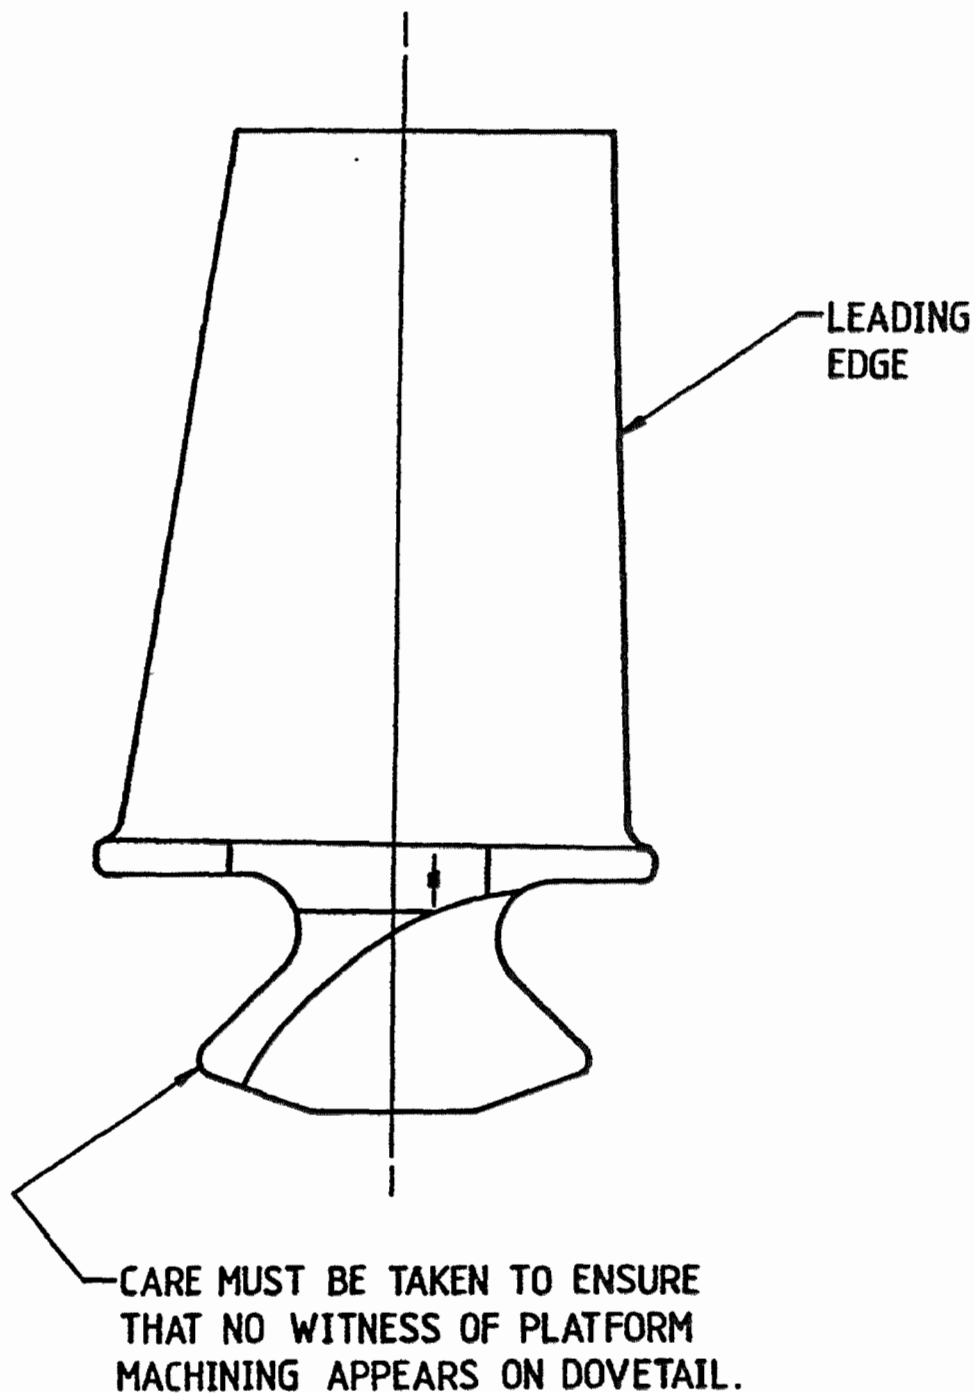
Figure 4

View on Arrow AA (See Figure 2)
