ENGINE - DIFFUSER AND COMBUSTOR GROUP - PROVIDE A NEW BRACKET ASSEMBLY WHICH HAS
ADDITIONAL SUPPORT FOR THE FIRE DETECTION RAIL - CATEGORY CODE 3 - MOD.ENG-72-0206

V2500-ENG-72-0206

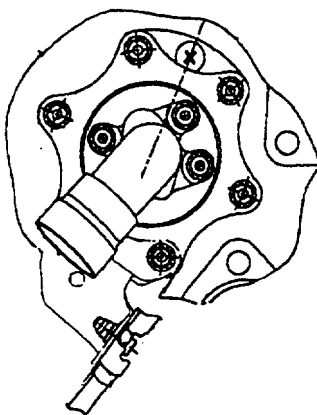
BEFORE

The original bracket did not give sufficient support to the fire detection rail.

Before and after views of configuration changes that affect the loop clamp bracket assembly that supports the fire seal

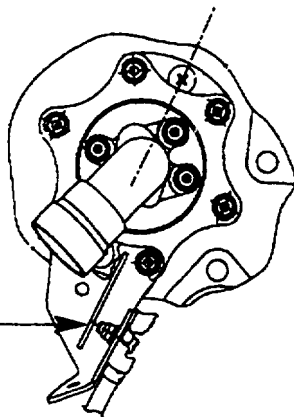
AFTER

THE NEW BRACKET
ASSEMBLY HAS A
REINFORCING RIB

To provide a stronger Loop Clamp Bracket Assembly that includes a reinforcing rib. This stronger Loop Clamp Bracket Assembly will give added support to the fire detection rail.

- (1) The Loop Clamp Bracket that supports the No. 4 bearing tube and the the fire detection rail is replaced with a Loop Clamp Bracket Assembly. This Loop Clamp Bracket Assembly has a reinforcing rail and provides added support for the fire detection rail.
