Subject: Transmittal of Revision 1 to Service Bulletin No.  
V2500-ENG-72-0208

**V2500-ENG-72-0208**

ENGINE - LP TURBINE ROTOR AND STATOR ASSEMBLY - INCORPORATE A REVISED  
TORQUING PROCEDURE FOR THE NO.5 BEARING REAR LOCK NUT

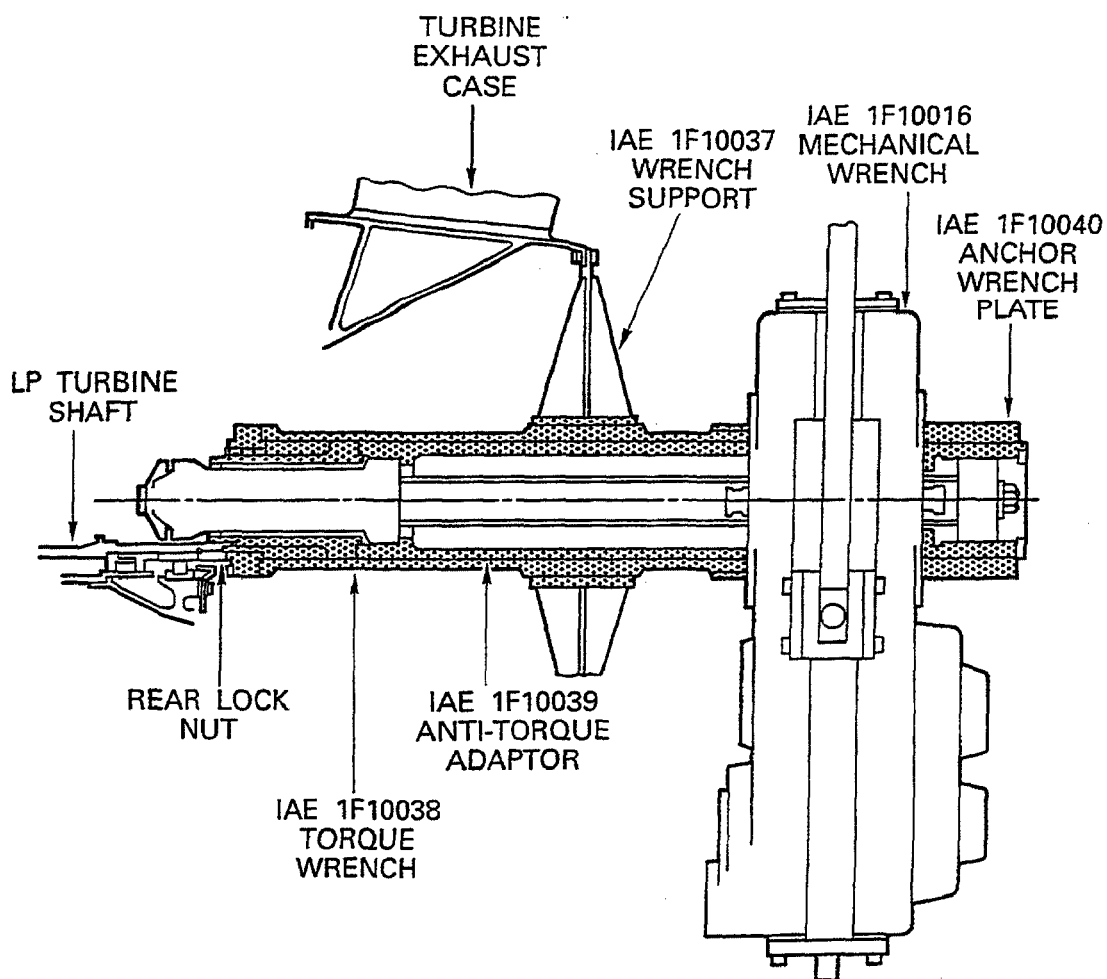
Install the turbine shaft rear lock nut  
Figure 1

The loose stacking between LP turbine shaft and carbon seal spacers may cause oil leakage from the No.5 bearing compartment chamber. This problem can be solved by changing tightening method from torque-set method to angle-of-turn method for tightening the Rear Lock Nut.

- (1) For V2500-A1 and V2500-A5 Engines which are installed onto Aircraft (Refer to Figure 1).

- (c) Remove the Exhaust Cone by the approved procedures in Reference (2), 78-11-12, Maintenance Practices Page 401.
  - (d) Remove the No.5 Bearing Compartment Cover from the engine by the approved procedures in Reference (2), Chapter/Section 72-50-00 Removal-01, Config-1 and Config-2.
  - (e) Re-torque the No.5 Bearing Rear Lock Nut by the following procedures;

- 5 Operate the mechanical wrench to release the rear lock nut.
- 6 Operate the mechanical wrench and torque the rear lock nut to 4000 to 6000 lbfin (452 to 678 Nm) .

- 7 Put an angle-of-turn of five to eight degrees to the rear lock nut.
- 8 Operate the mechanical wrench to release the torque until the torque value to zero.

- 9 Torque the rear lock nut to 4000 to 6000 lbfin (452 to 678 Nm) again.
- 10 Make a correlation mark between the IAE 1F10016 mechanical wrench and the IAE 1F10038 torque wrench.

- 11 Put an angle-of-turn of five to eight degrees to the rear lock nut.
- 12 Do step 8 again.
- 13 Do step 9 again and check the correlation mark. The correlation mark must be within two degrees maximum on the same place.

- 14 If the correlation mark within limit, apply last angle-of-turn of five to eight degrees to the rear lock nut and go to step 17.
- 15 If the correlation mark is out of limit, delete the correlation mark and do steps 10 to 13 again until correlation mark is within limit.

- 16 Apply last angle-of-turn of five to eight degrees to the rear lock nut.
- 17 Align the slot of the rear lock nut with the slot of the LP turbine shaft rear end. The alignment of the rear lock nut must be in torque direction.
