## SERVICE BULLETIN

ENGINE - LP COMPRESSOR - PROVIDE A NEW FAN FRAME ASSEMBLY AND ELIMINATE A T2.5CM THERMOCOUPLE - CATEGORY CODE 7 - MOD.ENG-72-0211

# V2500-ENG-72-0211

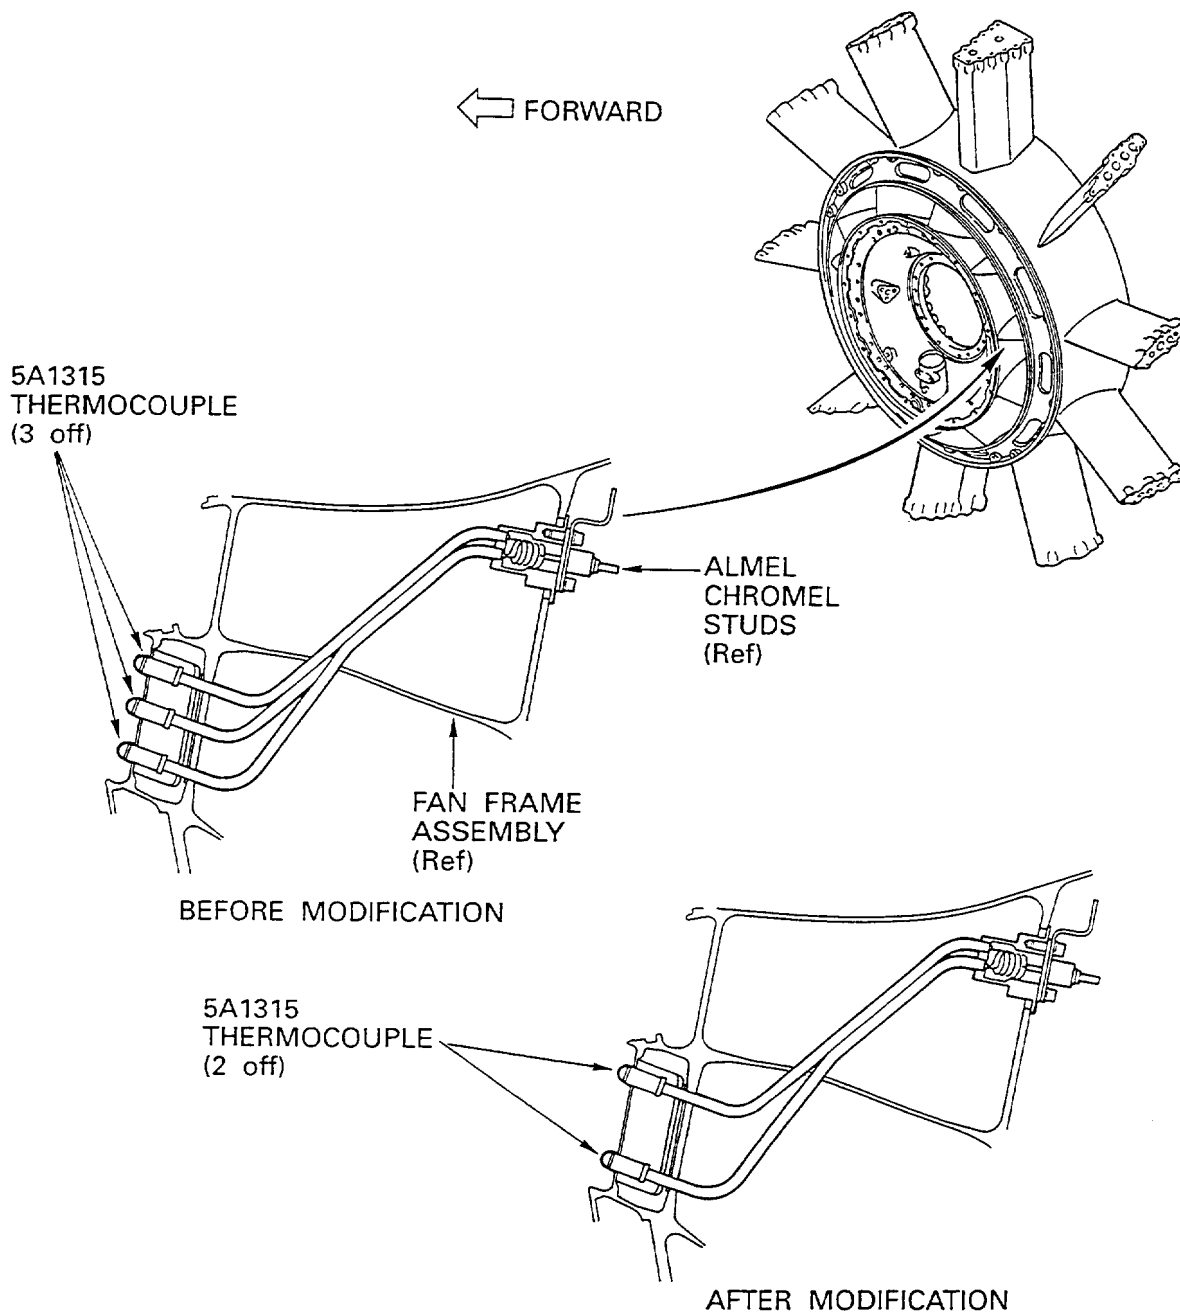
Modification of the thermocouple  
Fig.1

It was found during review that the existing T2.5 condition monitoring system can function reliably with a reduced number of thermocouples.

To reduce quantity of T2.5 CM thermocouples from three to two and replace the Front Bearing Compartment (FBC) rear buffer chamber seal drain tube with flow-restricting pin that is installed into the internal of the fan frame assembly.

- (1) The changes introduced by this Service Bulletin are as follows;
  - (a) to reduce quantity of T2.5CM thermocouples from three to two (See Figure 1).
  - (b) To eliminate the seal drain tube and modify the oil drain passage of fan frame assembly to restrict drain oil flow (See Figure 2).
