ENGINE - LP COMPRESSOR - PROVIDE A NEW FAN CASE-TO-MAIN GEARBOX ASSEMBLY MATING SEAL RING - CATEGORY CODE 6 - MOD.ENG-72-0212

V2500-ENG-72-0212

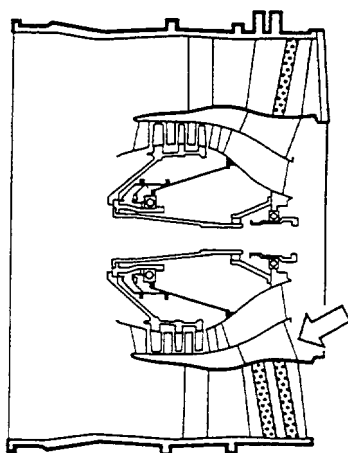
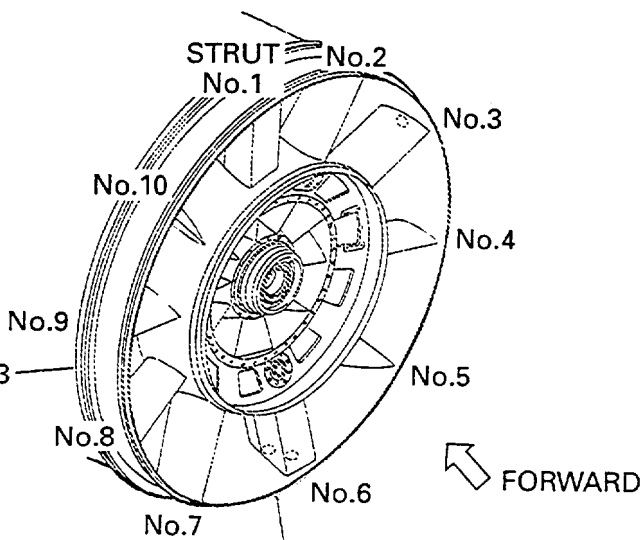
Before and After Alteration of Sealing Ring  
Fig.1

An investigation determined that the width of the existing Fan Case oil tube to Gearbox mating seal ring could result in the application of abnormal force during installation of the Gearbox.

Width of the Sealing Ring on the Oil Seal Tube is decreased. See Figure 1.

Install the 5A1641, Sealing Ring by the approved procedure given in Reference (1), Chapter/Section 72-32-00, Assembly-11.

SEALING RING  
REMOVE 5A2138 AND  
INSTALL 5A1641
