ENGINE - SECURING FEATURES - HP COMPRESSOR CASES - REVISED BOLTS FOR FJ FLANGE BRACKETS
- CATEGORY CODE 6 - MOD.ENG-72-0215

V2500-ENG-72-0215

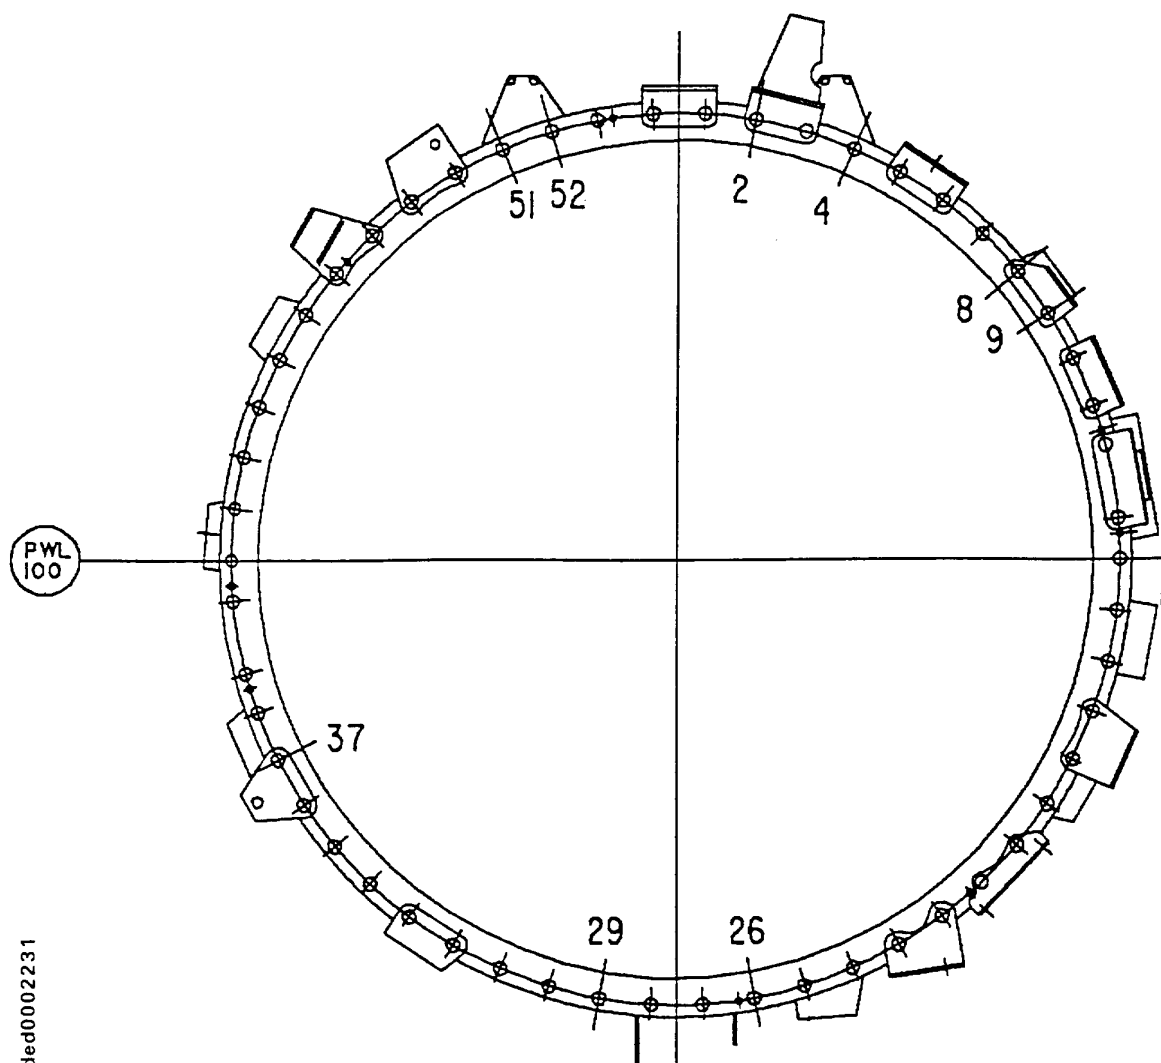
View on flange 'FJ' Looking forwards
Fig.1

At different positions on flange FJ, bolts that attach brackets do not have a sufficient threaded part. These bolts do not obey the V2500 standard specification.

- (i) The length of the bolts at positions 2, 8, 9 and 37 is increased.
- (ii) The length of the bolts at positions 4, 26, 29, 51 and 52 is decreased.

For the correct procedures to replace the affected bolts, refer to the Engine Manual (EM), Chapter/Section, 72-41-00, Assembly-02.

AT HOLE POSITIONS 4,26,29,51 AND 52 AS2III4 REPLACES AS2III7
AT HOLE POSITIONS 2,8,9 AND 37 AS2III7 REPLACES AS2III4
