ENGINE - LP COMPRESSOR - ADDITIONAL PLATE NUT ON THE NO.1 STRUT FAIRING PANEL FOR FIRE SHIELD - CATEGORY CODE 8 - MOD.ENG-72-0216

V2500-ENG-72-0216

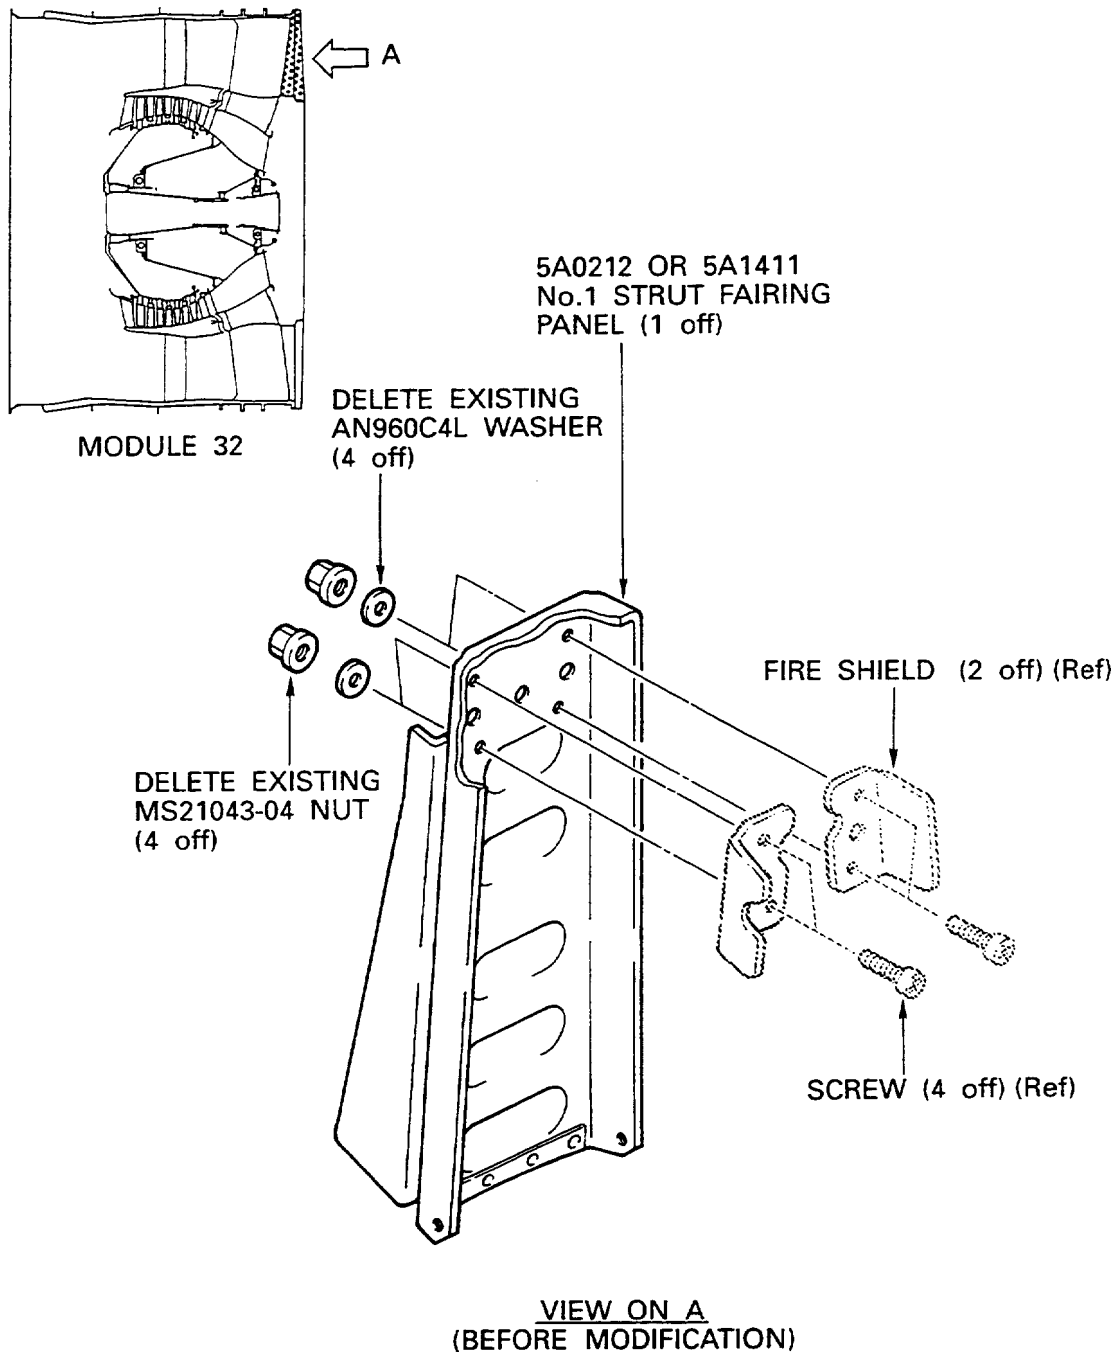
Before and after modification of the No.1 strut fairing panel
Fig.1 (Sheet 1 of 2)

The existing fire shield is secured by bolts and nuts with washers on the No.1 fairing panel, but this installation is difficult to remove the fire shield at the on-wing condition, because of hard access to the nuts and washers.

- (a) Four plate nuts are introduced at the four screw positions on the No.1 strut fairing panel to revise the current nuts and washers (see Figure 1).
- (b) The rivets which secure the plate nut are introduced at the eight positions on the No.1 strut fairing panel (See Figure 3).

Replace the current nuts and washers with plate nuts to enable the fire shield to be replaceable at the on-wing condition.
