# SERVICE BULLETIN

ENGINE - MAIN GEARBOX ASSEMBLY - PROVIDE A REWORK FOR THE MAIN OIL SCAVENGE PUMP HOUSING ASSEMBLY TO ELIMINATE AN INTERFERENCE WITH A PUMP PACKING - CATEGORY CODE 8 - MOD.ENG-72-0225

V2500-ENG-72-0225

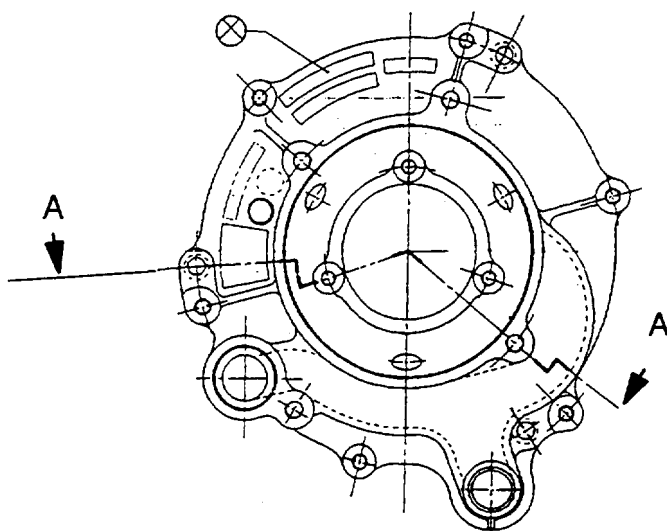
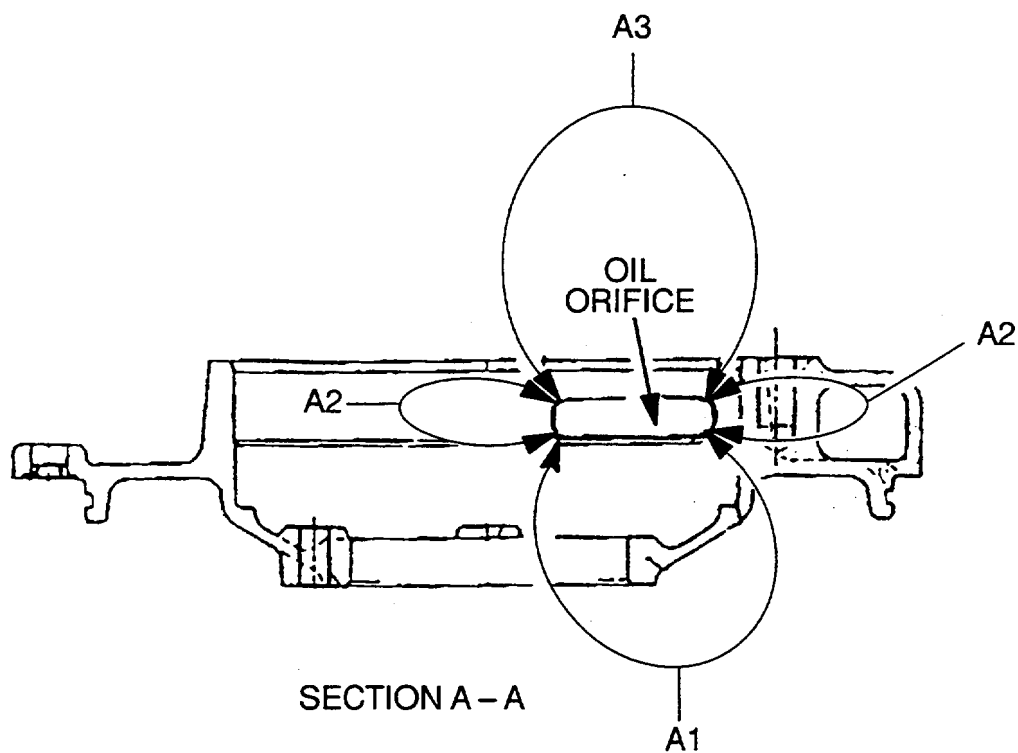
Oil scavenge pump housing  
Fig.1

- (a) At the oil scavenge pump installation the front packing fitted on the pump mounting flange could be damaged by interfering with the edges of the oil orifice present in the pump housing.

- (1) Blend edges in the area A1.  
Radius to be 0.06in. (1,5 mm)  
approximately.  
Blend in area A2 is optional.  
Do not blend in area A3

Refer to Figure 1.  
Refer to 70-35-03-350-501  
Use CoMat 02-140 triangular  
india stone  
Make sure that blended areas  
are smooth and that no burrs are  
left.
