ENGINE - LP COMPRESSOR - ENLARGE THE HOLE DIAMETER OF THE FAN CASE REAR EXTENSION -
CATEGORY CODE 4 - MOD.ENG-72-0226

V2500-ENG-72-0226

SERVICE BULLETIN

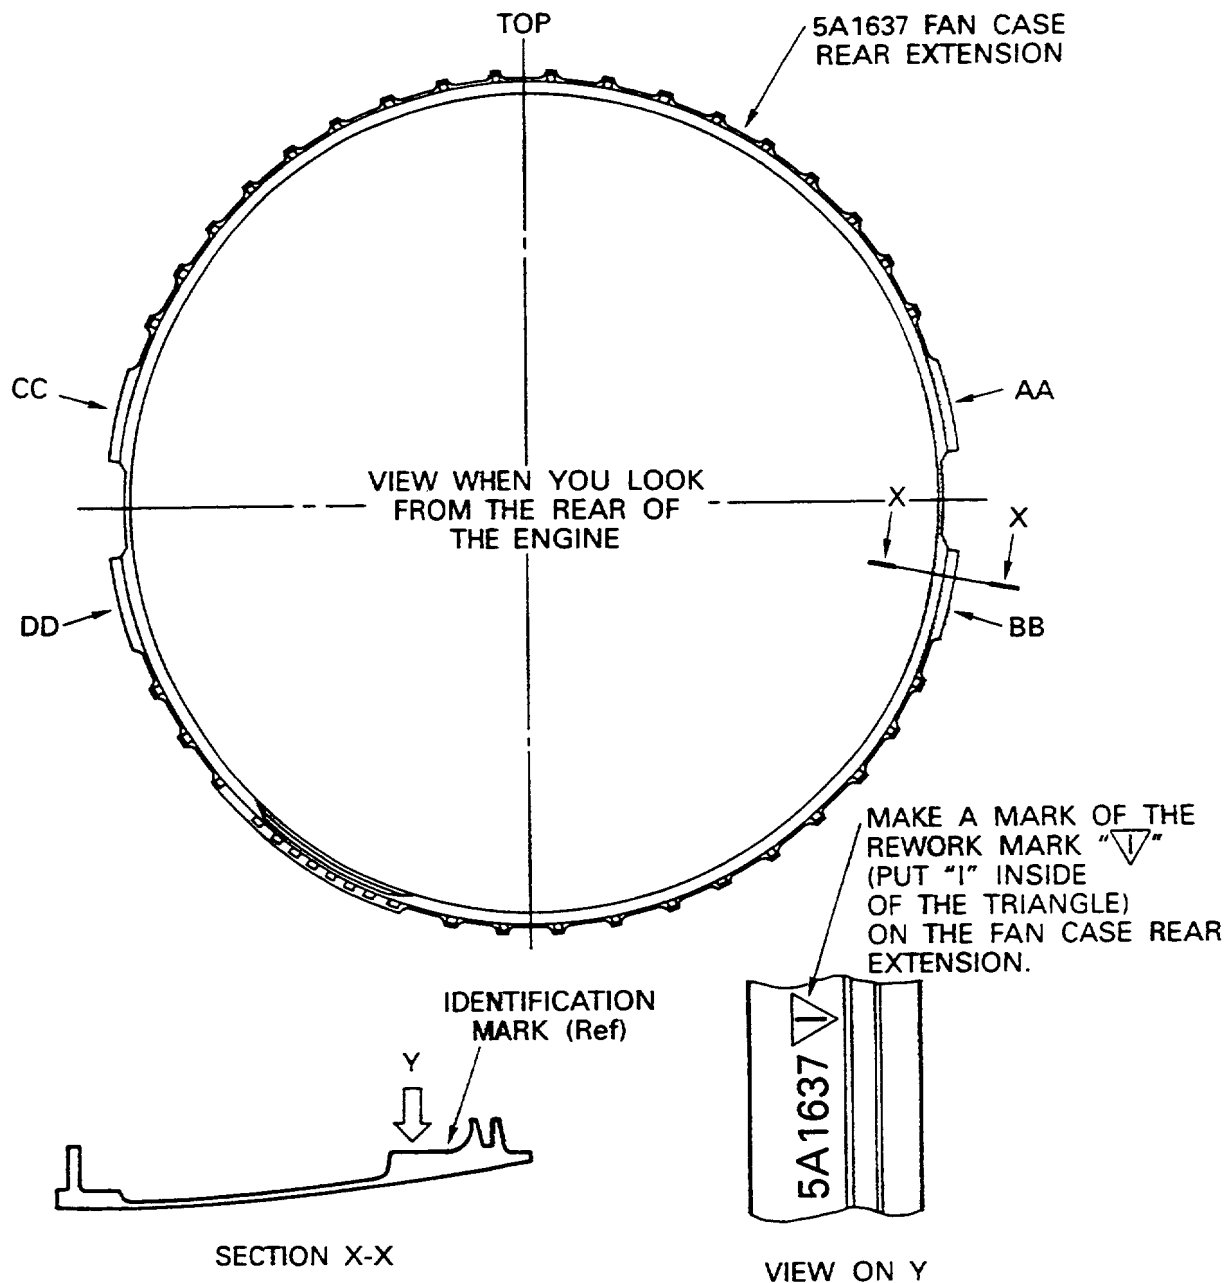
Rework of the Fan Case Rear Extension
Fig.1

Inspection revealed that diameter of the holes on the existing fan case rear extension is out of limit which may impede installation of the bolts.

- (a) Find the 16 holes which are to be enlarged on the fan case rear extension.
- (b) Put the applicable covers on all of openings.
- (c) Clean the 16 holes
- (d) Machine the holes in accordance with following methods;
(You can select the following two methods)

| (g) Make a mark of the Rework Mark adjacent to the identify marking area. | See Figure 1 and Reference (2), Control No./ TASK 70-09-00-400-501, Marking of Parts. |

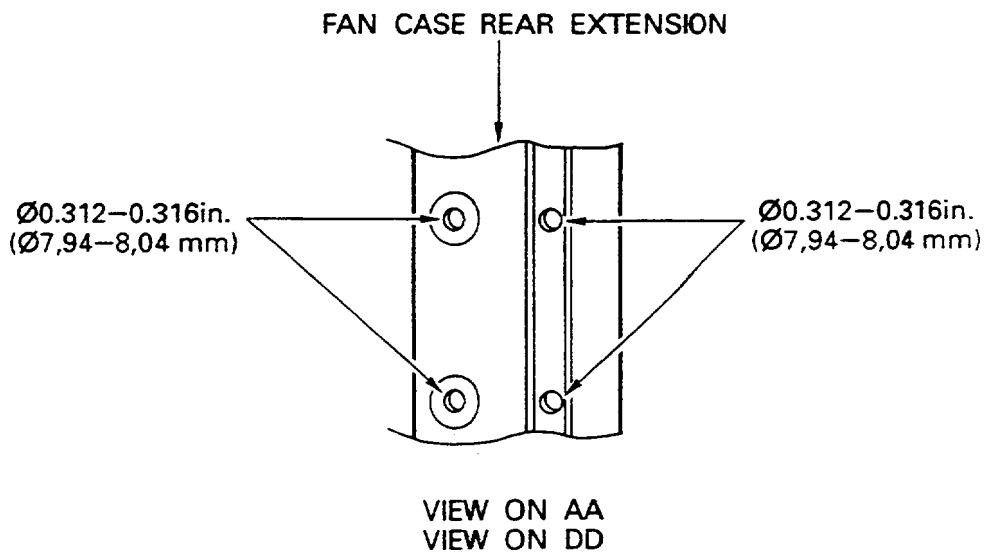
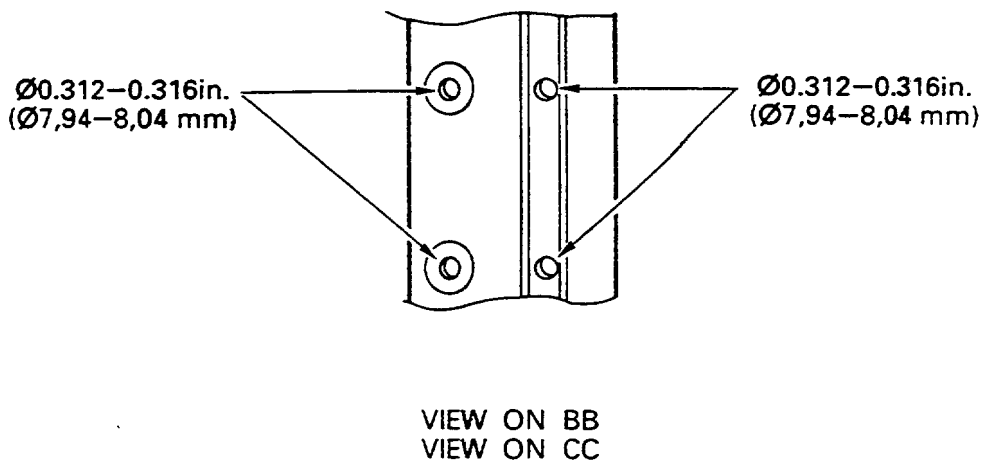
Rework of the Fan Case Rear Extension
Fig.2

NOTE: Diameter of the enlarged hole shall not exceed 0.316 in (8,04 mm).

Use 0.312 – 0.316 in (7,94 – 8,04 mm) hand reamer. remove small amounts of material per side for hole. See Reference (2), Control No./ TASK No. 70-32-01-320-501, Machine Reaming.

Use 0.312 – 0.316 in (7,94 – 8,04 mm) drill. Keep the center line to existing holes.

See Figure 2.
Measure the dimension and ensure that the edges are smooth.

Measure the dimension of the enlarged holes. |
