V2500-A1/A5/D5 SERIES PROPULSION SYSTEMS SERVICE BULLETIN

This document transmits Revision 3 to Service Bulletin EV2500-72-0227

V2500-ENG-72-0227

ENGINE - LP TURBINE - PROVIDE A NEW BLIND CAP WITH DECREASED SEAL LAND HEIGHT

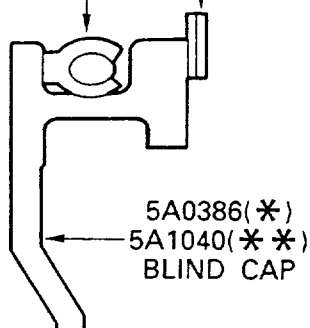
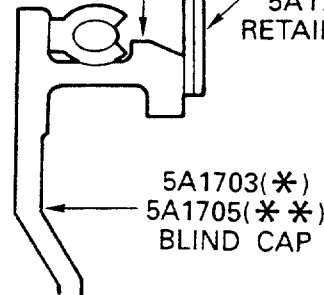
Before and after alteration of blind cap and retaining ring
Fig 1

It was confirmed that the distortion of the Sealing Ring can occur during installation of the Blind Cap and Sealing Ring Assembly into the LPT Shaft.

The distortion of the Sealing Ring resulted in oil leakage from the No.5 Bearing Compartment into the LPT Shaft and contamination of the Fan Blades.

SEAL LAND HEIGHT
REDUCED

TOOLS (SLIDER AND RESIZER)
REQUIRED TO ASSEMBLE
THE SEALING RING

NO TOOL REQUIRED TO ASSEMBLE
THE SEALING RING

- (a) The rear height of rear Blind Cap Seal Land is reduced. Refer to Figure 1.

- (b) The Retaining Ring is radically widened related to the feature change of the Blind Cap. Refer to Figure 1.
- (2) For V2500-A1 Engines, the existing Blind Cap is reworkable. Refer to Figure 2. For V2522-A5, V2524-A5, V2527-A5, V2527E-A5, V2527M-A5, V2530-A5, V2525-D5 and V2528-D5 Engines, the existing Blind Cap is not reworkable.
- (3) The old Seal Ring and the new Seal Ring are distinguished by the following colors:
