International Aero Engines

## V2500-A1 SERIES PROPULSION SYSTEMS SERVICE BULLETIN

V2500-ENG-72-0233

MODIFICATION SERVICE BULLETIN – ENGINE – LP COMPRESSOR – ROD ADJUSTMENT FEATURE  
RELOCATION OF LPC BLEED RIGGING

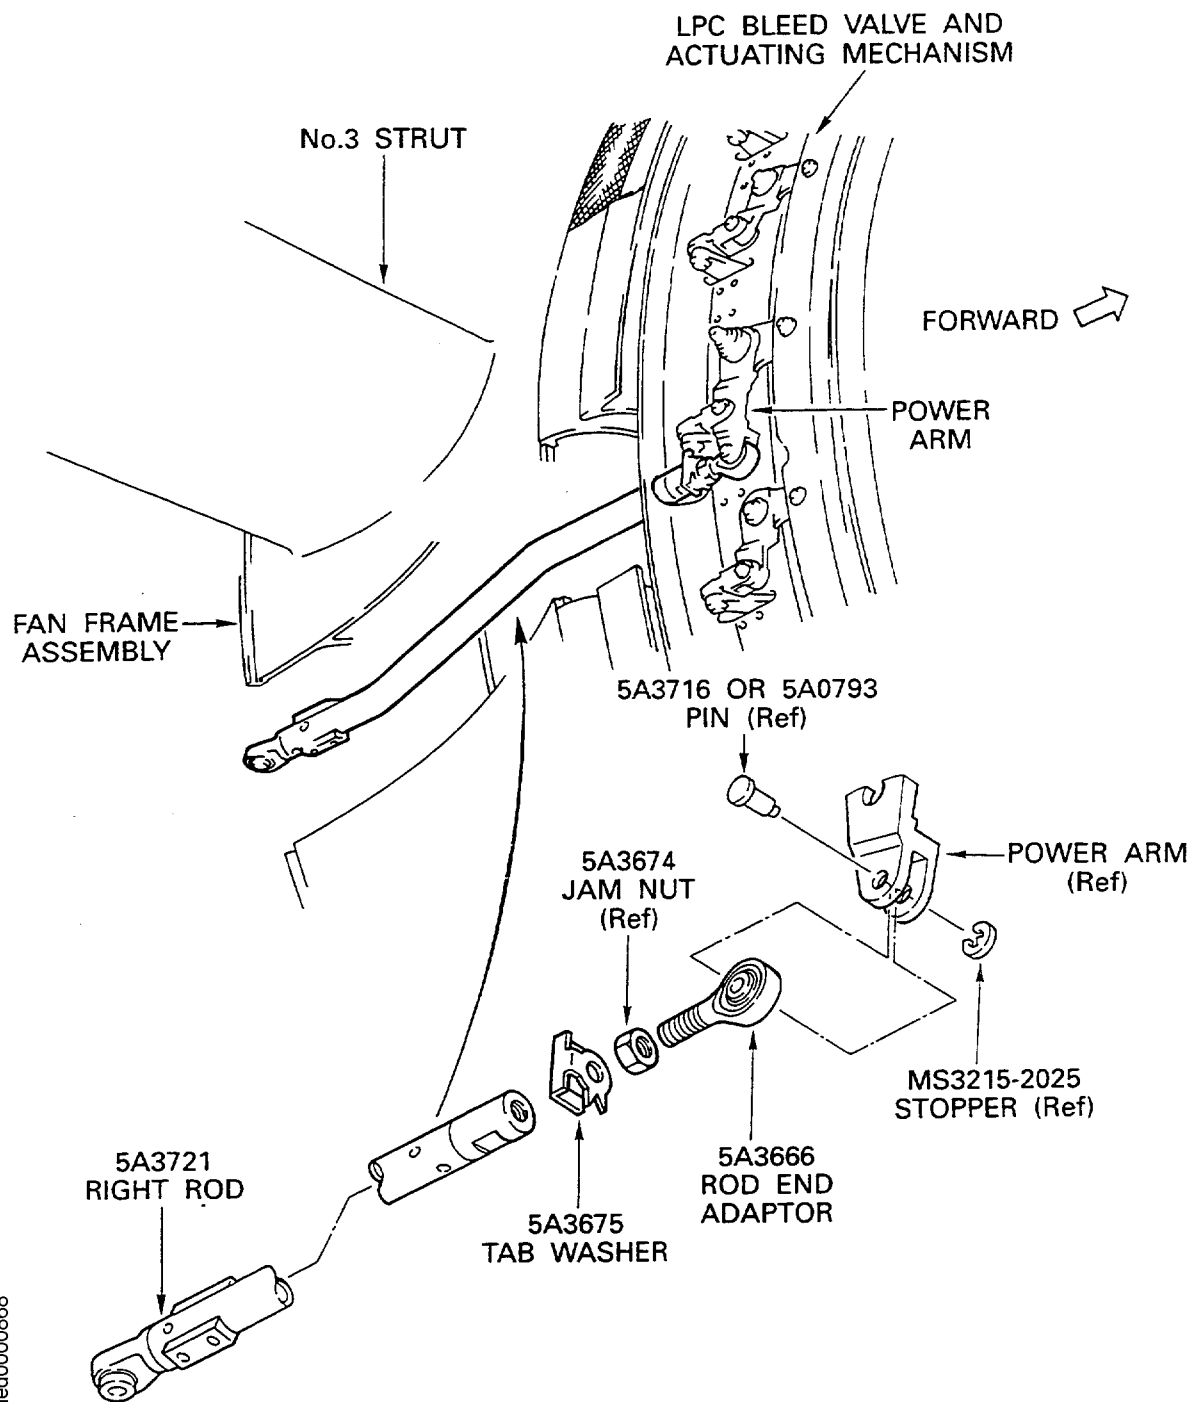
Fig.1 Before Alteration of the Right Rod Assembly of LPC Bleed Valve

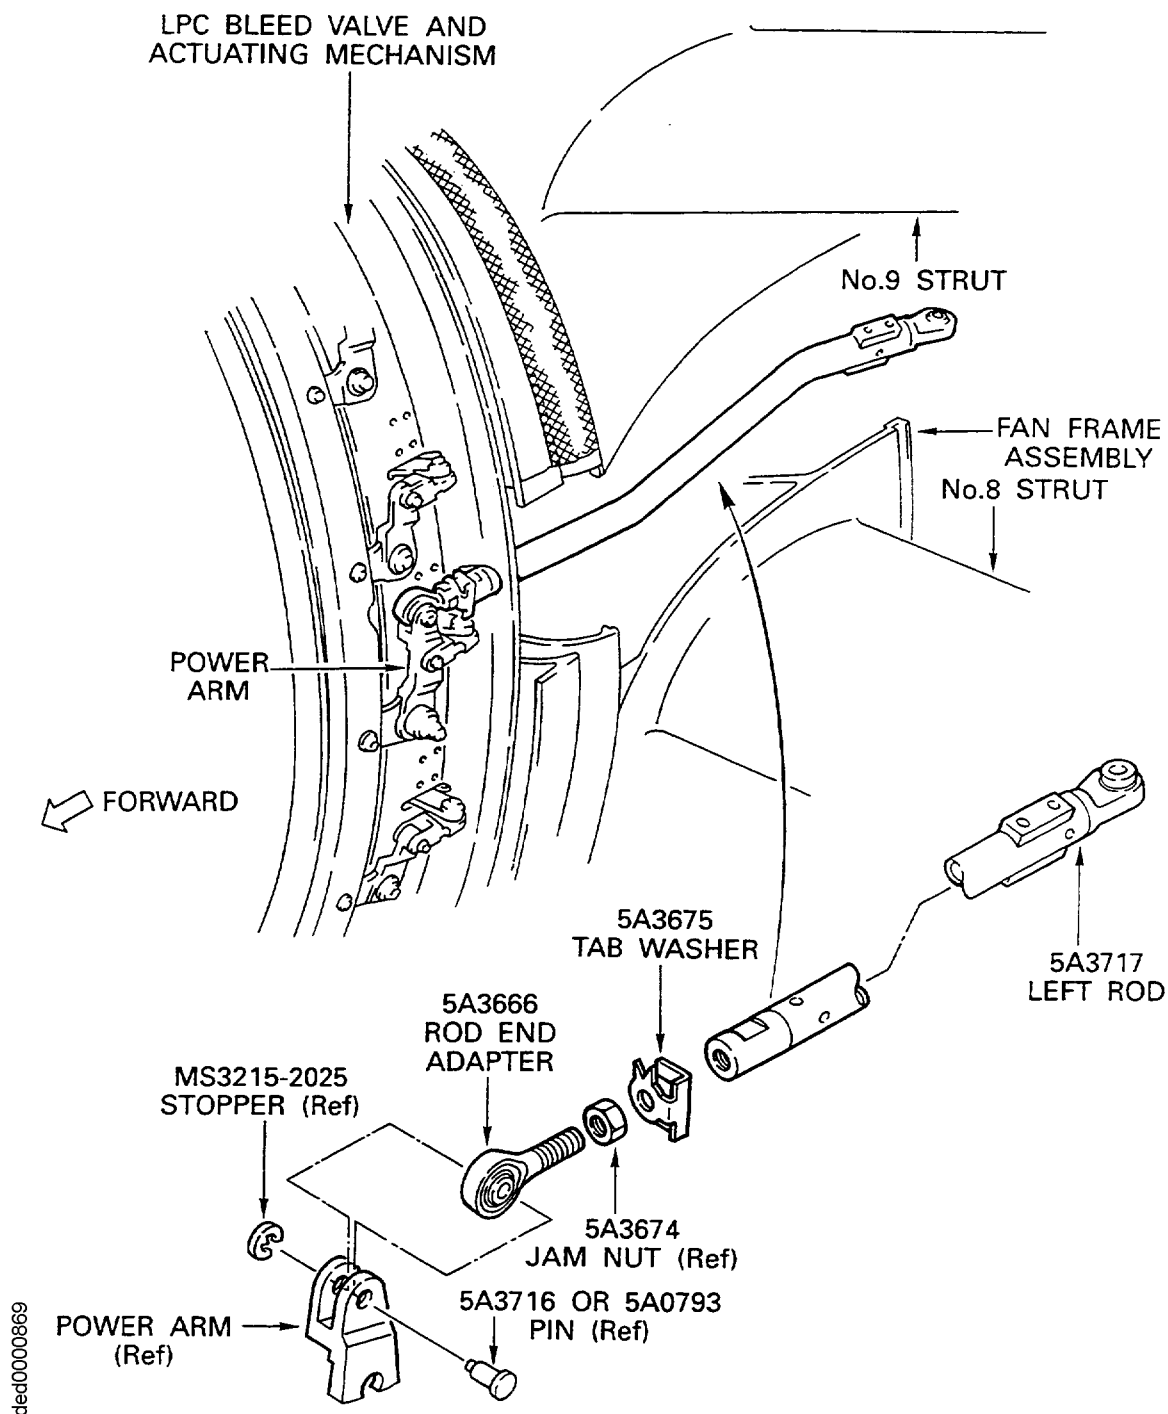
Fig.2 Before Alteration of the Left Rod Assembly of LPC Bleed Valve

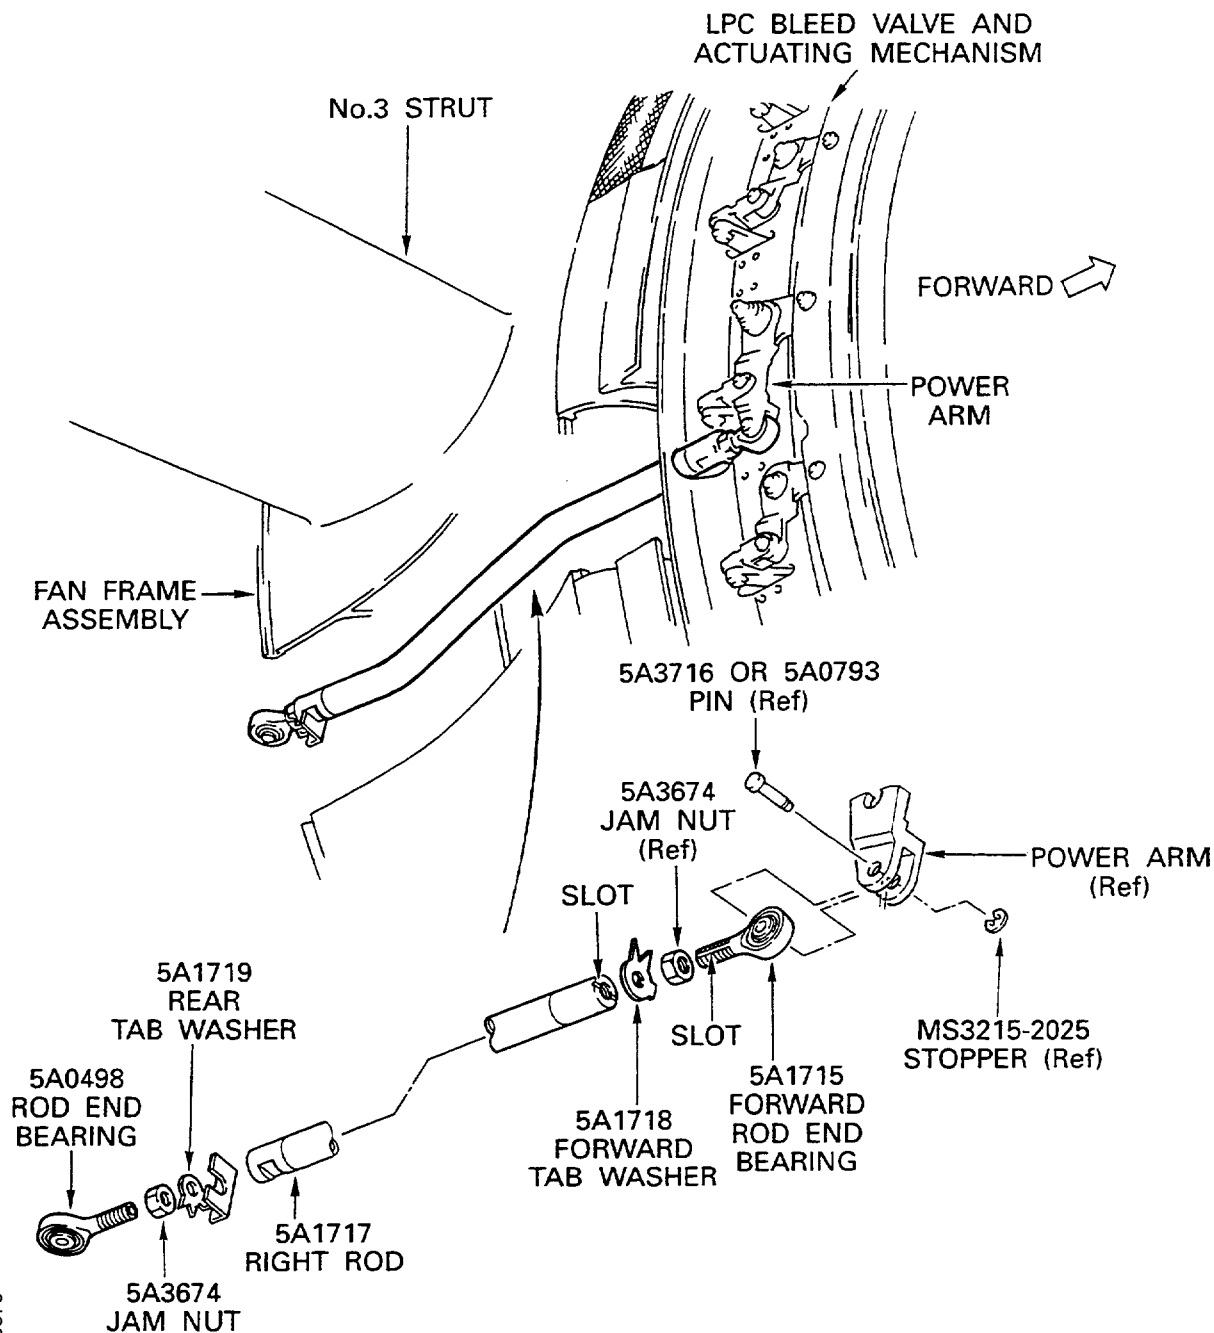
Fig.3 After Alteration of the Right Rod Assembly of  
LPC Bleed Valve

- (1) The procedures that follow must be done to accomplish this bulletin
  - (a) Install the rod assemblies by use of approved procedures given in Reference(3), TASK 72-32-00-430-008-B00, SUBTASK 72-32-00-430-303, ASSEMBLY-08, CONFIG-2.

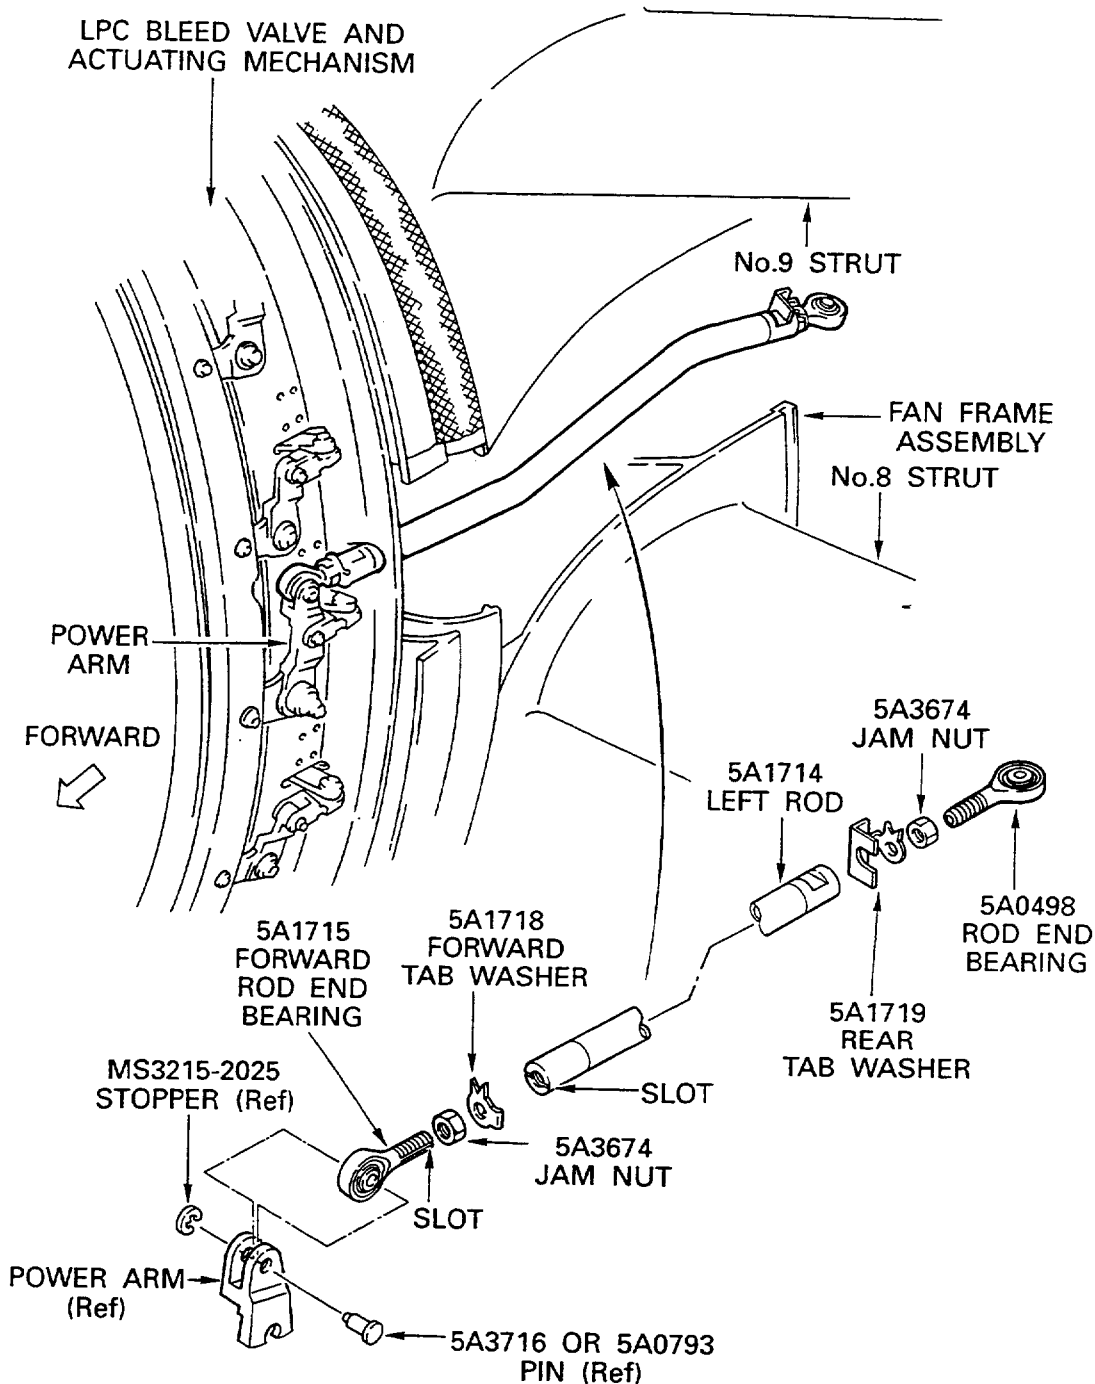
Fig.4 After Alteration of the Left Rod Assembly of  
LPC Bleed Valve

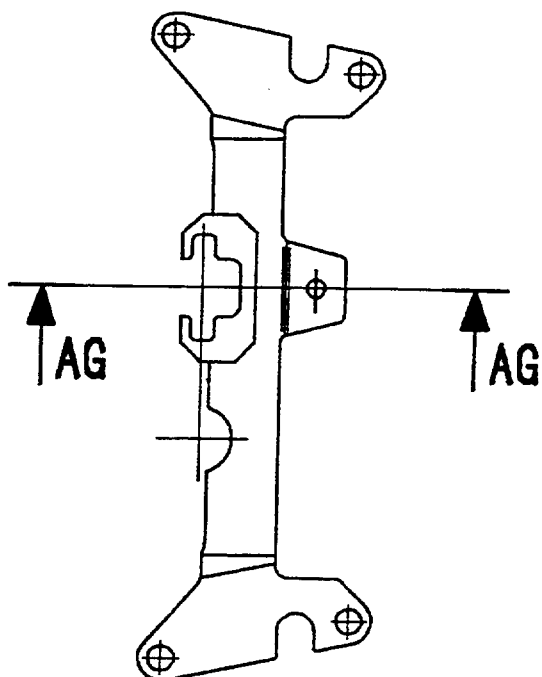
Rework of existing guide plates  
Fig 8

VIEW ON ARROW **AE**  
BSBVA MASTER GUIDE PLATE 5A0334

| (c) Rework the Guide, A/O BSBVA Master, in the area shown. | See Fig 8 and 9. Use standard workshop equipment. |
| (d) Remove sharp edges. | See Fig 8 and 9. Use standard workshop equipment. |

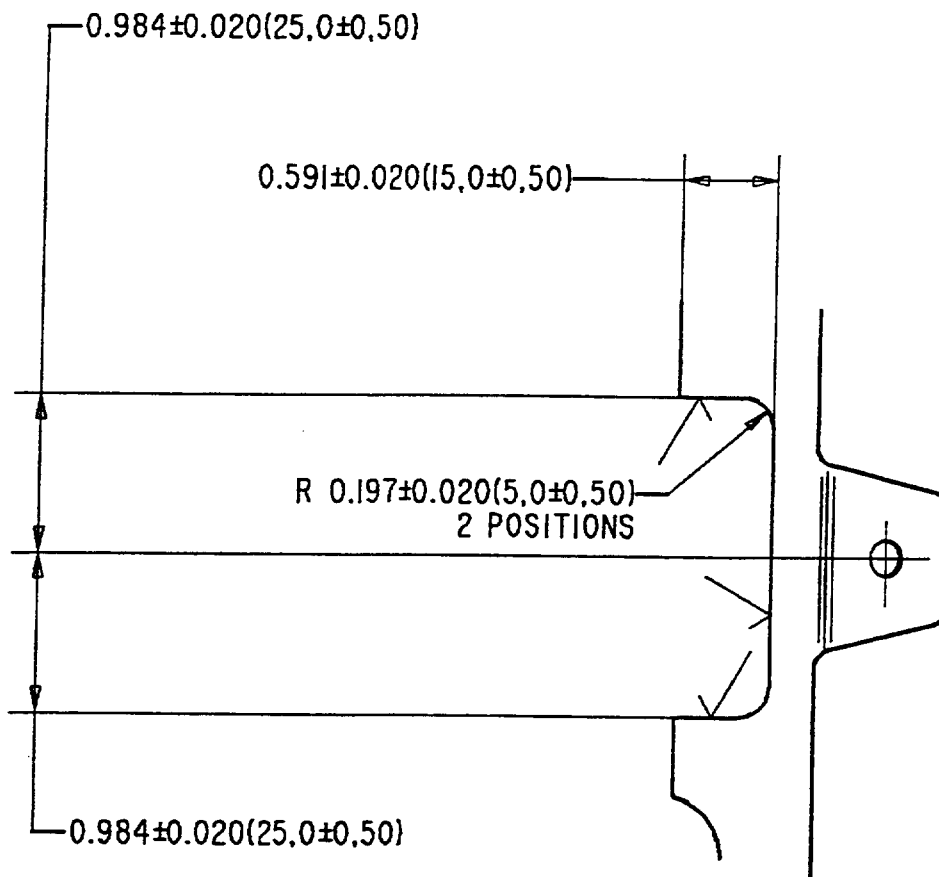
Rework of existing guide plates  
Fig 9

ENLARGED VIEW ON ARROW **AH**  
SHOWING REQUIRED MACHINING

- (f) Do a swab etch on the reworked area. Refer to SPM TASK 70-11-08-300-503 SUBTASK 70-11-08-300-002. Use chemical cleaning equipment.
- (g) Do a local penetrant crack test on the reworked area. Refer to SPM TASK 70-23-05-230-501. Use CoMat 06-022 Fluorescent penetrant, with penetrant crack test equipment.
- (i) If cracked Reject.
- (h) Visually examine and measure the dimensions of the reworked area. See Fig 8 and 9.
- (i) Cancel the existing part number and identify with the new part number. Refer to SPM TASK 70-09-00-400-501, SUBTASK 70-09-00-400-001. Use vibro engraving equipment.

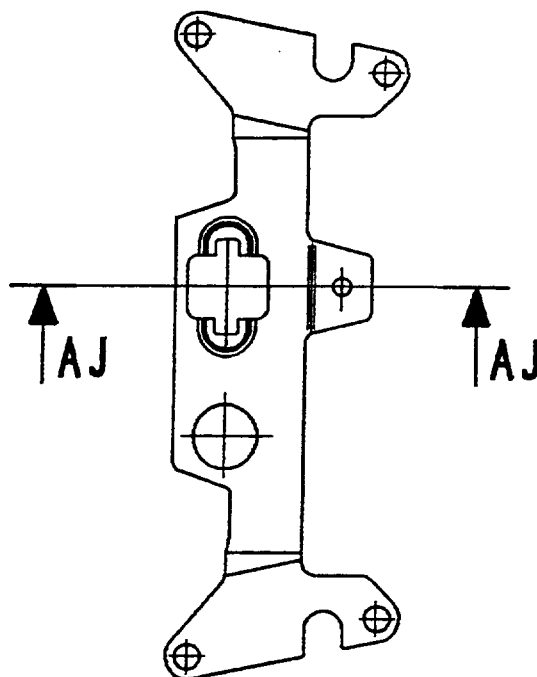
Rework of existing guide plates  
Fig 10

VIEW ON ARROW **AE**  
BSBVA MASTER GUIDE PLATE 5A9013

(c) Rework the Guide, A/O BSBVA Master, in the area shown.	See Fig 10 and 11. Use standard workshop equipment.
(d) Remove sharp edges.	See Fig 10 and 11. Use standard workshop equipment.

(i) If cracked	Reject.
(h) Visually examine and measure the dimensions of the reworked area.	See Fig 10 and 11.
(i) Cancel the existing part number and identify with the new part number.	Refer to SPM TASK 70-09-00-400-501, SUBTASK 70-09-00-400-001. Use vibro engraving equipment.

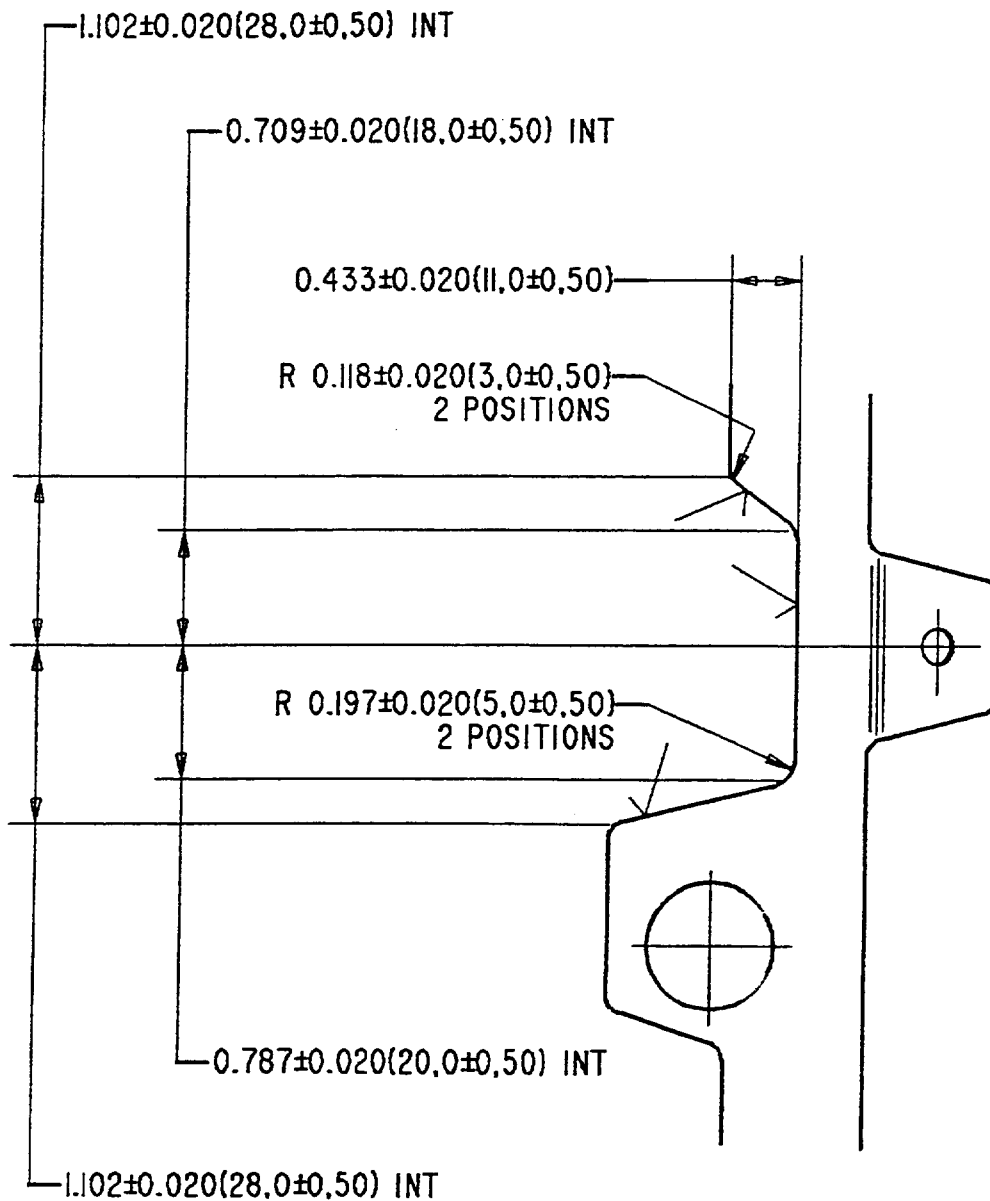
Rework of existing guide plates  
Fig 11

ENLARGED VIEW ON ARROW **AK**  
SHOWING REQUIRED MACHINING

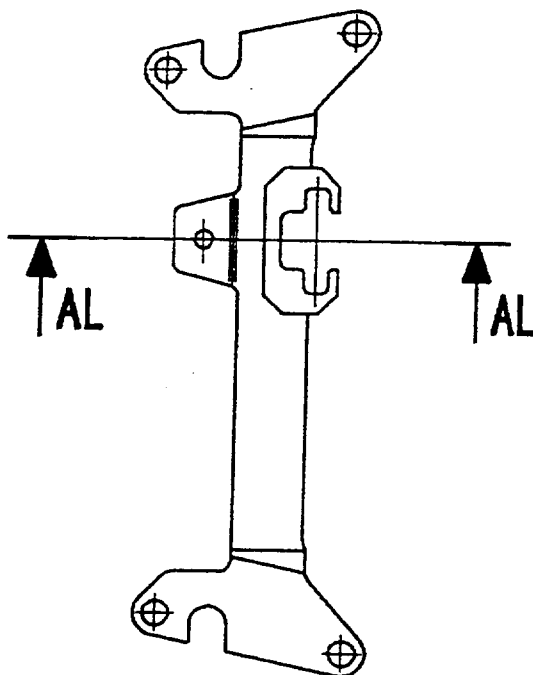
Rework of existing guide plates  
Fig 12

VIEW ON ARROW **AF**  
BSBVA SLAVE GUIDE PLATE 5A0335

| (c) Rework the Guide, A/O BSBVA Slave, in the area shown. | See Fig 12 and 13. Use standard workshop equipment. |
| (d) Remove sharp edges. | See Fig 12 and 13. Use standard workshop equipment. |

- (g) Do a local penetrant crack test on the reworked area. Refer to SPM TASK 70-23-05-230-501. Use CoMat 06-022 Fluorescent penetrant, with penetrant crack test equipment.
- (i) If cracked Reject.
- (h) Visually examine and measure the dimensions of the reworked area. See Fig 12 and 13.
- (i) Cancel the existing part number and identify with the new part number. Refer to SPM TASK 70-09-00-400-501, SUBTASK 70-09-00-400-001. Use vibro engraving equipment.

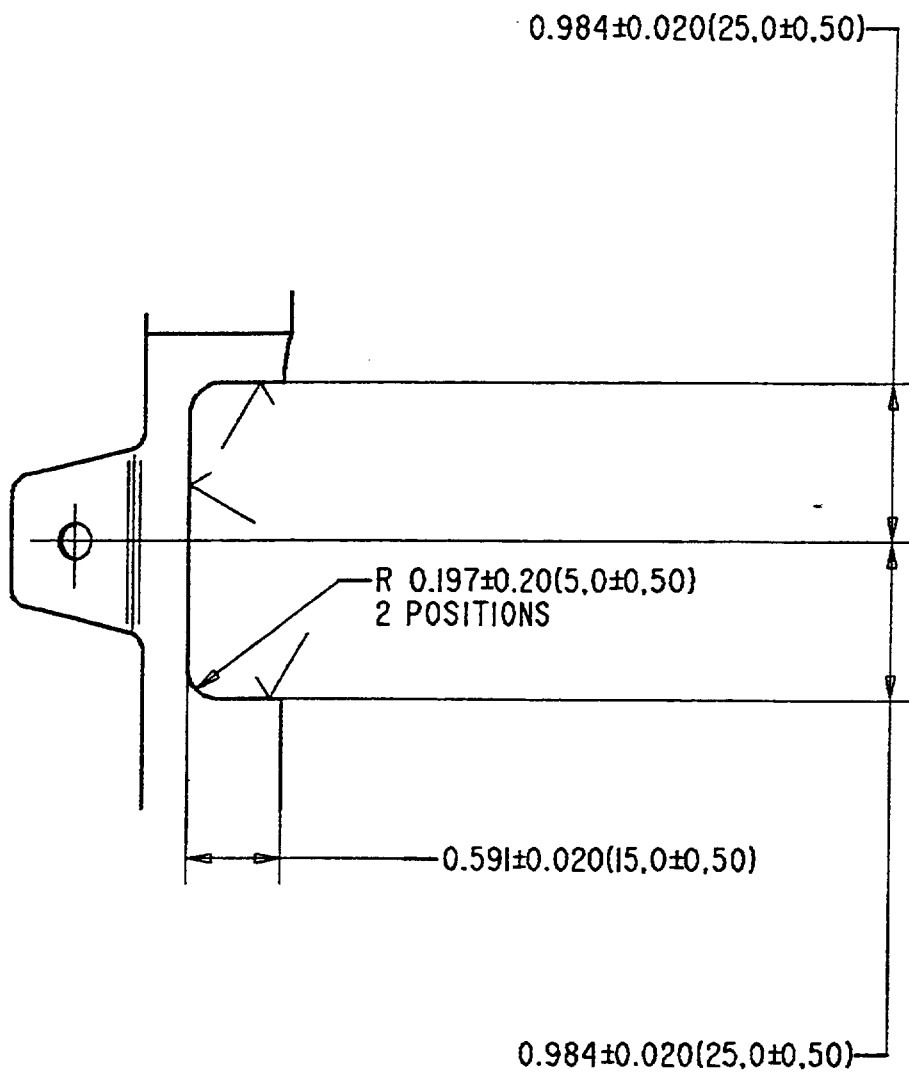
Rework of existing guide plates  
Fig 13

ENLARGED VIEW ON ARROW **AM**  
SHOWING REQUIRED MACHINING

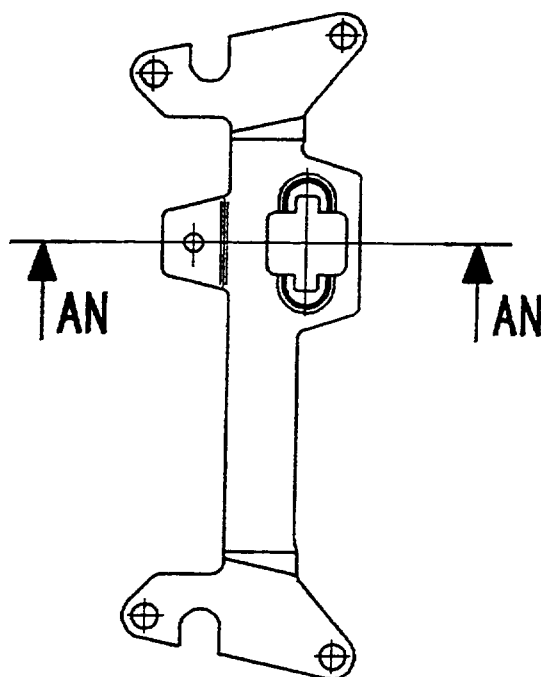
Rework of existing guide plates  
Fig 14

VIEW ON ARROW **AF**  
BSBVA SLAVE GUIDE PLATE 5A9017

- (b) Mark off the area of the Guide, A/O BSBVA Slave, that is to be removed. See Fig 5, 6, 7, 14 and 15. Use standard workshop equipment.
- (c) Rework the Guide, A/O BSBVA Slave, in the area shown. See Fig 14 and 15. Use standard workshop equipment.

- (d) Remove sharp edges. See Fig 14 and 15. Use standard workshop equipment.
- (e) Chemical clean the Guide, A/O BSBVA Slave. Refer to SPM TASK 70-11-03-300-503. Use chemical cleaning equipment.

- (i) If cracked Reject.
- (h) Visually examine and measure the dimensions of the reworked area. See Fig 14 and 15.
- (i) Cancel the existing part number and identify with the new part number. Refer to SPM TASK 70-09-00-400-501, SUBTASK 70-09-00-400-001. Use vibro engraving equipment.

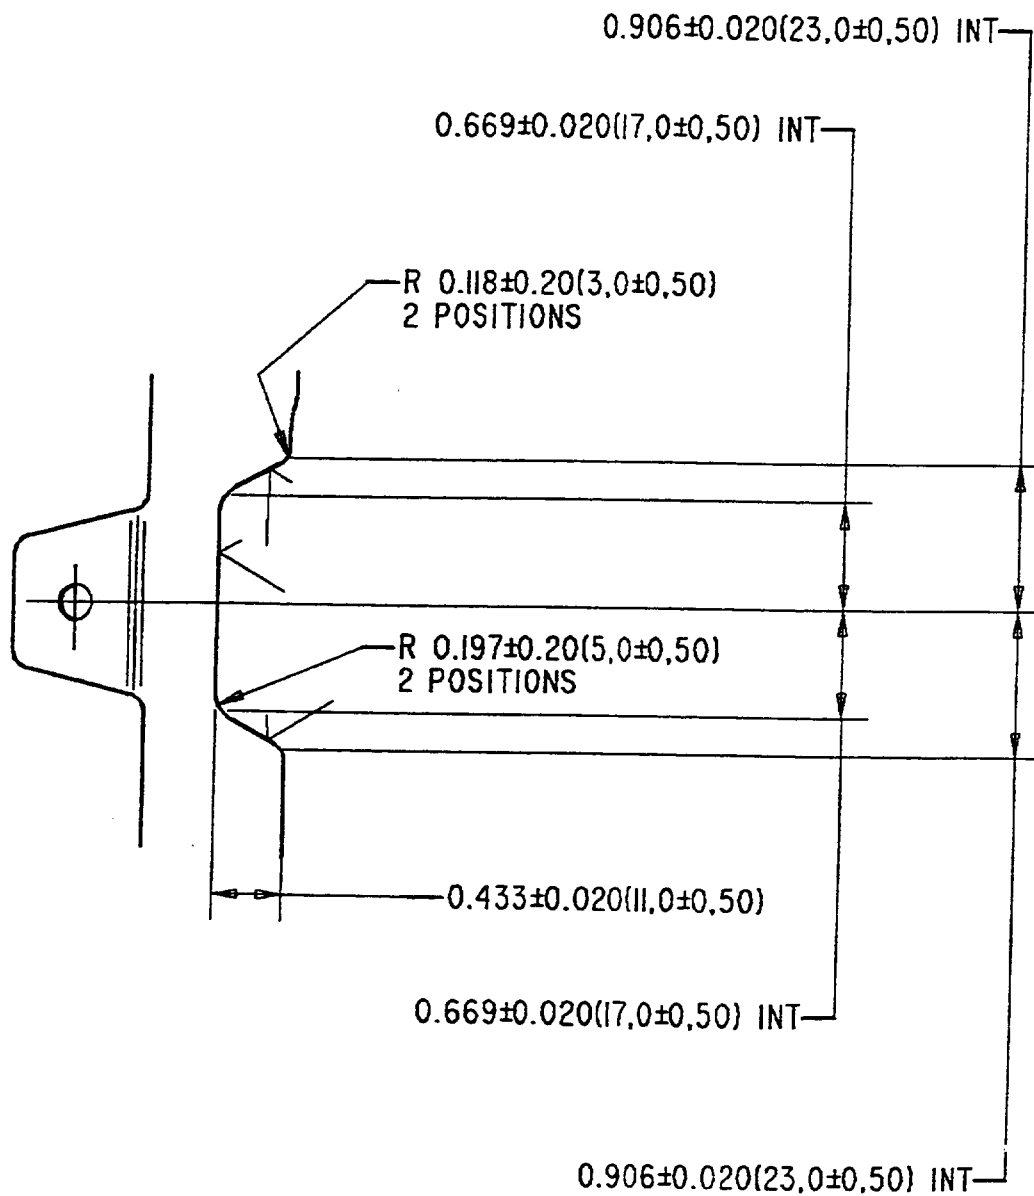
Rework of existing guide plates  
Fig 15

ENLARGED VIEW ON ARROW **AP**  
SHOWING REQUIRED MACHINING
