# International Aero Engines SERVICE BULLETIN

Subject: Transmittal of Revision 2 to Service Bulletin  
No.V2500-ENG-72-0234

**V2500-ENG-72-0234**

**ENGINE - LP COMPRESSOR - TRIMMING OF ANNULUS FILLER PLATFORM EDGE**

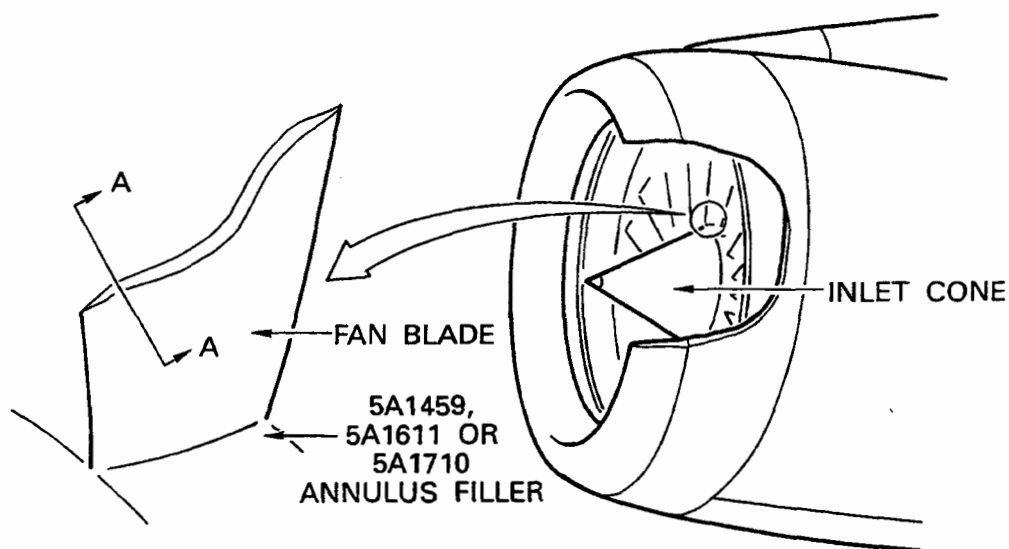
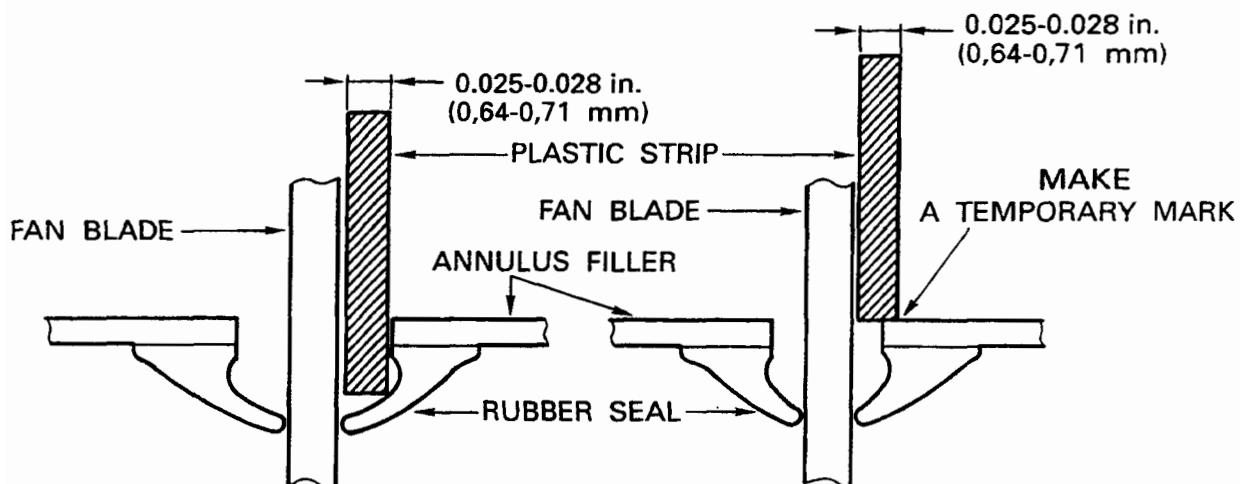
Check the gaps between the Annulus Fillers  
and the Stage 1 LP Compressor Fan Blade  
Figure 1

- (1) This Service Bulletin applies to the engines which experienced the N1 Vibration Shifting.
- (2) This Service Bulletin introduces the trimming of the platform edge of the 5A1459, 5A1611 or 5A1710, Annulus Filler to keep each gap between the Annulus Filler and the Stage 1 LP Compressor Fan Blade by minimum 0.025 in (0,64 mm).
- (3) Existing Annulus Fillers, which have not kept the gap minimum 0.025 in (0,64 mm), should be reworked (See Figure 1).

(1) Check each gap between the 5A1459, 5A1611 or 5A1710 Annulus Filler and the Stage 1 LP Compressor Fan Blade as follows:  
(Refer to Figure 1)

PUT THE PLASTIC STRIP INTO THE GAP BETWEEN THE ANNULUS FILLER AND THE CONVEX SIDE OF THE FAN BLADE, AND TRAVERSE IT. IF IT STUCK IN THE GAP, MARK ON THE ANNULUS FILLER.

- (2) Make a temporary mark on the Annulus Filler with the width 0.025 - 0.028 in (0,64 - 0,71 mm) from the Fan Blade using the Plastic Strip (Refer to Figure 1).

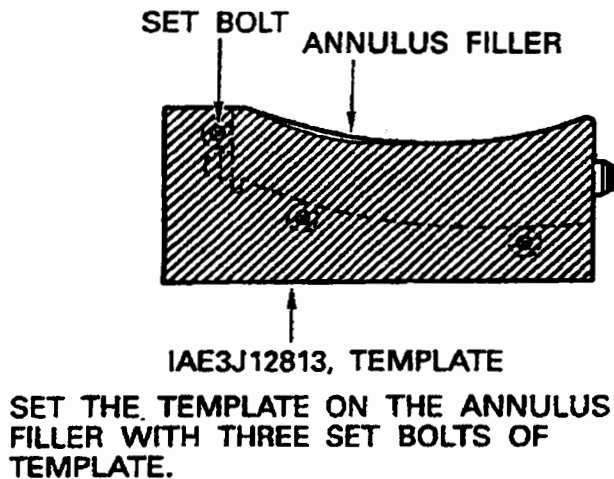
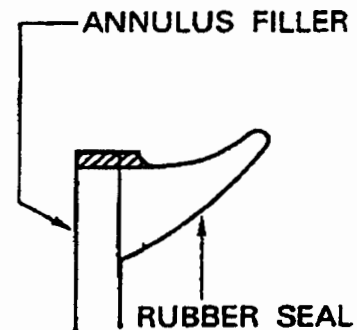
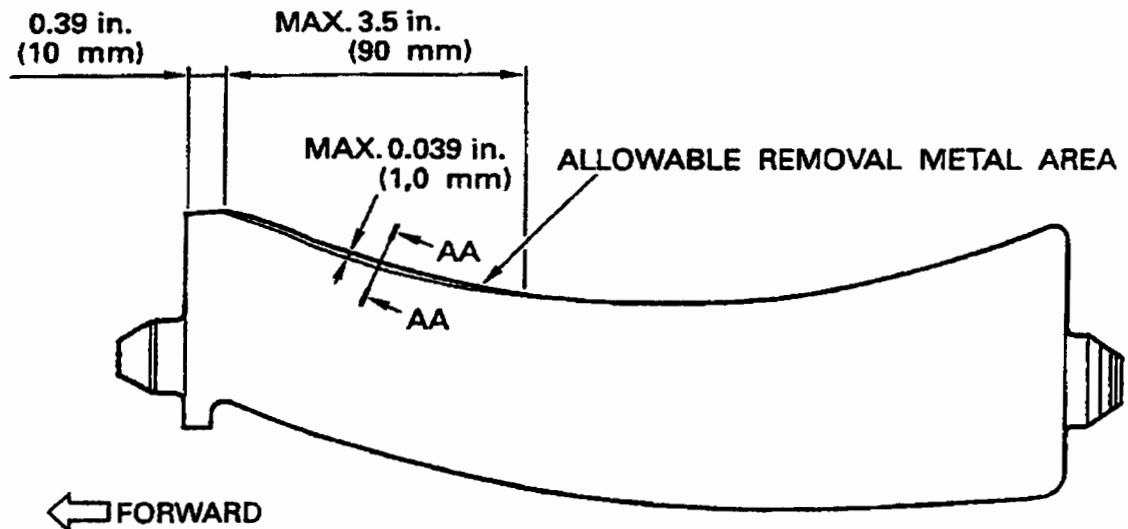
Trimming of the Annulus Filler Platform Edges  
Figure 4

If the mark is not hidden and out of the Template, do Paragraph D for trimming of the Annulus Fillers.

TRIM THE HATCHED AREA

<u>Procedure</u>	<u>Supplemental Information</u>
R a) Trim the Annulus Filler along R with the temporary mark made R in Paragraph B. (2) R or by maximum amount R R R R R R	Refer to Figure 4 for minimum amount trimming, refer to Figure 4A for maximum amount trimming, Refer to Reference (4) , TASK 70-35-03-300-501 Hand Polish and Blend Procedure.

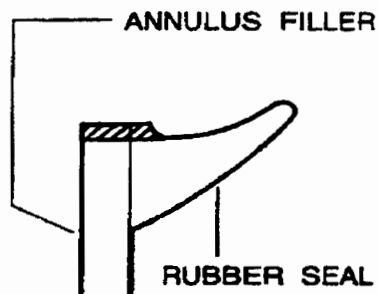
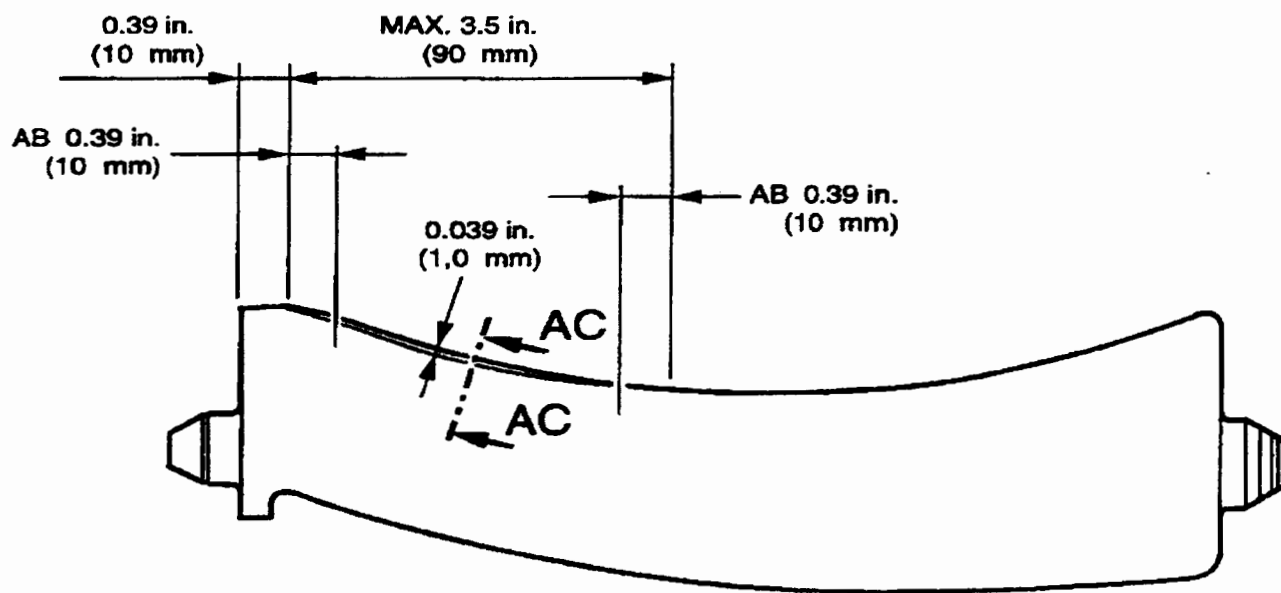
Trimming of the Annulus Filler Platform Edges  
Figure 4A

R CAUTION: THE ANNULUS FILER TRIMMED MAXIMUM AMOUNT MAY INCREASE THE  
R POSSIBILITY OF RUBBER SEAL FLIPPING AT OPERATION WHICH MAY  
R RESULT IN THE LOW PRESSURE ROTOR VIBRATION PROBLEM.

TRIM THE HATCHED AREA

**NOTE:** DECREASE THE TRIMMING DEPTH FROM 0.039 in. (1.0 mm) TO 0 in. (0 mm) UNIFORMLY IN AREAS AB.

R If the IAE3J12813, Annulus Filler Trimming Template is not  
R available, you can do a rework of the Annulus Filler one time  
R by trimming the maximum amount.
