International Aero Engines SERVICE BULLETIN

ENGINE - HP TURBINE ROTOR AND STATOR ASSEMBLY - PROVIDE A NEW ORIFICE PLATE WITH
AN INCREASED OPENING SIZE

72-45-00

V2500-ENG-72-0236

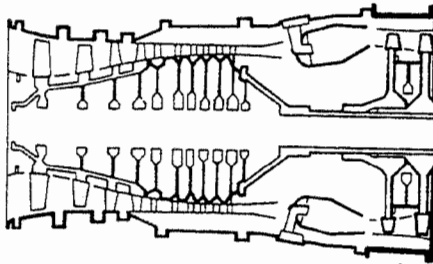
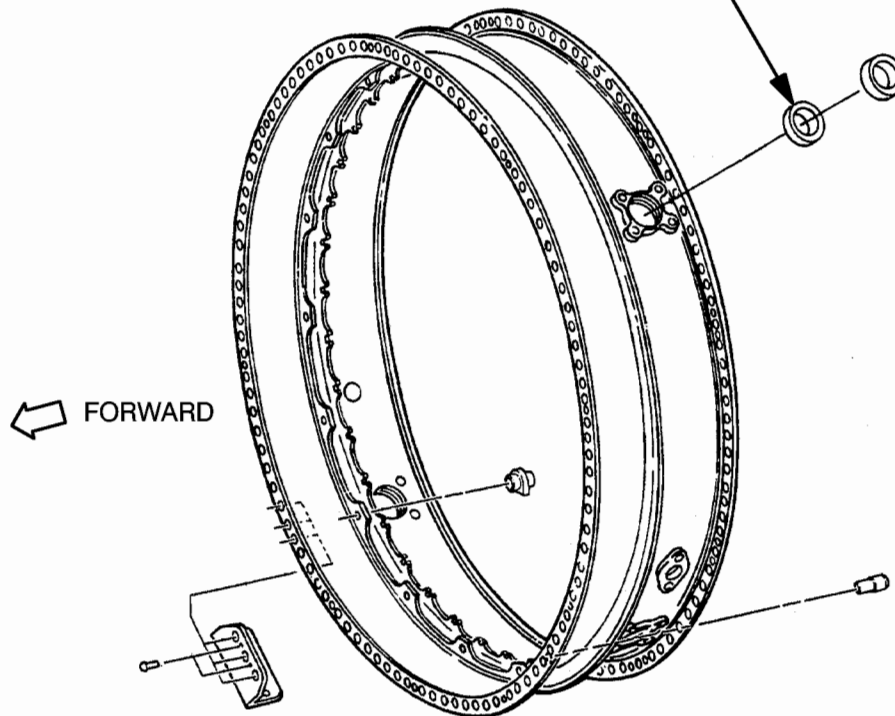
Location of the Orifice Plate
Figure 1

CAUTION: FAILURE TO INCORPORATE THE INCREASED FLOW ORIFICE AT THE FIRST OPPORTUNITY CAN RESULT IN HIGHER OPERATING TEMPERATURES IN THE AREA OF THE HIGH PRESSURE TURBINE SECOND STAGE AIR SEAL. THIS CAN LEAD TO THE LONG TERM PREMATURE REPLACEMENT OF THE AIR SEAL AND SECOND STAGE DISK DUE TO FAILURE TO MEET ENGINE MANUAL INSPECTION REQUIREMENTS.

- (1) Condition:
Potentially high operating temperatures in the front and rear knife edge cavities of the high pressure turbine second stage airseal.
- (2) Background:
The possibility of increased high pressure turbine second stage airseal knife edge clearances in overhauled engines can lead to ingestion of hot, flowpath gases into the front and rear air seal cavities. This hot flowpath gas increases the operating temperatures of the second stage air seal and the second stage disk in the blade attachment area.
- (3) Objective:
Increase the flow of cooling air being fed to the second stage air seal cavities through the second stage vane by increasing the size of the cooling air supply orifice. This will eliminate the hot gas ingestion and reduce the operating temperatures of the second stage air seal and disk.
- (4) Substantiation
Satisfactorily completed by structural analytical review.

- (a) Set-up and machine to open the 0.835-0.845 in. (21,21-21,46 mm) diameter to 0.870 - 0.880 in. (22,10 - 22,35 mm) diameter.

- 1 Hold concentric to the outside diameter 0.010 in. (0.254 mm).

- 2 Break sharp edges 0.003 - 0.015 inch (0,08-0,38 mm).

REPLACE THE 2A3692 ORIFICE PLATE
WITH THE 2A3734* ORIFICE PLATE (4 off)
