SERVICE BULLETIN

ENGINE - HP TURBINE ROTOR AND STATOR ASSEMBLY - PROVIDE NEW STAGE 2 HPT VANES -
CATEGORY CODE 8 - MOD.ENG-72-0237

V2500-ENG-72-0237

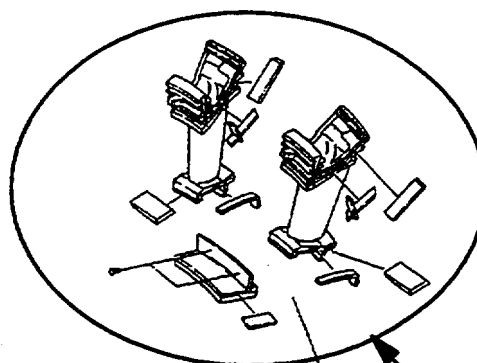
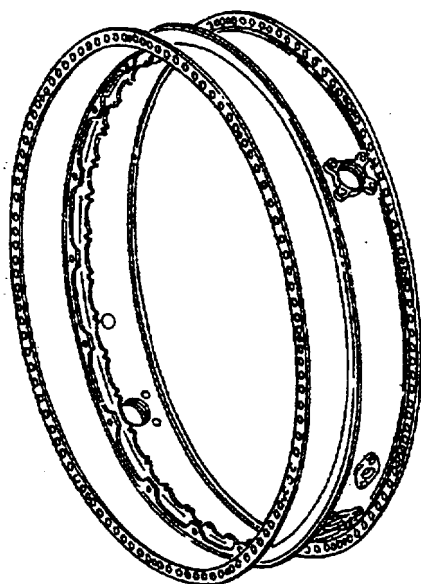
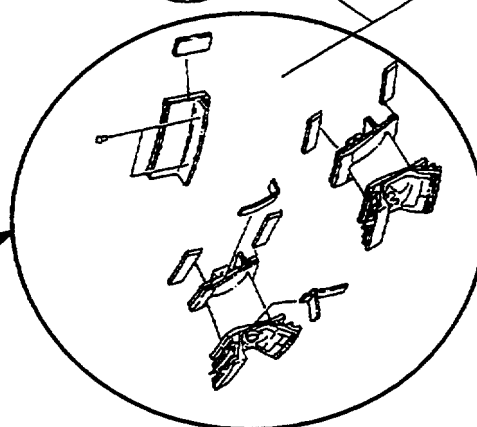
Location of the Stage 2 High Pressure Turbine (HPT) Vane Assemblies
Fig.1

INSTALL THE
2A3812 RING
SEGMENT AND
VANE CLUSTER
ASSEMBLY (17 off)

INSTALL THE
2A3822 RING
SEGMENT AND
VANE CLUSTER
ASSEMBLY (2 off)
