DATE ~~R~~ Feb.20/02**V2500-A5/D5 PROPULSION SYSTEMS SERVICE BULLETIN**

This document transmits Revision 2 to Service Bulletin EV2500-72-0241

ENGINE – STAGE 1 TURBINE NOZZLE ASSEMBLY – PROVIDE A NEW STAGE 1 HPT COOLING DUCT ASSEMBLY AND SEGMENTS

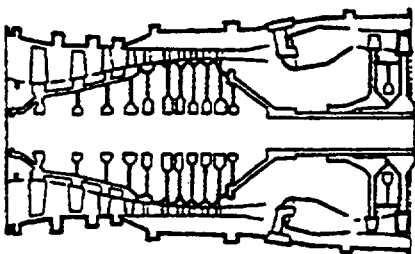
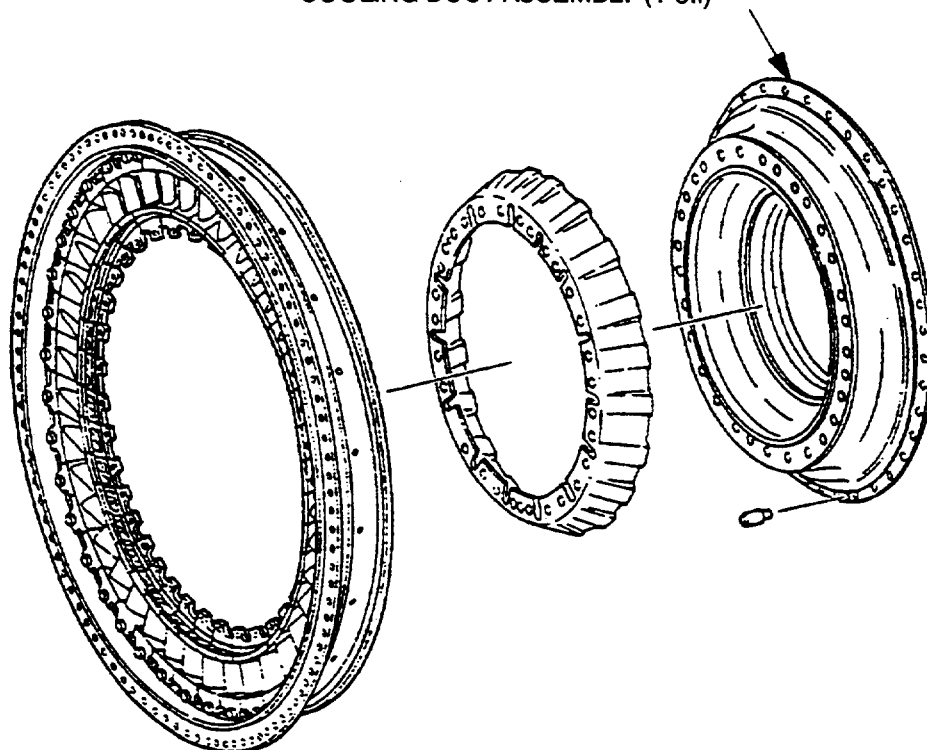
Location of the Stage 1 High Pressure Turbine Duct Assembly  
Figure 1

INSTALL THE 2A3180-01 STAGE 1 HPT  
COOLING DUCT ASSEMBLY (1 off)

- (1) Do a modification of the 2A2141-01 Stage 1 High Pressure Turbine (HPT) Duct Assembly (1 off). See Reference (3), 72-44-50 Figure/Item No. 01-010).

(3) Install the 2A3180-01 Stage 1 High Pressure Turbine (HPT) Cooling Duct Assembly (1 off) by the procedure given in Reference (5), Chapter/Section 72-44-00, Assembly (for V2522-A5, V2524-A5, V2527-A5, V2527E-A5, V2527M-A5 and V2530-A5 Engines) or Reference (6), Chapter/Section 72-44-00, Assembly (for V2525-D5 and V2528-A5 Engines).

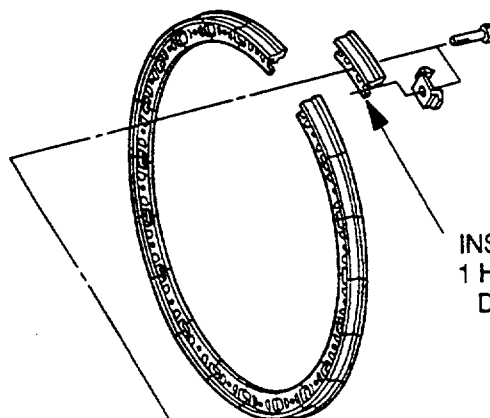
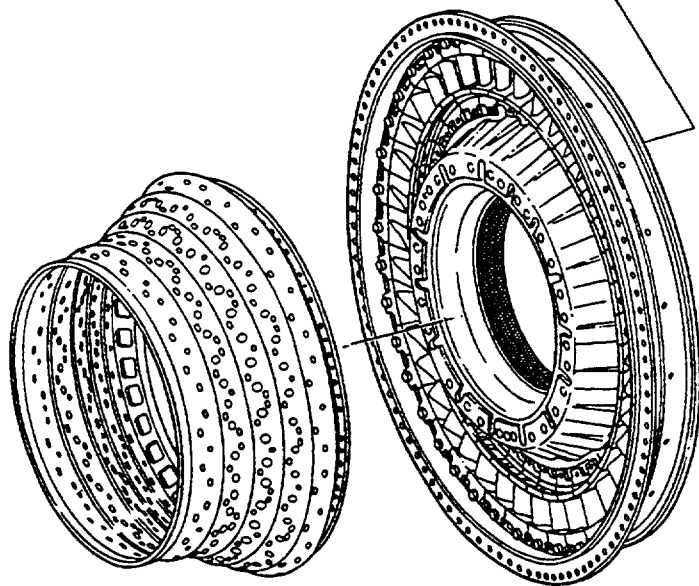
Location of the Stage 1 High Pressure Turbine Duct Segments  
Figure 2

INSTALL THE 2A3181 STAGE  
1 HIGH PRESSURE TURBINE  
DUCT SEGMENTS (20 off)

- (2) Do a modification of the 2A2364 Stage 1 High Pressure Turbine (HPT) Duct Segments (20 off). See Reference (3), 72-44-60 Figure/Item No. 01-010).
- (a) Set-up and machine to open the two 0.079 - 0.083 in. (2,007 - 2,108 mm) to 0.114 - 0.124 in. (2,90 - 3,15 mm) diameter. Refer to Figures 2 and 4. Reference (4).

(4) Install the 2A3181 High Pressure Turbine (HPT) Duct Segments (20 off) by the procedure given in Reference (5), Chapter/Section 72-44-00, Assembly (for V2522-A5, V2524-A5, V2527-A5, V2527E-A5, V2527M-A5 and V2530-A5 Engines) or Reference (6), Chapter/Section 72-44-00, Assembly (for V2525-D5 and V2528-A5 Engines)
