ENGINE - LP COMPRESSOR - REMOVAL OF THE SHARP EDGE OF THE PANEL SUPPORTING BRACKET -
CATEGORY CODE 6 - MOD.ENG-72-0246

V2500-ENG-72-0246

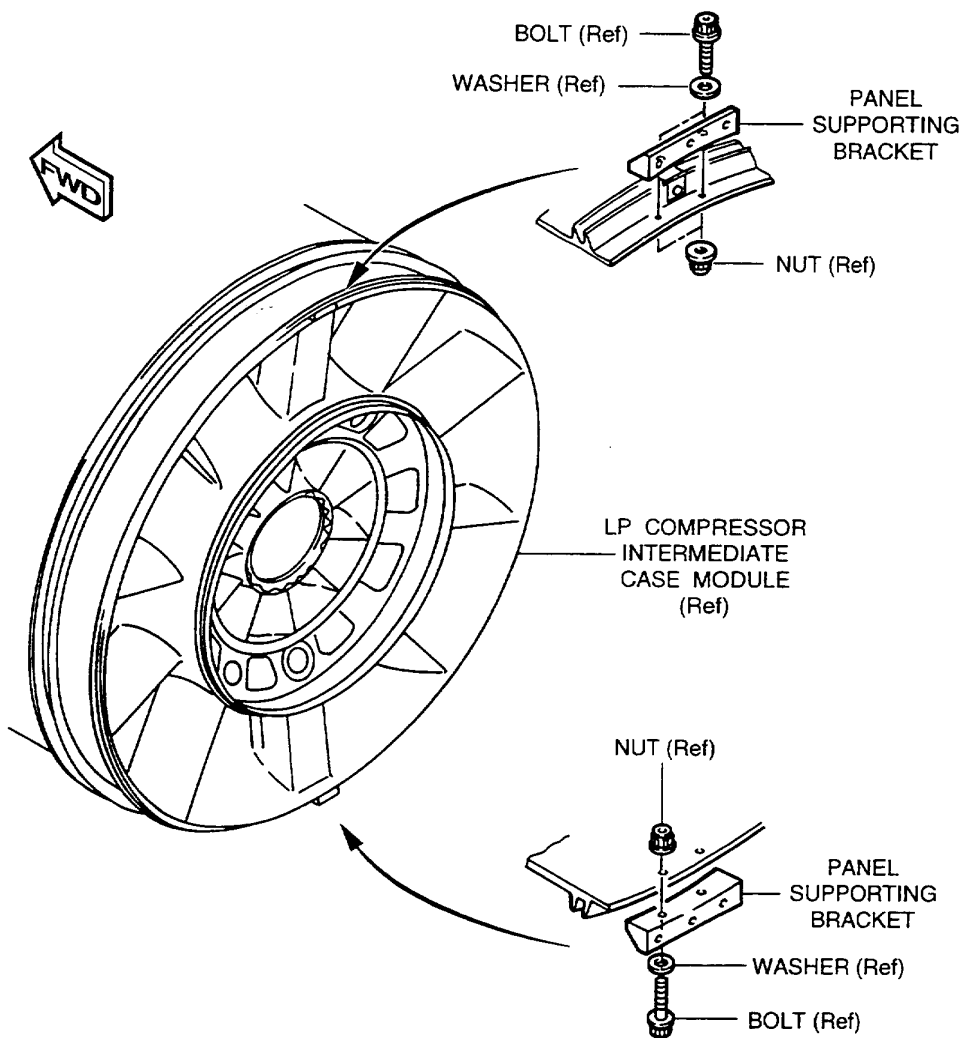
Location of Panel Supporting Brackets
Fig.1

The sharp edge on the Panel Supporting Bracket can damage the Block Seal on the Thrust Reverser Cross Over Beam.

- (1) This Service Bulletin instructs to replace two existing Panel supporting Brackets with sharp edge to the new Brackets with rounded corner (See Figure 1).
- (2) Existing Panel Supporting Bracket can be reworked (See Figure 2).
