ENGINE - LP COMPRESSOR - DELETION OF SILVER PLATING ON THE LPC INTERMEDIATE CASE MODULE  
ATTACHING BOLTS - CATEGORY CODE 6 - MOD.ENG-72-0247

V2500-ENG-72-0247

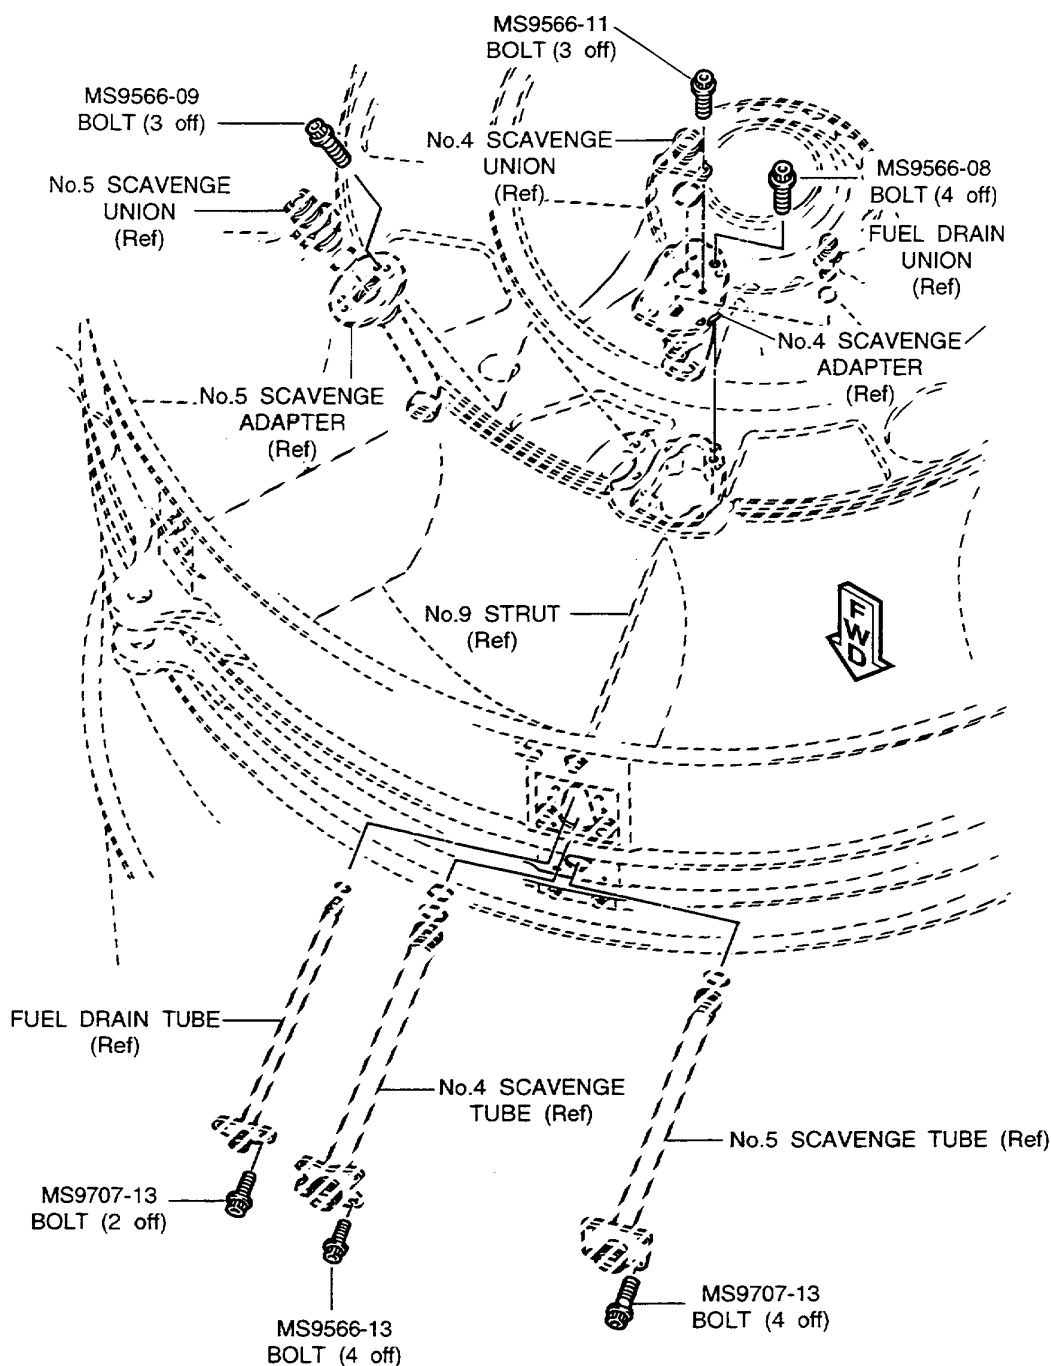
Install the LPC Intermediate Case Module Attaching Bolts  
Fig.1

The existing bolts which secure the No.4 and No.5 scavenge tubes, the No.4 and No.5 scavenge adapters, the fuel drain tube and the No.4 scavenge union are plated by silver on the threaded area. This silver plating impedes the proper installation between bolts and inserts.

It was revealed that the silver plating of the bolts is unsuitable at above locations, because the silver plated bolts and the inserts may turn together when the plated bolts are installed to the fan frame. The insert will be displaced inside the fan frame.

- (1) Install the three MS9566-09, Bolts which secure the adapter (72-32-03,01-933) by the approved procedure in Reference (2), Chapter/Section 72-32-00, Assembly-11.

- (2) Install the four MS9566-08, Bolts which secure the adapter (72-32-03,01-920) by the approved procedure in Reference (2), Chapter/Section 72-32-00, Assembly-11.

- (3) Install the three MS9566-11, Bolts which secure the No.4 scavenge union (72-32-03,01-994) by the approved procedure in Reference (2), Chapter/Section 72-32-00, Assembly-11.

- (4) Install the two MS9707-13, Bolts which secure the fuel drain tube (72-32-96,01-300) by the approved procedure in Reference (2), Chapter/Section 72-32-00, Assembly-11.

- (5) Install the four MS9566-13, Bolts which secure the No.4 scavenge tube (72-32-96,01-350) by the approved procedure in Reference (2), Chapter/Section 72-32-00, Assembly-11.

- (6) Install the four MS9707-13, Bolts which secure the No.5 scavenge tube (72-32-06,01-400) by the approved procedure in Reference (2), Chapter/Section 72-32-00, Assembly-11.
