SERVICE BULLETIN

<u>PRESSURE TUBE ASSEMBLIES FOR BRAZE AT THE INBOARD ENDS - CATEGORY CODE 4 - MOD.ENG-72-0248</u>

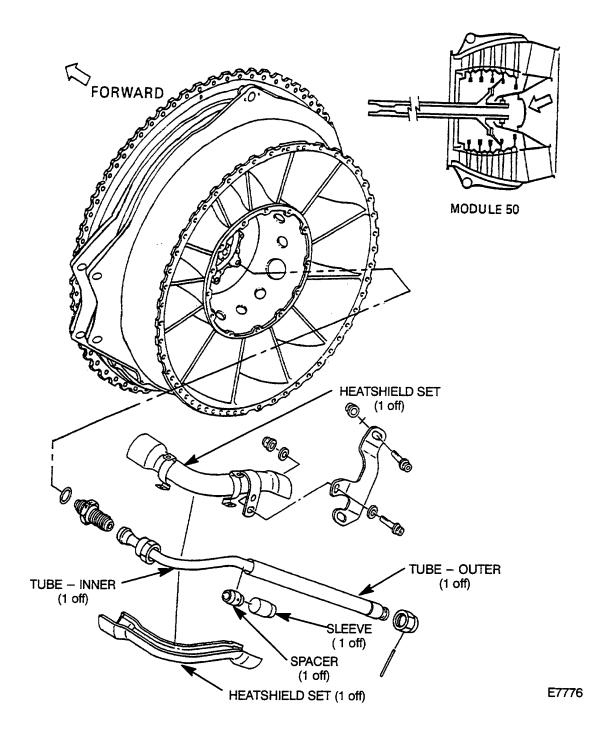
Location of the No. 5 Bearing Pressure Tube Assembly Fig.1

The inboard ends of the 2A3091-01 Pressure Tube Assembly and the 2A3092-01 Scavnege Tube Assembly can be brazed at the location of the sleeve and the spacer. This condition does not allow the outer tube (heatshield) to grow normally during engine operation, which can cause the tube assemblies to crack and result in subsequent loss of engine oil.

- (3) Inspect the 2A3091-01 No. 5 Bearing Pressure Tube Assembly (1 off) by Figures 1, 3, and as follows:
 - (a) Visually inspect to verify the tube assembly is not brazed at the inboard end where the outer tube sleeve fits around the tube spacer.
 - (b) Hold the inner tube and push on the outer tube sleeve with your finger.
 - (c) Determine if the outer tube moves in relation to the inner tube when you press on the outer tube sleeve with your finger.
 - 1 The outer tube is not brazed at the inboard end (outer tube sleeve) if you can remove it with respect to the inner tube.

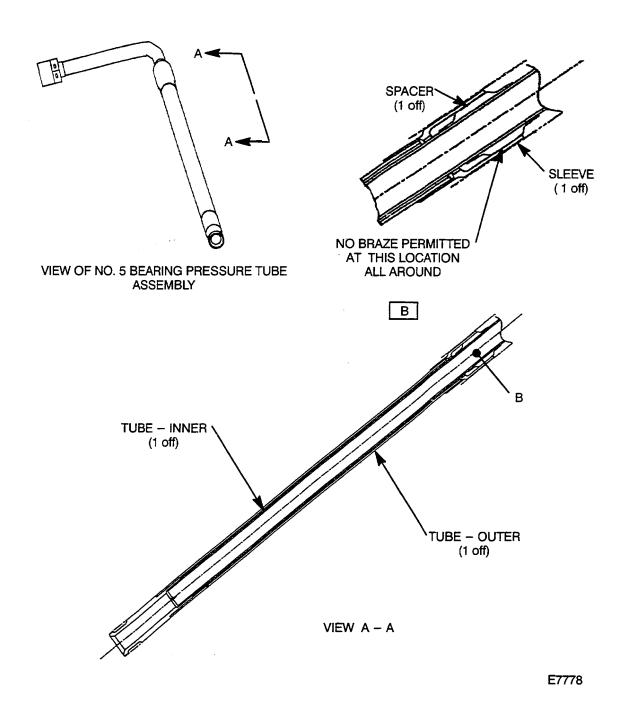
Inspection of the No.. 5 Bearing Pressure Tube Assembly Fig.3

2 The outer tube is brazed at the inboard end (outer tube sleeve) if you cannot move it with respect to the inner tube.

NOTE: Braze material should be visible with naked eye.

(5) No. 5 Bearing Scavenge and Pressure Tube Assemblies which are found brazed at the inboard ends can continue in service for twenty-five cycles.

- (1) Inspect the 2A3091-01 No. 5 Bearing Pressure Tube Assembly (1 off) and the 2A3092-01 No. 5 Bearing Scavenge Tube Assembly (1 off) by steps (3) and (4) from paragraph F. and Figures (3) and (4).
- (2) Scrap any tube assembles which are found with braze at the inboard end where the sleeve and spacer are located.

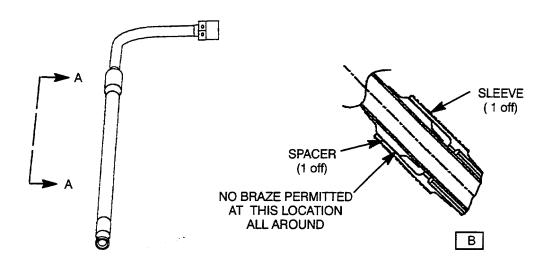
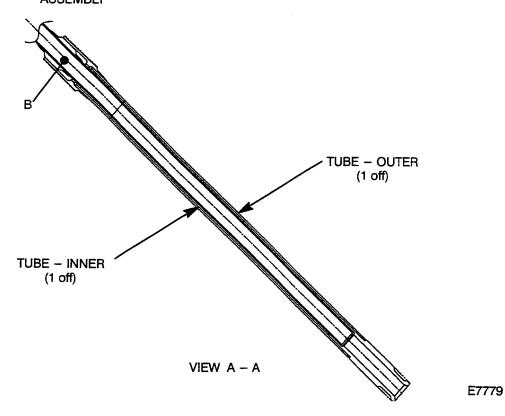
$\begin{array}{c} \text{Modification of the No. 5 Bearing Scavenge Tube Assembly} \\ \text{Fig.4} \end{array}$

- (4) Inspect the 2A3092-01 No. 5 Bearing Scavenge Tube Assembly (1 off) by Figures 2, 4, and as follows:
 - (a) Visually inspect to verify the tube assembly is not brazed at the inboard end where the outer tube sleeve fits around the tube spacer.
 - (b) Hold the inner tube and push on the outer tube sleeve with your finger.
 - (c) Determine if the outer tube moves in relation to the inner tube when you press on the outer tube sleeve with your finger.
 - 1 The outer tube is not brazed at the inboard end (outer tube sleeve) if you can remove it with respect to the inner tube.

2 The outer tube is brazed at the inboard end (outer tube sleeve) if you cannot move it with respect to the inner tube.

NOTE: Braze material should be visible with naked eye.
