ENGINE - LP COMPRESSOR - RE-DESIGN THE LPC BLEED VALVE ACTUATING ROD - CATEGORY CODE 6
- MOD.ENG-72-0250

V2500-ENG-72-0250

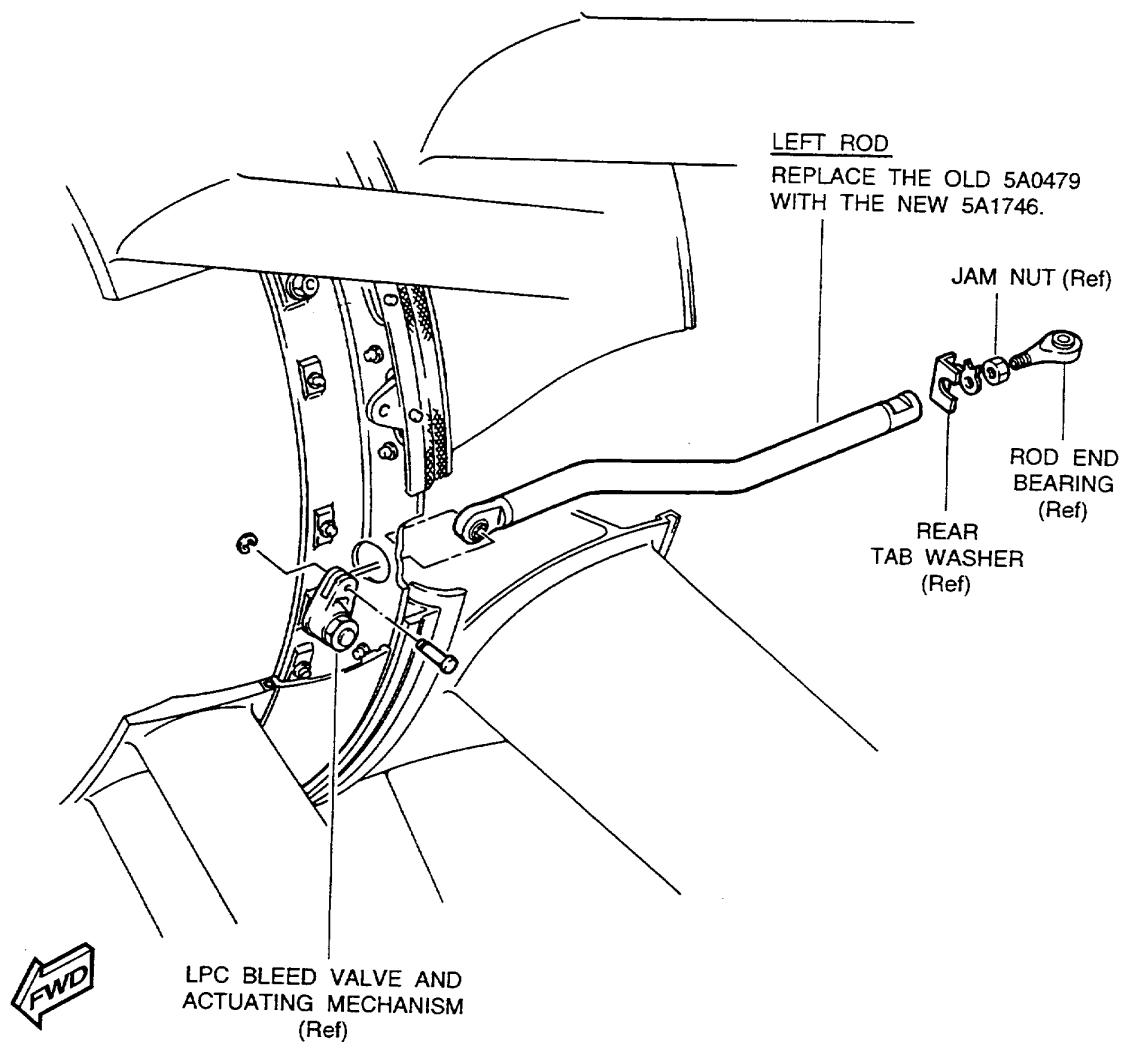
Replacement of LPC Bleed Valve Actuating Rod
Fig.1 (Sheet 1 of 2)

There is insufficient clearance between the LPC Bleed Valve Actuating Rod and the Fan Frame Wall.

It was found if the Bleed Valve Actuating Rods are interchanged between engines, contact between the rod and the fan frame wall can occur. This results in the track check message of 2.5 Bleed Valve Actuating System (2.5 BLD ACT) on the cockpit monitor.

- (1) Install the new 5A1746, Left Rod and the new 5A1747, Right Rod into the Left and Right LPC Bleed Valve Actuating Rod Mechanism by the approved procedures of Reference (2), Chapter/Section 72-32-00, Assembly-08.
(Refer to Figure 1, Sheet 1 and 2)
