ENGINE - POWER PLANT - EEC HARNESS WITH ADDITIONAL ANTI-CHAFE PROTECTION IN THE AREA OF
THE LIGHTNING-STRIKE PROTECTION SLEEVES - CATEGORY CODE 6 - MOD.ENG-72-0256

V2500-ENG-72-0256

International Aero Engines

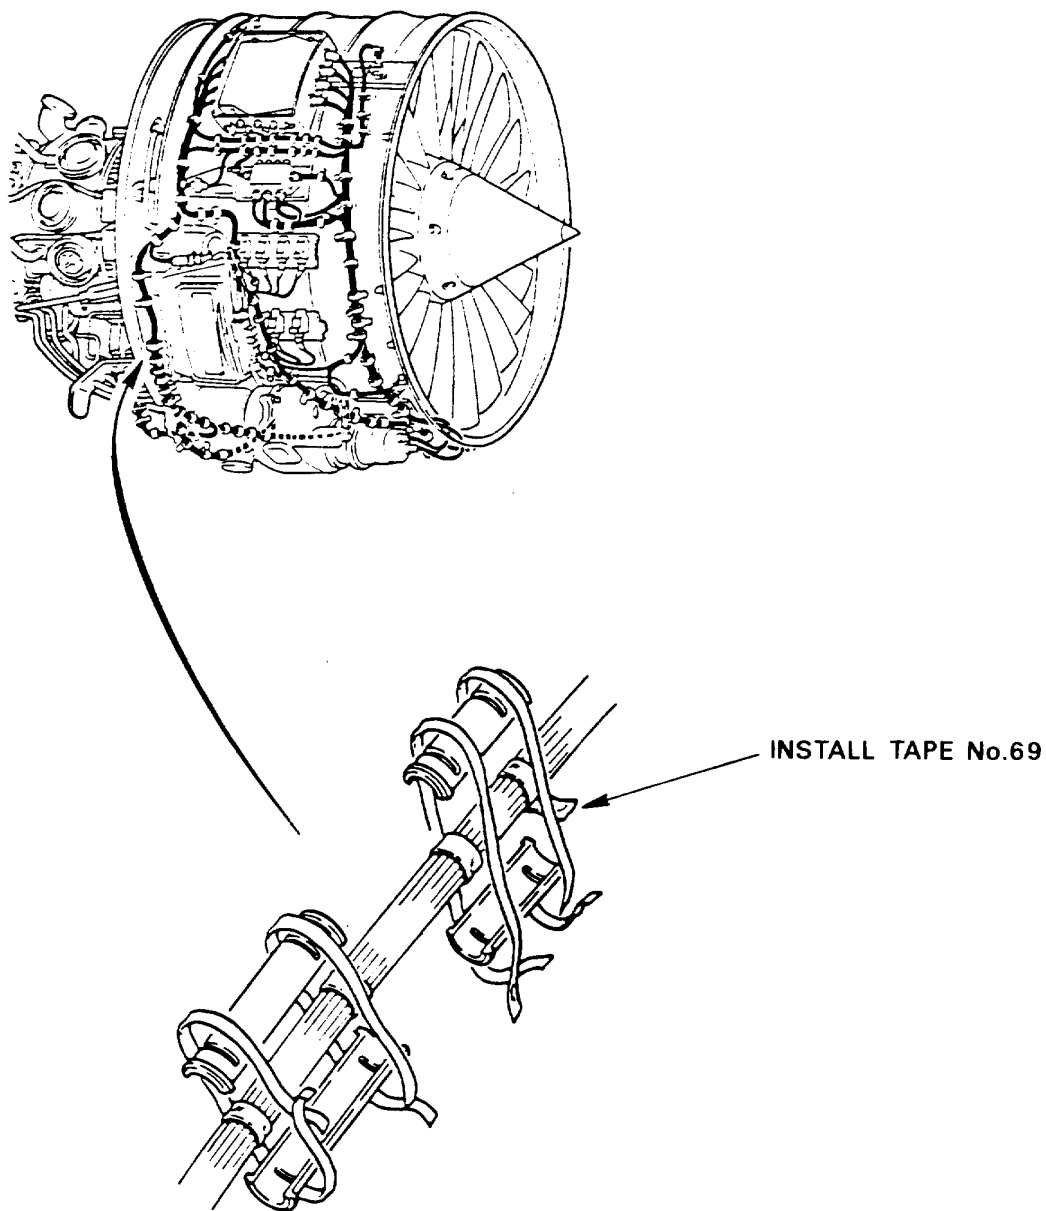
Location of EEC harness tape
Fig.1

Chafing of the Electronic Engine Control (EEC) harness can occur in the area of the lightning-strike protection sleeves.

(9) Remove 718G lacing tape from the lightning strike protection sleeves at 4 positions	Refer to Figure 1
(10) Remove the split sleeves PN5A9345 (2 off), PN5A9342 (2 off) and the scotchboy tape No.69 from the EEC harness at 4 positions	Refer to Figure 1
