<u>ENGINE - HP TURBINE ROTOR AND STATOR ASSEMBLY - PROVIDE NEW STAGE 2 HIGH PRESSURE</u>

<u>TURBINE VANES - CATEGORY CODE 8 - MOD.ENG-72-0259</u>

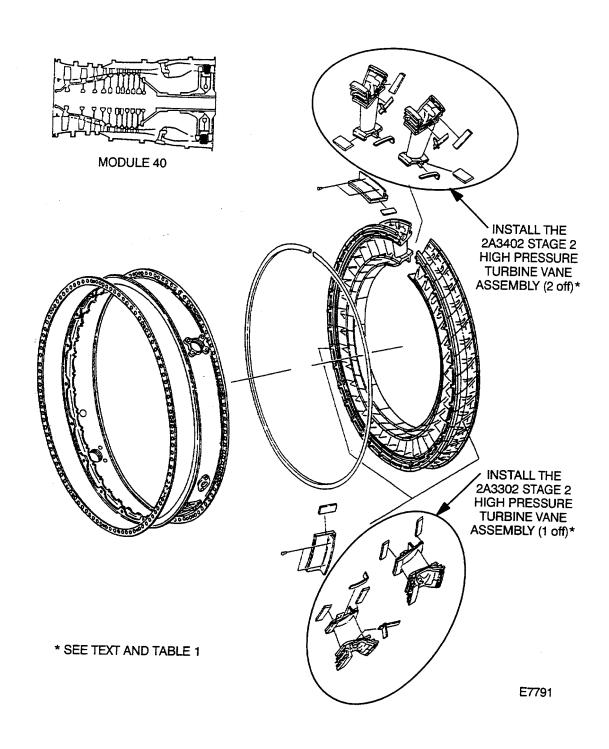
Location of the Stage 2 High Pressure Turbine (HPT) Vane Assemblies Fig.1

Potentially high operating temperatures in the front and rear knife edge cavities of the high pressure turbine scond stage air seal.

The possibility of increased high pressure turbine second stage air seal knife edge clearances in overhauled engines can lead to ingestion of hot, flowpath gases into the front and rear air seal cavities. This ingestion increases the operating temperatures of the second stage air seal and the second stage disk in the blade attachment area. An interim change to the second stage vanes was provided by V2500-ENG-72-0237, which increased the flow of cooling air being fed to the second stage air seal cavities through the vanes by providing an aditional machined-in hole adjacent to the cast-in cooling air feed hole.

A. Replace the 2A3832 Stage 2 HPT Vane Assembly (2 off) with the 2A3402 Stage 2 HPT Vane Assembly when you assemble the new Stage 2 HPT Ring Segment and Vane Cluster Assembly by the procedure specified in Reference (4) or (5), Chapter/Section 72-45-24 Repair 18 (VRS 3391).

B. Replace the 2A3842 Stage 2 HPT Vane Assembly (1 off) with the 2A3302 Stage 2 HPT Vane Assembly when you assemble the new Stage 2 HPT Ring Segment and Vane Cluster Assembly by the procedure specified in Reference (4) or (5), Chapter/Section 72-45-24 Repair 18 (VRS 3391).
