V2500-A5 SERIES PROPULSION SYSTEM SERVICE BULLETIN

This document transmits Revision 1 to Service Bulletin EV2500-72-0267

V2500-ENG-72-0267

ENGINE – HP TURBINE ROTOR AND STATOR ASSEMBLY – INTRODUCE NEW SECOND STAGE TURBINE
BLADES WITH MORE DURABLE TIPS AND IMPROVED REPAIRABILITY

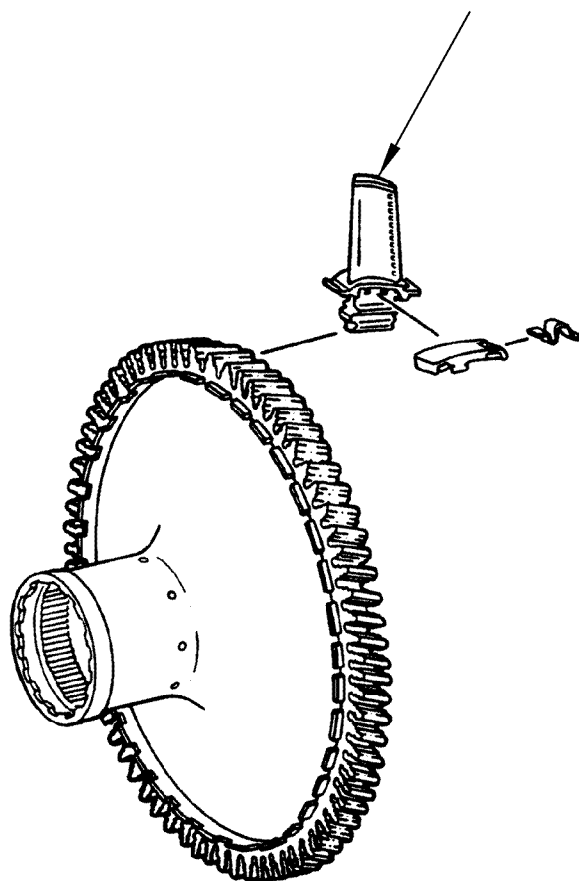
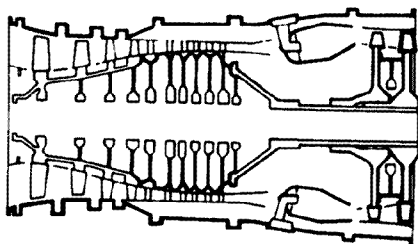
Location of the Stage 2 HPT Blade Assembly
Figure 1

(1) Condition: Tip wear has been exhibited on second stage turbine blades.

REPLACE THE STAGE 2 HPT
BLADE ASSEMBLY
PN 2A2702 WITH PN 2A8702

- (1) Replace the Stage 2 HPT Blades (72 off) by the approved procedure given in Reference (2), Chapter/Section 72-45-30, Assembly-01 and Figure 1.
- (2) Recording Instructions
 - (a) A record of accomplishment is required.
