SERVICE BULLETIN

ENGINE - LP COMPRESSOR - MOVE THE MARK OF THE LASH VALUE ON THE PTO PINION BEVEL
GEARSHAFT - CATEGORY CODE 6 - MOD.ENG-72-0270

V2500-ENG-72-0270

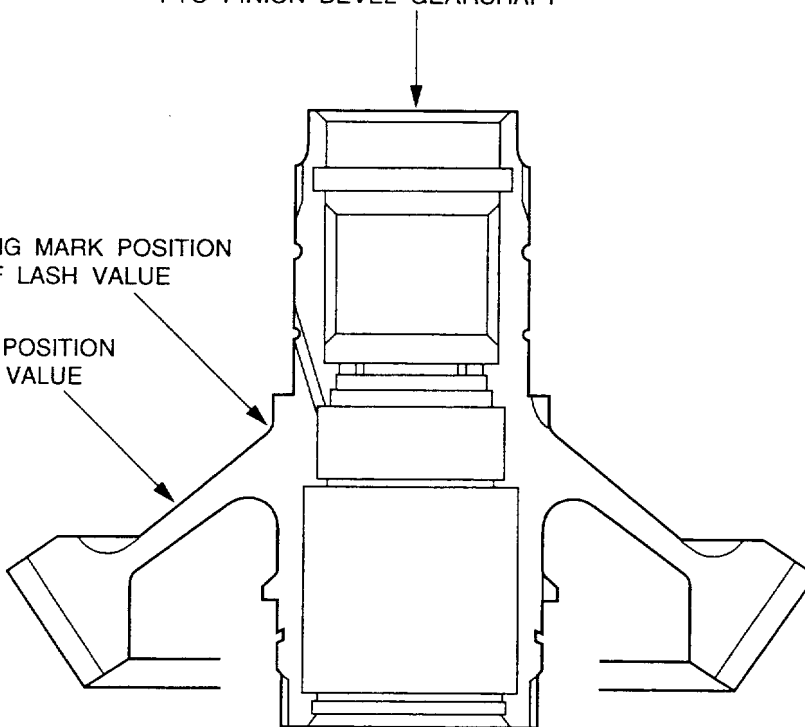
Move the mark of the Lash Value on PTO Pinion Bevel Gearshaft
Fig.1

The mark of the lash value at the existing position on the PTO Pinion Bevel Gearshaft is not readable in the assembled condition.

EXISTING MARK POSITION
OF LASH VALUE

NEW MARK POSITION
OF LASH VALUE

(a) Find the existing mark of the lash value on the PT0 Pinion Bevel Gearshaft. (Refer to Figure 1)

(b) Make the mark of the same lash value on to a new readable position as shown in Figure 1.

(c) Cancel the existing mark by two solid lines.

(d) Remove raised metal (Refer to Reference (2), TASK No. 70-09-00-400-501).

MOVE THE MARK OF THE SAME LASH VALUE AS
THE EXISTING ONE ON TO THE NEW READABLE
POSITION BY VIBRATION PEENING METHOD.
