SERVICE BULLETIN

ENGINE - HIGH PRESSURE TURBINE ROTOR AND STATOR ASSEMBLY - PROVIDE AN INSPECTION FOR
THE STAGE 2 HPT AIR SEAL - CATEGORY CODE 5 - MOD.ENG-72-0272

V2500-ENG-72-0272

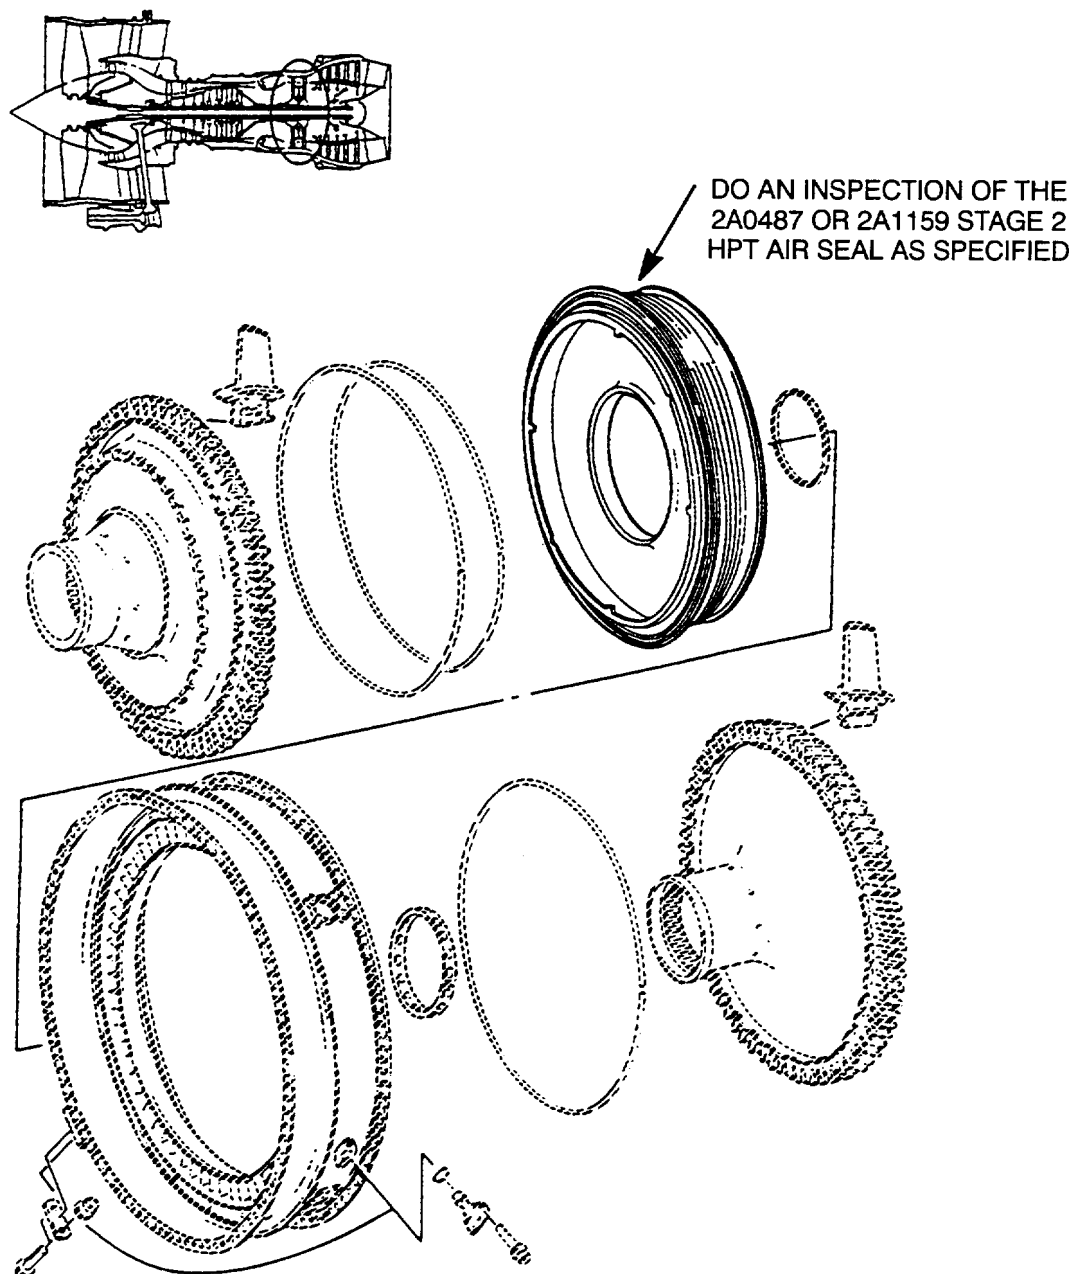
Location of the 2A0487 or 2A1159 Stage 2 HPT Air Seal
Fig.1

- (2) Do an inspection of the 2A0487, 2A1159 Stage 2 HPT Air Seal to find the dimension at location T. See Figures 1 and 2.
 - (a) Remove seals from service, which are less than 0.147 in. (3,734 mm) at location T.

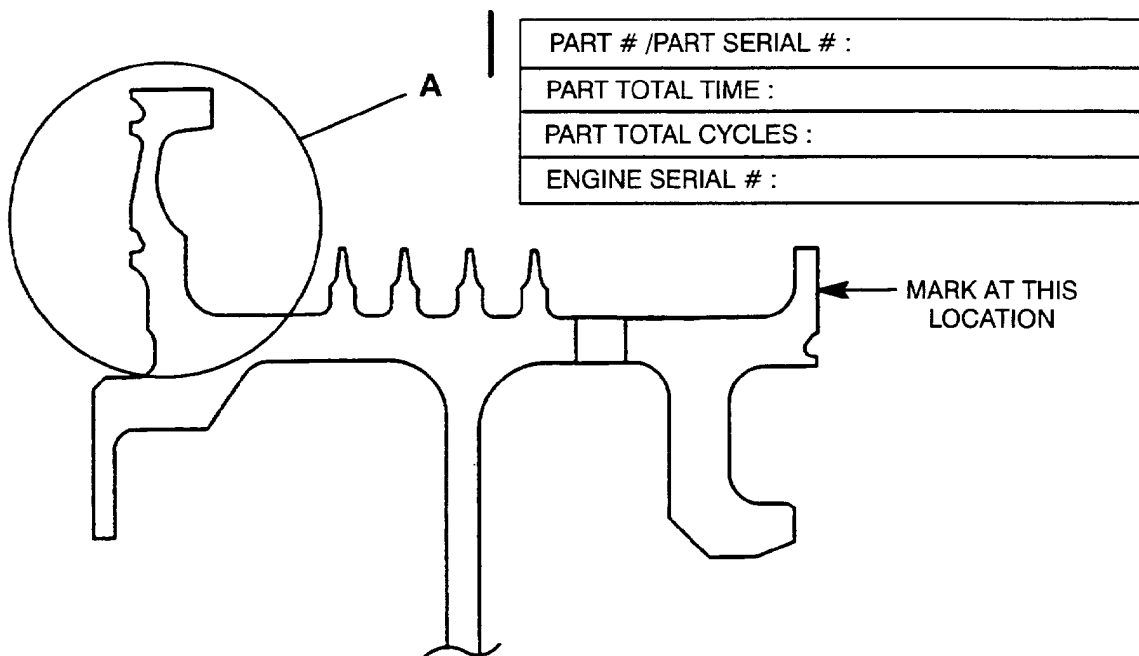
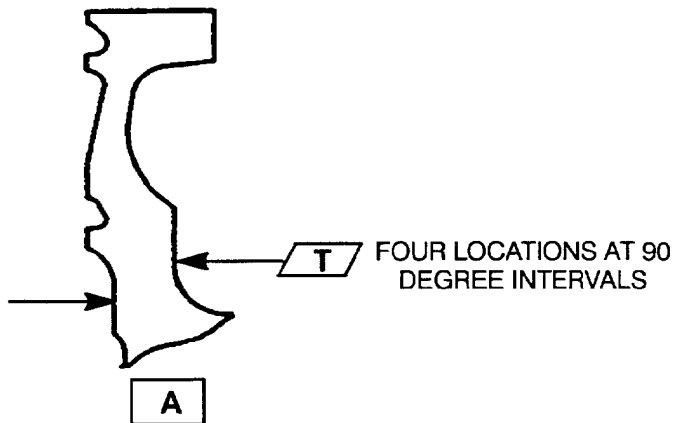
Inspection of the 2A0487 or 2A1159 Stage 2 HPT Air Seal
Fig.2

Analytical studies have shown that at extreme blue print tolerance the Stage 2 HPT Air Seal could have a flange thickness which would predict a lower than 15k cycle life.

- (b) You can return seals to service, which are more than or equal to 0.147 in. (3,734 mm) at location T.
 - 1 Mark the Service Bulletin number adjacent to the existing part number. Use the vibration peen method specified in Reference (2), Control No./TASK No. 70-09-00-400-501.
