## V2500-A5/D5 SERIES PROPULSION SYSTEM SERVICE BULLETIN

This document transmits the Revision 1 of Service Bulletin V2500-ENG-72-0279.

**V2500-ENG-72-0279**  
Transmittal - Page 1 of 1

ENGINE – LP COMPRESSOR – TO INTRODUCE A SMALL DIAMETER PIN ON THE LPC BLEED VALVE  
RING

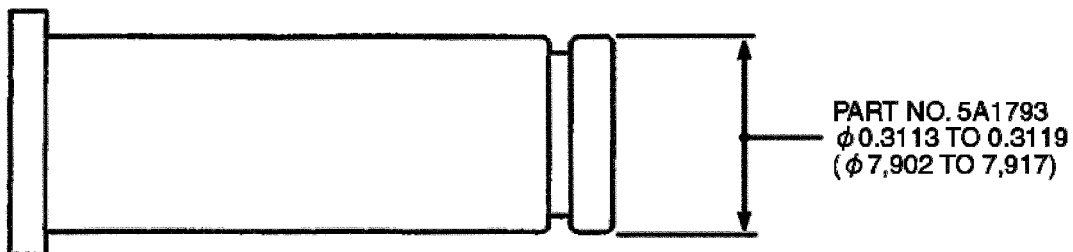
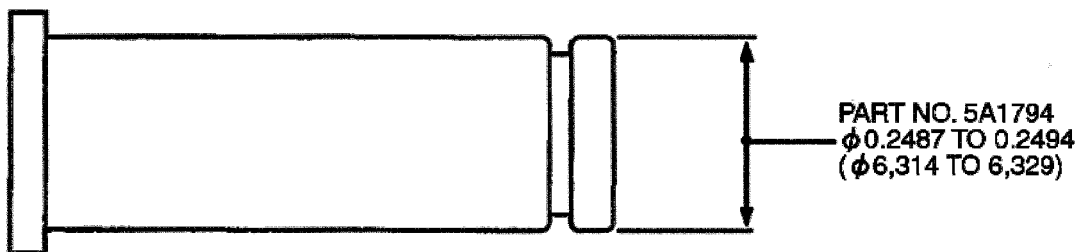
Size of new pins  
Fig.1

There is insufficient clearance between the pins and the spherical bearings on the LPC bleed valve ring. Choking of small metal particles produced by the fretting corrosion results in sticking the bleed valve.

- (1) This Service Bulletin introduces new small diameter pins on the LPC Bleed Valve Ring (see Figure 1).

The clearance between the pins and spherical bearings to be increased by the incorporation of small diameter pins. This service bulletin intends to prevent the bleed valve sticking caused by the choking up with small particles. Further design change in pins will be introduced to significantly reduce the fretting corrosion.
