DATE ~~R~~ Oct.21/02**V2500-A1/A5/D5 PROPULSION SYSTEMS SERVICE BULLETIN**

This document transmits Revision 1 to Service Bulletin EV2500-72-0282

ENGINE – PROVIDE NEW FRONT AND REAR NO. 4 BEARING FACE SEALS1. Planning InformationA. Effectivity

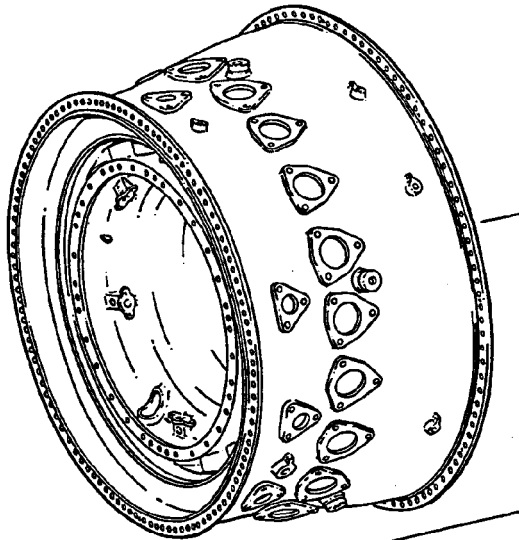
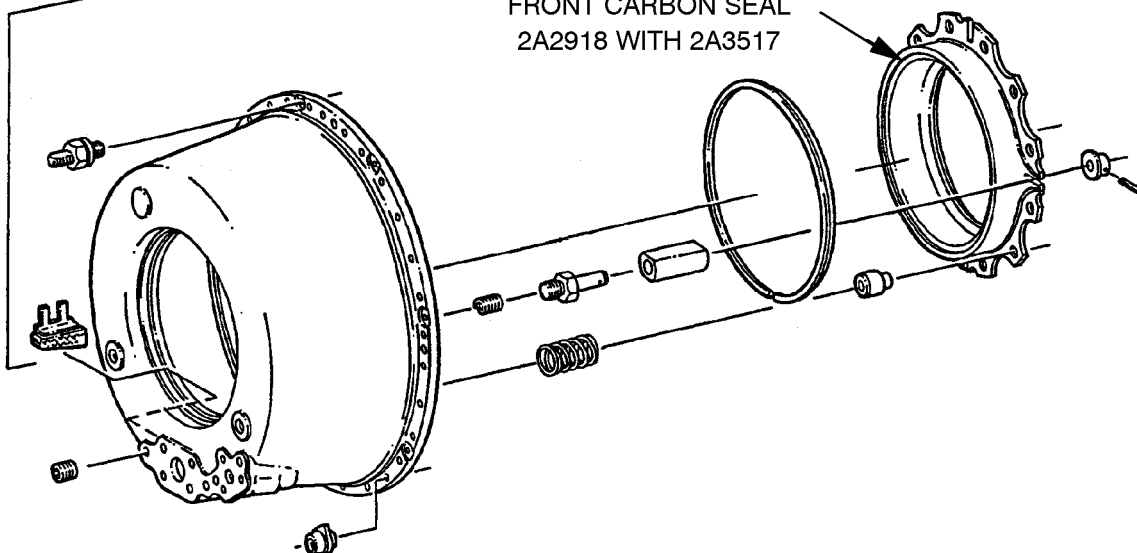
No. 4 bearing front seal assembly
Fig 1

REPLACE NO. 4 BEARING
FRONT CARBON SEAL
2A2918 WITH 2A3517

- (1) Disassemble the No. 4 Front Seal Assembly by the approved procedures in reference (5) or (6), Chapter/Section task 72-42-33-040-001.
 - (a) Replace the Carbon Seal Assembly PN, 2A2918 with PN, 2A3517.

- (b) Assemble the No. 4 Front Seal Assembly by the approved procedures in reference (5) or (6), Chapter/Section task 72-42-33-440-001.
 - (c) After modification identify the No. 4 Front Seal Assembly PN, 2A2930 as PN, 2A3535 by the approved procedure in reference (7) Chapter/Section 70-09-00.
