SERVICE BULLETIN

<u>ENGINE - LP COMPRESSOR - INTRODUCE A REWORK PROCEDURE ON THE FAN FRAME ASSEMBLY - CATEGORY CODE 8 - MOD.ENG-72-0286</u>

(2) Engine: (a) V2500-A1 Engines prior to serial number V0305.

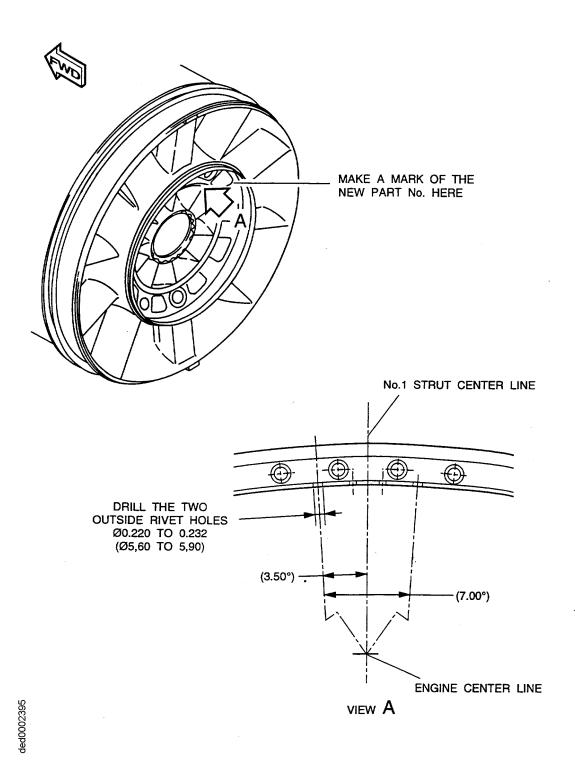
Rework of the Fan Frame Assembly Fig.1

The existing IAE service bulletin No. V2500-ENG-72-0150 does not have rework procedure of the fan frame assembly. The rework is required to change secured method of mount tube stopper from rivet type to bolt type on the fan frame assembly.

The existing mounting tube stopper has shown damage at some locations. The operators wish to accomplish the partial application of the IAE service bulletin No. V2500-ENG-72-0150, although the operators can not accomplish the above bulletin completely.

- (2) Rework procedure of fan frame is introduced to enlarge the current two rivet holes to bolt holes (See Figure 1).
- (3) For relationship with other Service Bulletins, See Figure 3 "Family Tree Chart".

- Remove the existing rivets from the fan frame assembly
- (c) Remove the mount tube stopper
- (d) Make sure the drilling position Refer to Figure 1 on the fan frame assembly

(e) Make the diameter of the rivet
hole larger at two positions
(Outside of existing rivet holes)

Refer to Figure 1, Use a 0.220 to 0.232 in. (5,60 to 5,90 mm.) drill

(g) Remove all sharp edges from the new holes and make a smooth surface Use standard workshop equipment

(i) Do a crack test the affected areas

(j) Make a mark of the new part No. on the fan frame assembly adjacent to the old part No., make two lines (====) on the old part No. to erase it Use the Vibro-Peen method, Refer to Figure 1 and A.(1), (a)

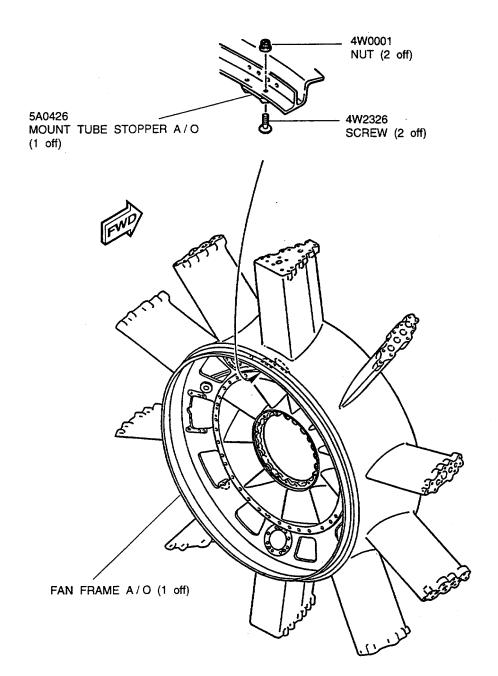
Install the mount tube stopper on the fan frame assembly Fig.2 $\,$

(1) The new mount tube stopper which is secured by the bolts and nuts are introduced (See Figure 2).

(1) Install the 5A0426, mount tube stopper to the fan frame assembly with the two 4W2326, screws and 4W0001, nuts. Refer to Figure 2.
