ENGINE - FAN CASE FIRE RAIL AND ECS SENSE LINE WITH MODIFIED BRACKETS - CATEGORY CODE
6 - MOD.ENG-72-0287

V2500-ENG-72-0287

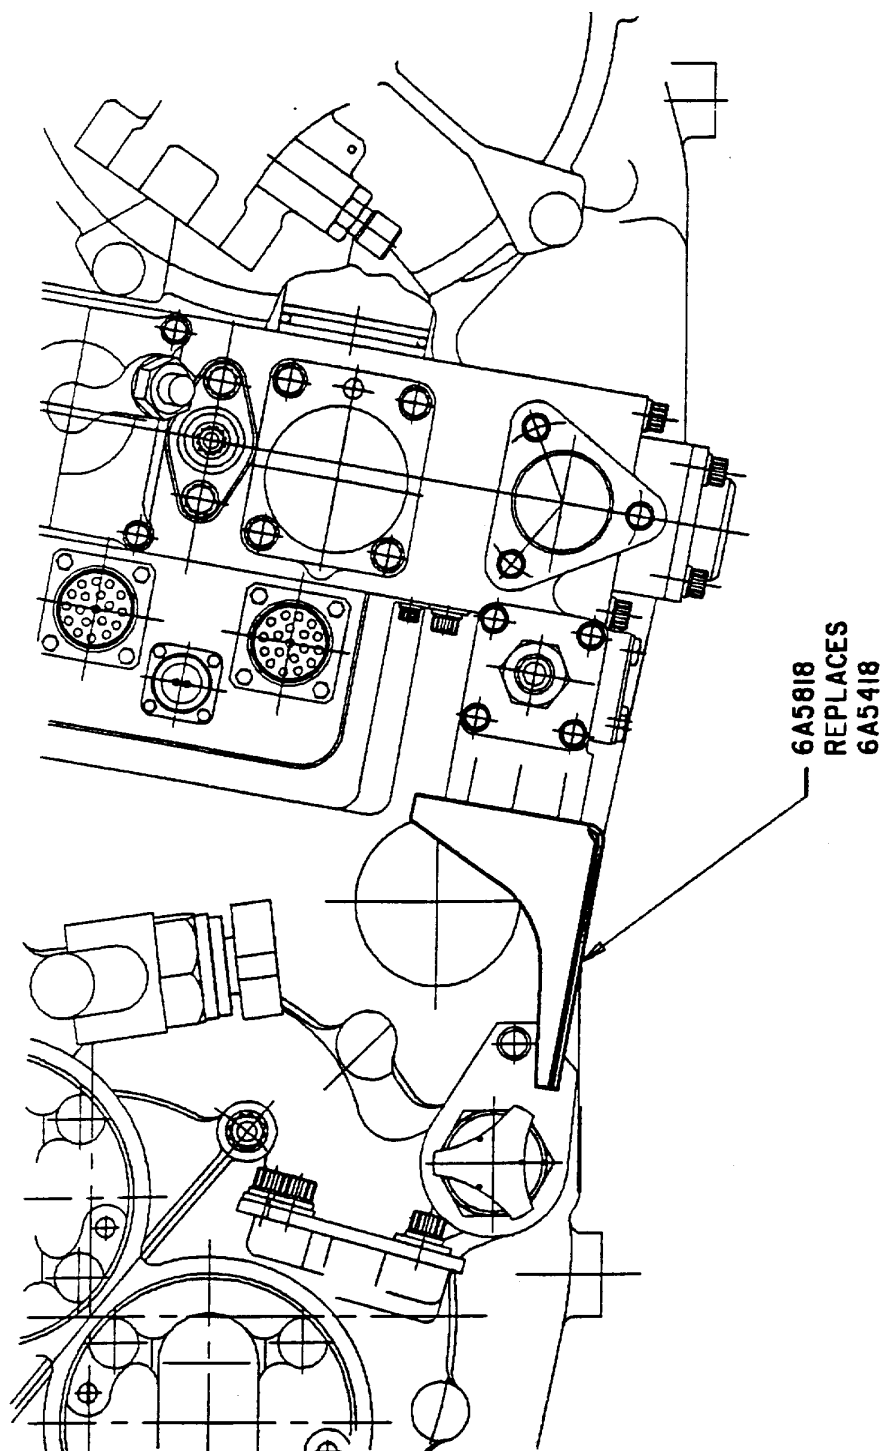
- (a) During a Transient Acoustic Propagation (TAP) test of the fancase fire-detection rail, resonance was recorded.

The problem is caused by the stiffness of the support bracket, which is not sufficient.

View looking forward on gearbox - Before and after alteration
Fig.1

- (1) To make the support of the fire detection rail better, three brackets have been changed. Two of the brackets are installed on the case of the gearbox. The other is installed on the flange for the HP-fuel servo tube and FMU. The changes are as follows:
 - (a) The material of the brackets has been changed from titanium (TAK) to stainless steel (EBM).
 - (b) To increase the area of the support, the length of the brackets installed to the gearbox have increased.
 - (c) The bend radius of one of the brackets installed to the gearbox, has increased.
 - (d) The contour of the web of the two remaining brackets has increased.
- (2) The stub-bracket installed at bolt holes 10 and 11 of flange FN of the LP turbine has changed. To give additional clearance between the bracket and the ECS line, the length of the mating flange has increased.

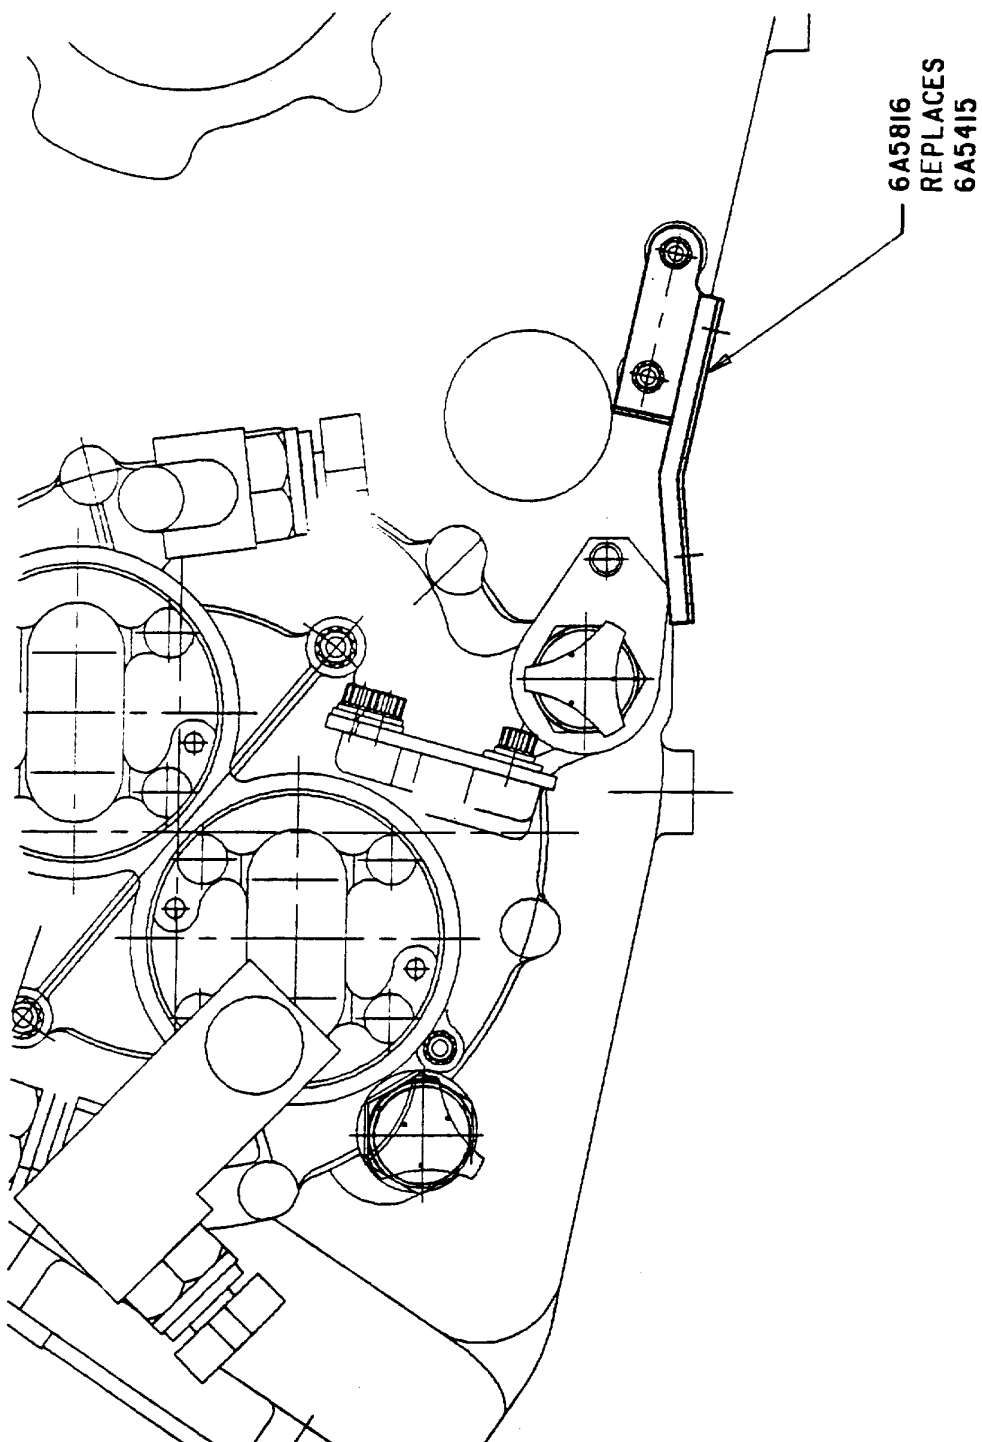
View looking forward on gearbox (FMU Removed) - Before and after alteration
Fig.2

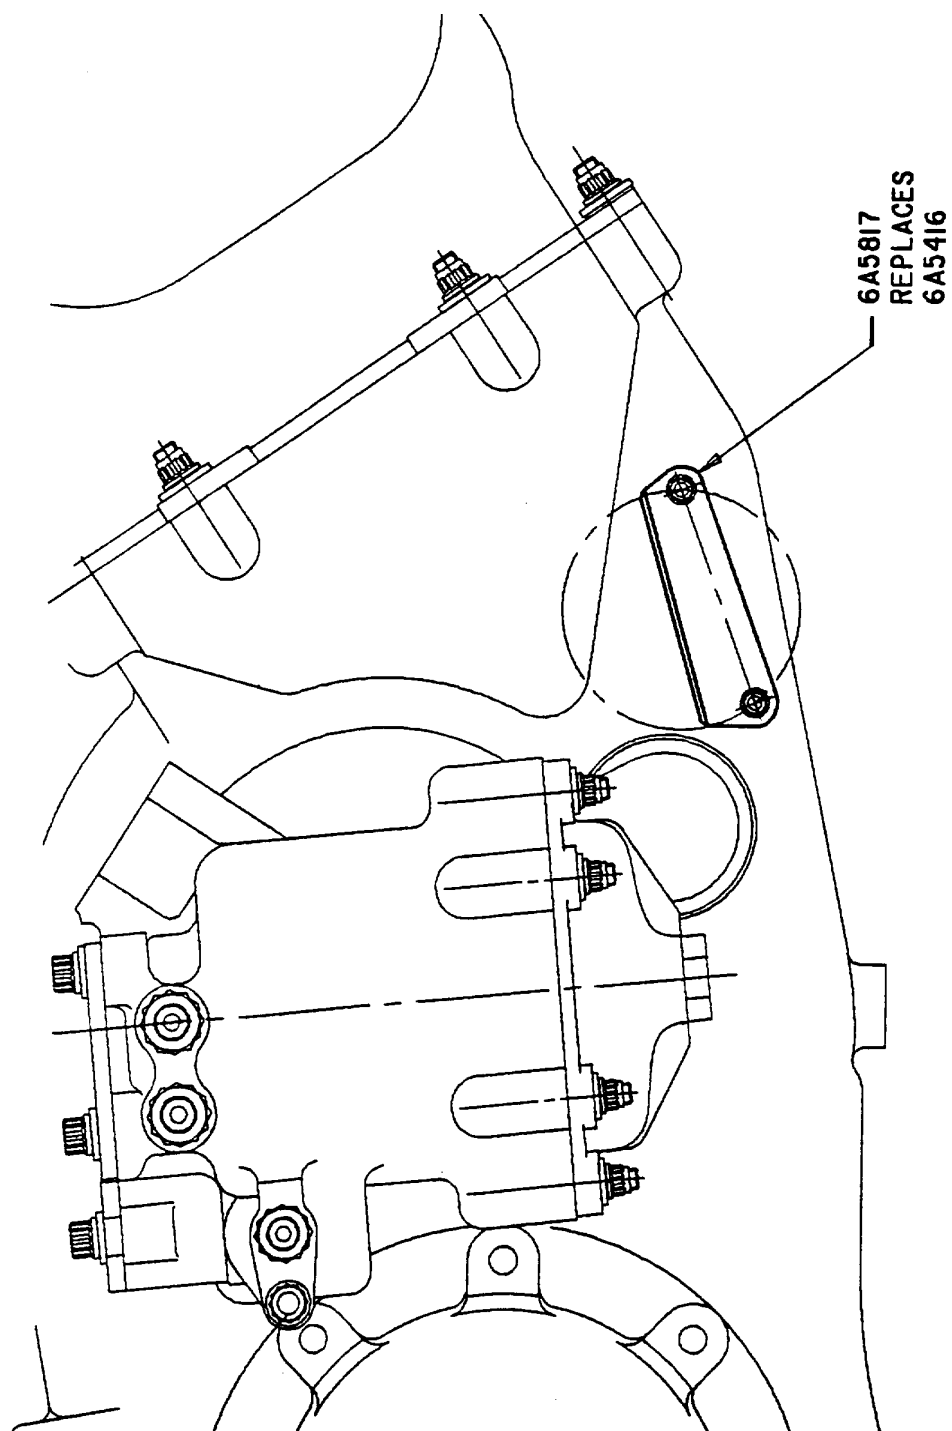
View looking rearward on gearbox - Before and after alteration
Fig.3

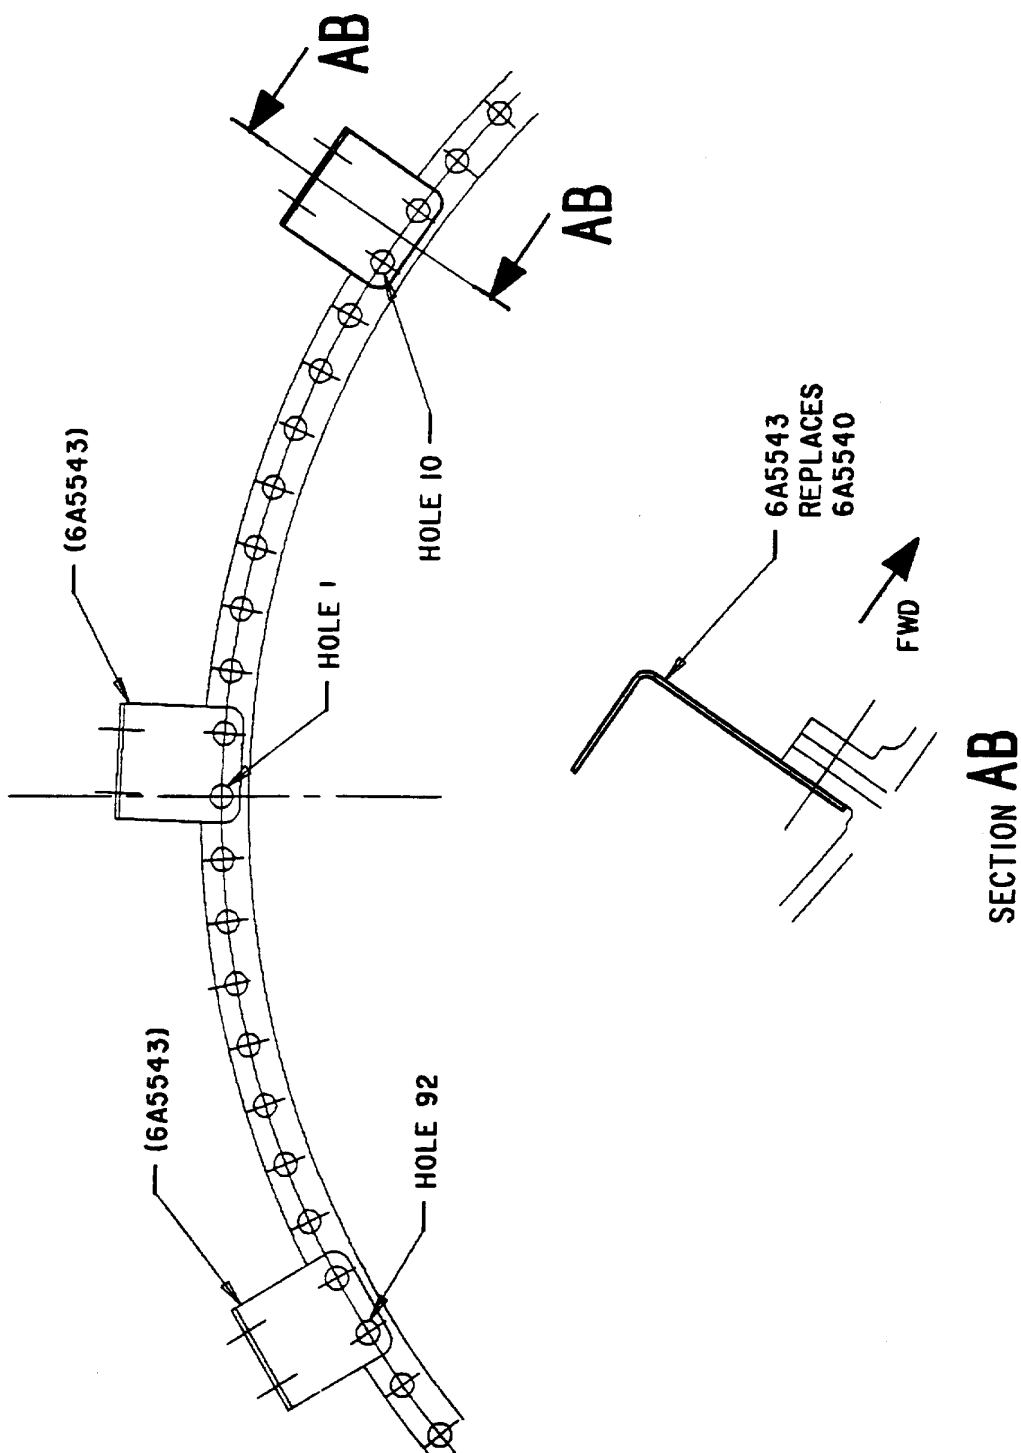
- (b) Also, the clearance between the ECS line and a stub-bracket installed at bolt holes 10 and 11 of the LP-turbine FN flange, is not sufficient.

The problem is caused by the route of the ECS line. To increase the clearance, a change to the bracket is necessary.

View looking forward on flange FN - Before and after alteration
Fig.4
