ENGINE - ENGINE HP COMPRESSOR DISCS (STAGES 3 TO 8) - INTRODUCTION OF REVISED STAGE 7
AND 8 SEAL WIRES - CATEGORY CODE 6 - MOD.ENG-72-0289

V2500-ENG-72-0289

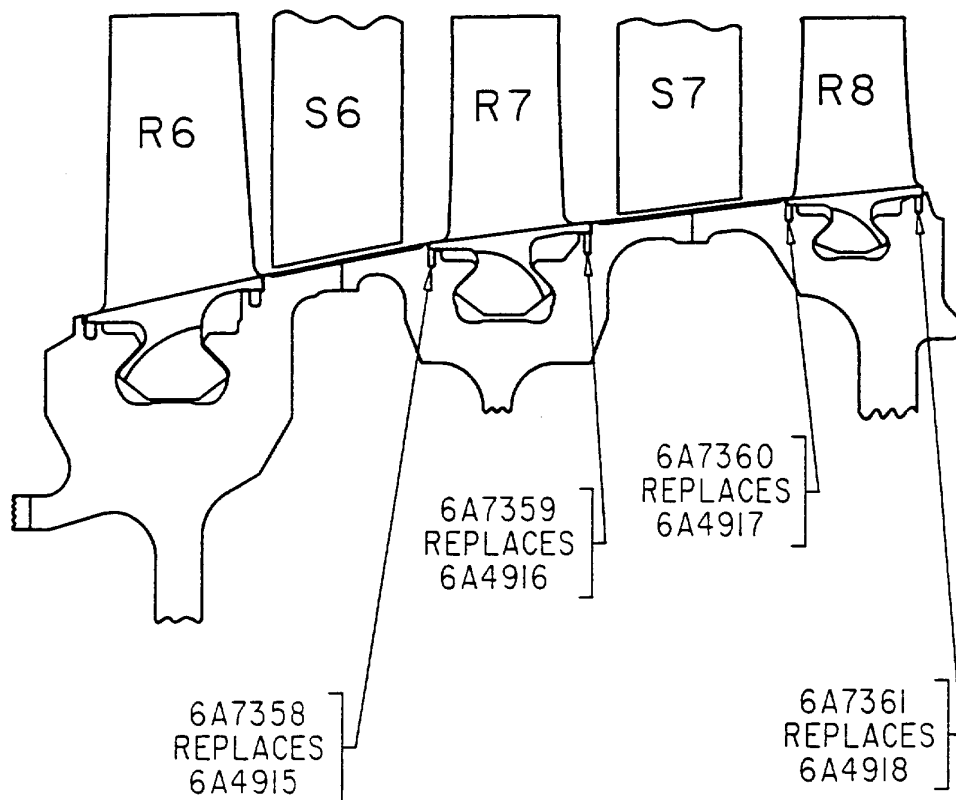
General section through the HP compressor - Before and after alteration
Fig.1

Fretage on the sides of the slots for the stage 7 and 8 sealing wires in the HP compressor stage 3 to 8 drum assembly can occur.

The problem is caused by sharp edges at the split line of the seal wire, together with the vibration of the wire during engine operation.

(a) A fillet has been added that rounds off the ends of the wire at the split line.

(b) The chamfer has decreased from 30 to 15 degrees.

(2) The front and rear seal wires that exist can be reworked. (Refer to Fig.1 and Fig.2)
