Subject : Transmittal of Revision 2 to Service Bulletin No. V2500-ENG-72-0294

# International Aero Engines SERVICE BULLETIN

## ENGINE - LP TURBINE ASSEMBLY - DUCT SEGMENT INNER - REMOVAL SHEETMETAL FIN

## ENGINE - LP TURBINE - DUCT SEGMENT INNER - REMOVAL OF SHEET METAL RIM

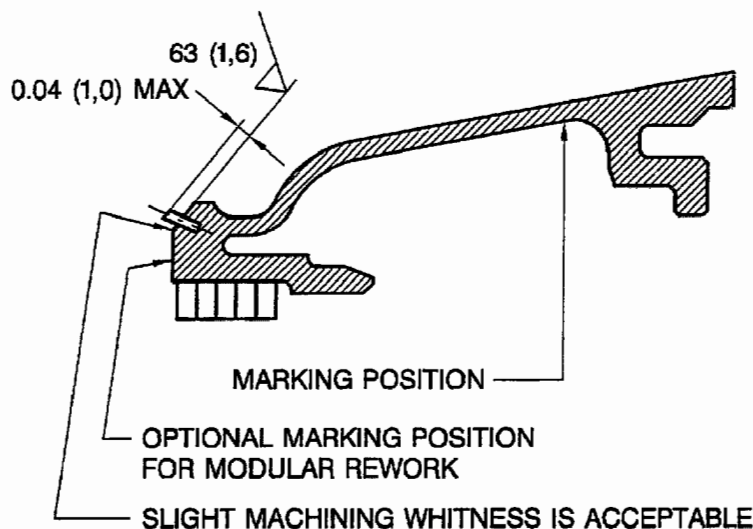
LPT Inner Diffuser duct – marking position  
Figure 1

Tear down has shown that the liberation of the 2nd stage blade rear platforms was due to an interference with the sheet metal seal rims on the LPT inner diffuser transition ducts. Investigation concluded that this damage is due to bowed rotor conditions. Similar interaction between 2nd blade rear platforms and LPT inner diffuser duct segments has been seen on A1 engines, but to a less degree, with no liberated platforms.

- (1) Protect the LPT transition duct and the spline and thread at the front end of the shaft.  
Use local manufactured cover or tape.
- (2) Machine off the Sheet Metal Rim Seal
  - (a) Use Pneumatic Hand Held Grinder and Rotary Files or equivalent. Refer to Fig 1.
  - (b) Break sharp edges
- (3) Re-identify the Inner Diffuser Ducts at the optional marking position. Refer to Fig 1.

- (1) Machine off the Sheet Metal Rim Seal
  - (a) Use Pneumatic Hand Held Grinder and Rotary Files or equivalent. Refer to Fig 1.
  - (b) Break sharp edges
- (2) Re-identify the Inner Diffuser Ducts at the marking position and cross out the old part number. Refer to Fig 1.

- THIS REWORK IS BASED ON APPROVED ENGINEERING CHANGE EC97VM022 AND CAN BE DONE ON PART NUMBER 3A0771 AS A PIECE PART OR IN MODULAR ASSEMBLED CONDITION.
- GRIND OFF SEAL LIP. 0.04 (1,0) MAX PROTRUSION PERMISSABLE AFTER REWORK.
- AFTER REWORK CHANGE PART NO. FROM 3A0771 TO 3A2493. USE THE MECHANICAL VIBROPEEN METHOD AS PER SPM-TASK 70-09-00.
- IF THE REWORK IS PERFORMED ON A SEGMENT ASSEMBLED TO THE MODULE THEN MARK THE PART AT THE OPTIONAL MARKING POSITION WITH 3A2493 AND THE SERVICE BULLETIN NO. V2500-ENG-72-0294. AT NEXT OPPORTUNITY OF ACCESS CROSS OUT THE OLD PART NO. 3A0771 AND REPLACE BY PART NO. 3A2493.
