Subject: Transmittal of Revision 1 To Service Bulletin Number

ENGINE - CONVERSION - PROVIDE INSTRUCTIONS TO CHANGE THE V2500-D5 ENGINE RATING BY MODIFYING THE DATA ENTRY PLUG

V2525-D5 V2528-D5

V2500-ENG-72-0298

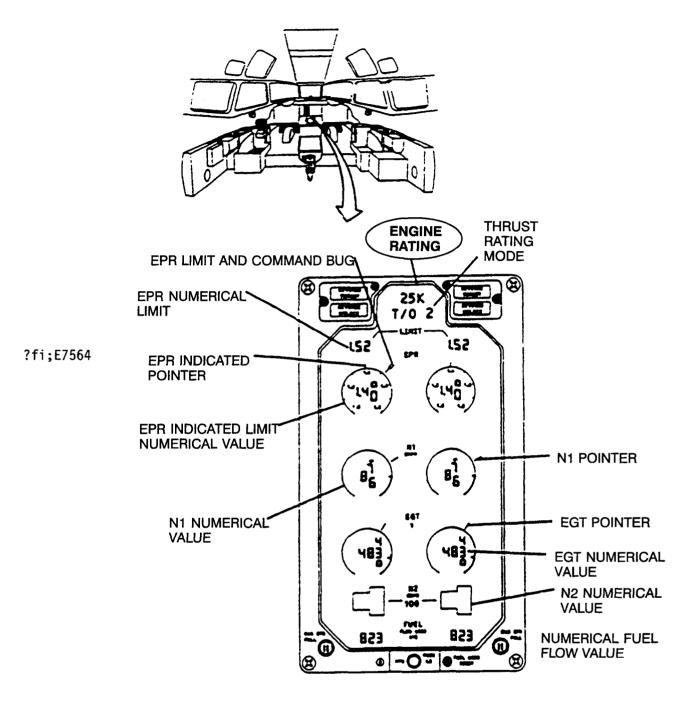
Engine Display Panel Electronic Engine Control Adjustment/Test Figure 6

If this does not agree, the Data Entry Plug must be corrected or replaced; until then the aircraft can not be dispatched.

- J. Check the data entry plug wiring by viewing the Engine Rating indicated on the Engine Display Panel comparing this to the Data Plate information, when the EEC and the DEP are installed on the aircraft. Use the procedure specified in Reference (2), Chapter/Section 73-21-02 or 73-21-34, EEC Adjustment/Test. Aircraft 28V dc Power/Engine Display Panel Adjustment /Test, to view the EDP, and Figure 6.
