SERVICE BULLETIN

ENGINE - MAIN GEARBOX ASSEMBLY - MODIFICATION OF O-RING FOR THE ANGLE GEARBOX SUPPORT - CATEGORY CODE 6 - MOD.ENG-72-0301

V2500-ENG-72-0301

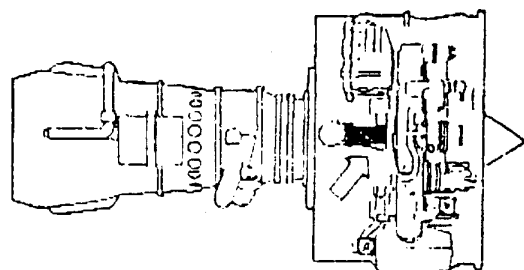
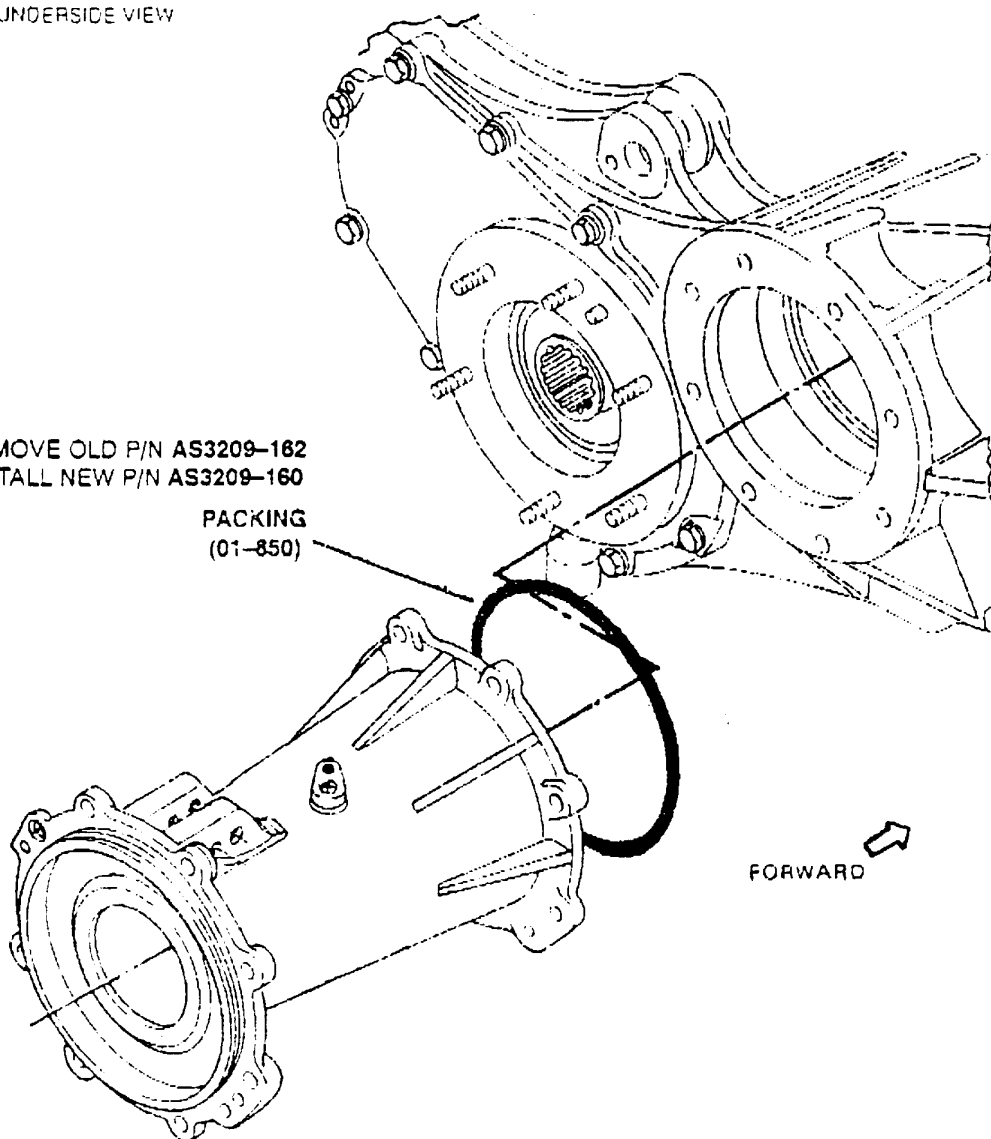
Angle Gearbox Support
Fig.1

Damage to the toroidal sealing ring of the angle gearbox support can occur. The problem is caused by excessive compression to the sealing ring as a result of adverse tolerance conditions.

In extreme stack-up condition, the seal ring can be cut during assembly.

- (1) Install the new Packing AS3209-160 (Refer to V2500-D5 Engine Manual (EM), Chapter/Section 72-60-10, Disassembly/Assembly).

REMOVE OLD P/N AS3209-162
INSTALL NEW P/N AS3209-160
