## V2500 A5/D5 SERIES PROPULSION SYSTEMS SERVICE BULLETIN

This document transmits Revision 7 to Service Bulletin EV2500-72-0302

# V2500-ENG-72-0302

ENGINE – HP TURBINE ROTOR AND STATOR ASSEMBLY – INTRODUCE FIRST AND SECOND STAGE  
TURBINE BLADES WHICH HAVE PROTECTIVE COATING IN THE DAMPER POCKET AREA UNDER THE  
PLATFORM

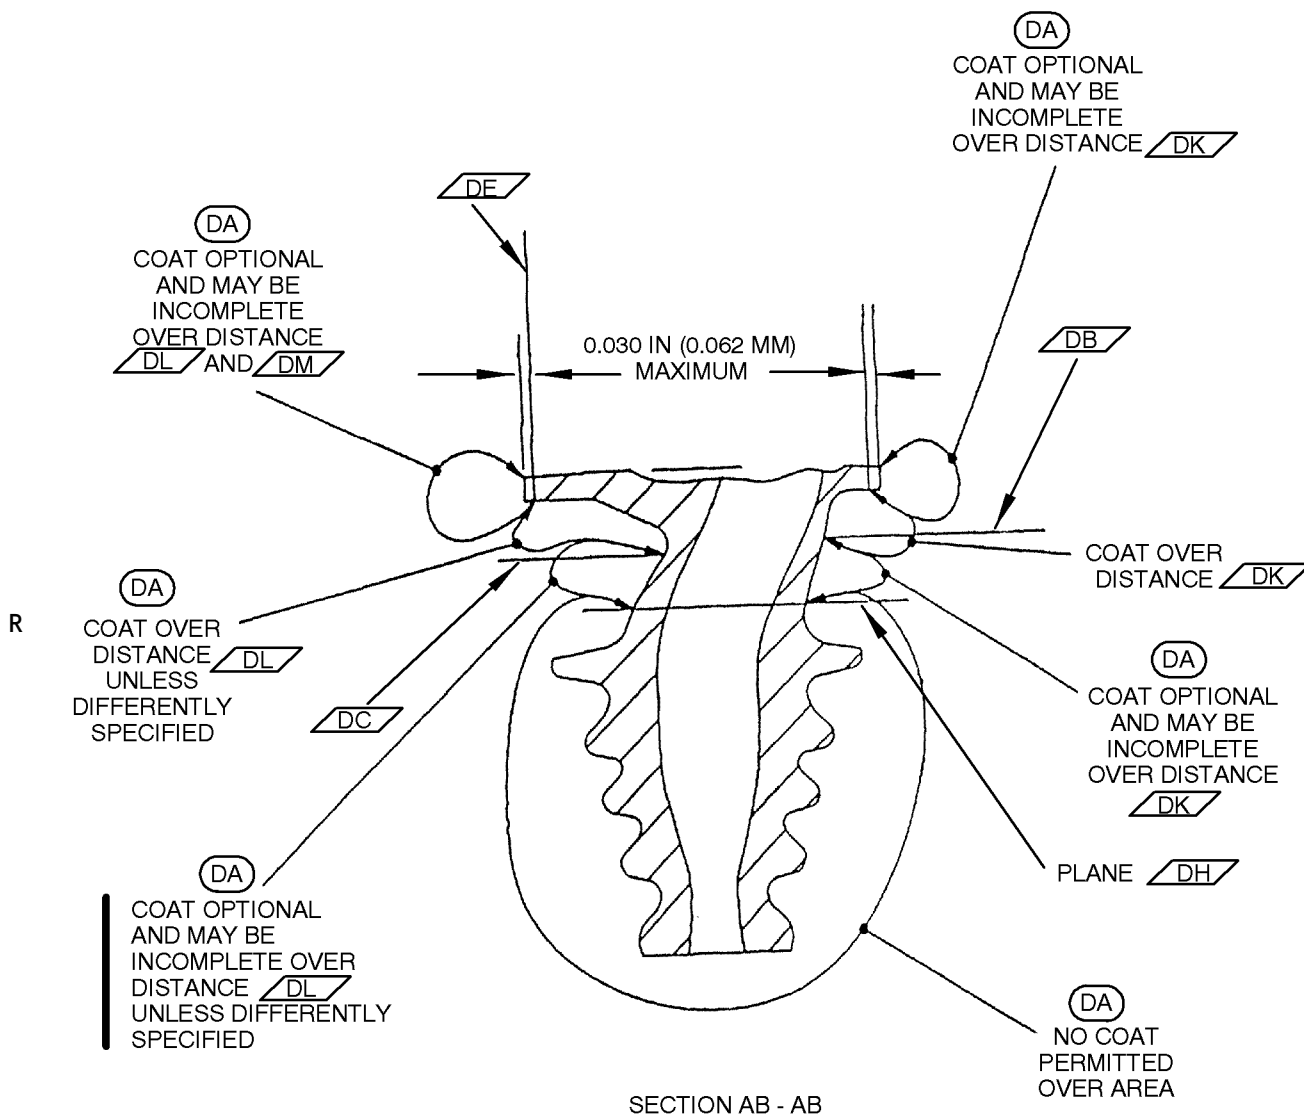
**Modification of the Stage 1 High Pressure Turbine Blade Assembly**  
**Figure 2 (Sheet 7)**

Remove	Incorporate	Reason for change
Pages 1 to 38 of the Service Bulletin	Pages 1 to 39 of the Service Bulletin	To correct Part Nos. in material and reidentification sections. To correct Fig.2 (Sheet 7).
All pages of Appendix 1	Pages 1 to 5 of Appendix 1	To correct Part Nos. in material and reidentification sections. To correct Fig.2 (Sheet 7).

(DA) COAT IN THE APPLICABLE AREA BY THE PROCEDURE SPECIFIED IN THE TEXT
