# International Aero Engines SERVICE BULLETIN

Subject: Transmittal of Revision 1 to Service Bulletin  
No.V2500-ENG-72-0305

**V2500-ENG-72-0305**

**ENGINE - LP COMPRESSOR - TO INTRODUCE A CHROME PLATING PIN  
ON THE LPC BLEED VALVE RING**

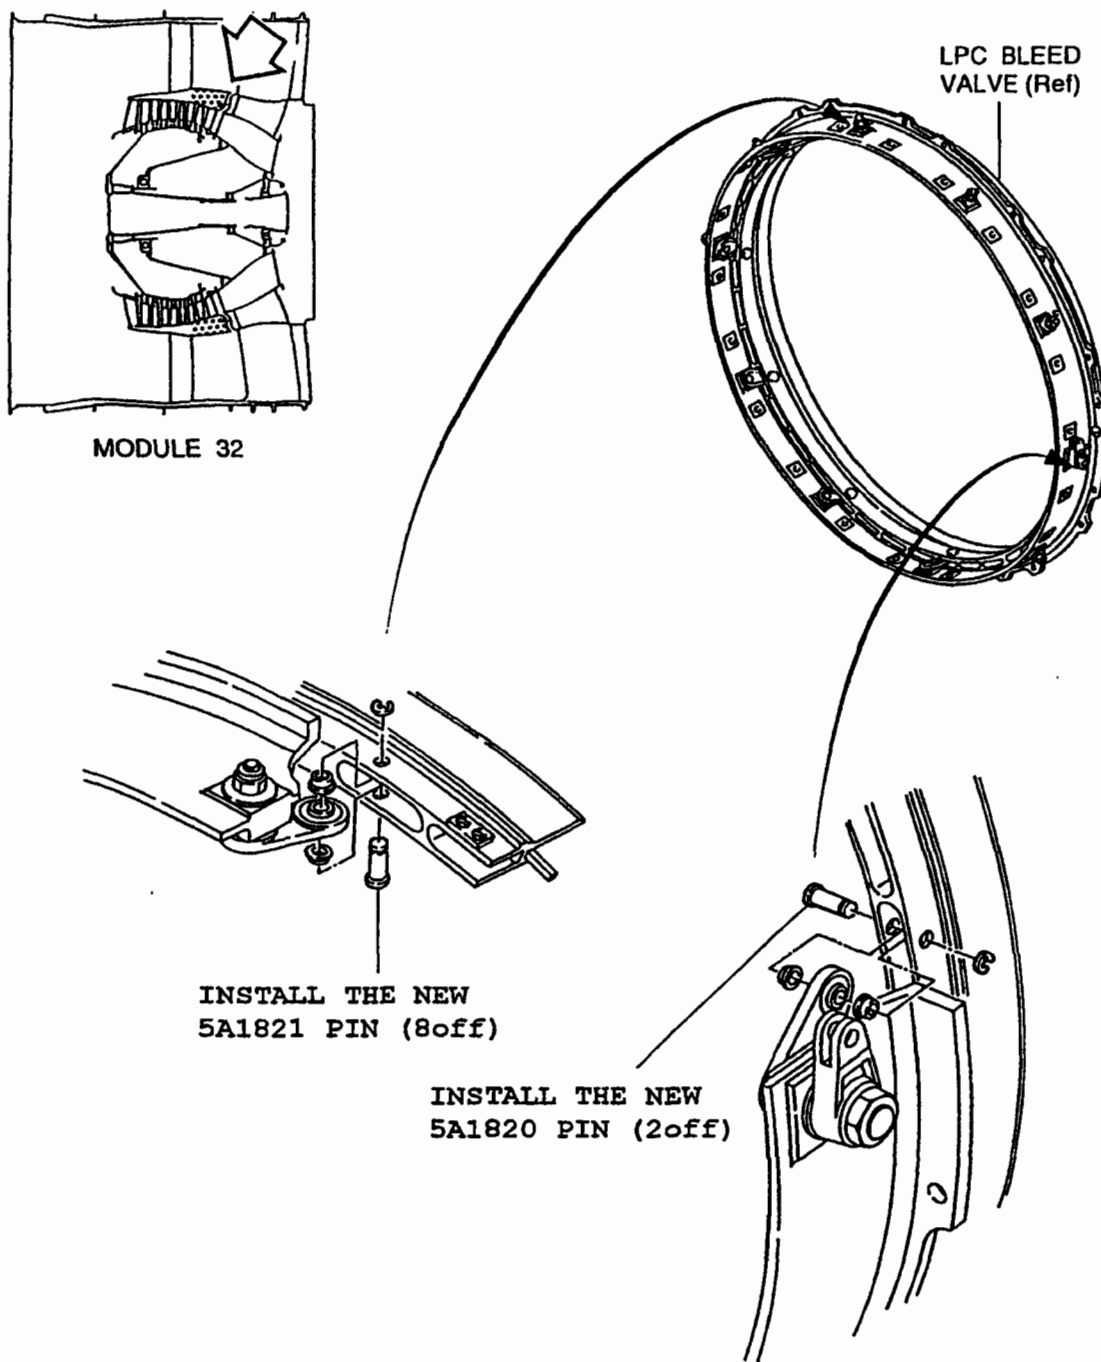
Booster Stage Bleed Valve and Actuating Mechanism  
Figure 1

There is insufficient clearance between the pins and the spherical bearings on the LPC bleed valve ring. Choking of small metal particles produced by the fretting corrosion results in sticking the bleed valve.

**Install the new pins (5A1820, 2 off and 5A1821, 8 off) in the LPC Bleed Valve Ring. For the correct procedure, refer to the Engine Manual(EM), Chapter/Section 72-32-70, ASSEMBLY-01, CONFIG-2 (For V2500-A5) and Chapter/Section 72-32-70, ASSEMBLY-01 (For V2500-D5). Refer to Figure 1.**
