International Aero Engines SERVICE BULLETIN

ENGINE - LP COMPRESSOR - TO INCORPORATE BUSHES ON
THE LPC BLEED SYNCHRONIZING RING

V2500-A1

V2500- ENG-72-0306

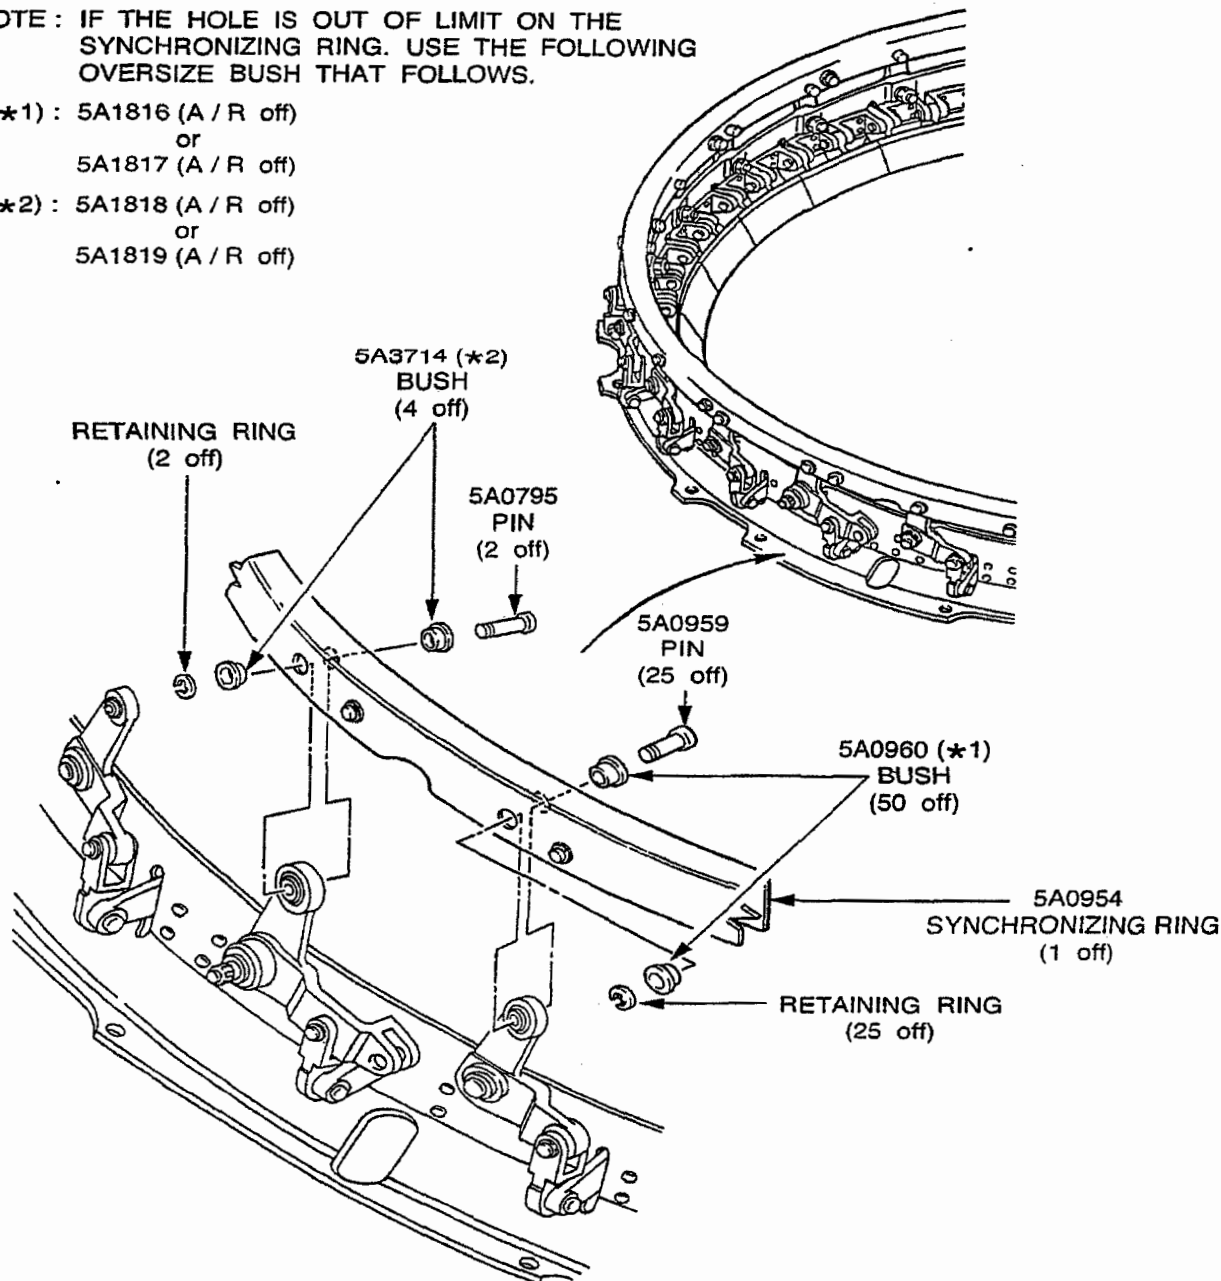
Figure 1

NOTE : IF THE HOLE IS OUT OF LIMIT ON THE
SYNCHRONIZING RING. USE THE FOLLOWING
OVERSIZE BUSH THAT FOLLOWS.

(★1) : 5A1816 (A / R off)
or
5A1817 (A / R off)

(★2) : 5A1818 (A / R off)
or
5A1819 (A / R off)

Install the Bushes to the LPC Synchronizing Ring

- (a) Additional 50 bushes are installed into the link arm holes on the synchronizing ring. (Refer to Figure 1)
- (b) At the same time, new oversize bushes are also introduced as a definition of repair of synchronizing ring.

NOTE: The existing bushes can be replaced with oversize bushes, if the wear is out of limit on the power arm holes and link arm holes of the synchronizing ring.

- (1) Install the 50 5A0960, bushes in to the link arm holes of the 5A0954, synchronizing ring at all locations (Two at each location). For the correct procedures, refer to the A1 Engine Manual Chapter/Section 72-32-70, ASSEMBLY-01, CONFIG-1. (Refer to Figure 1)

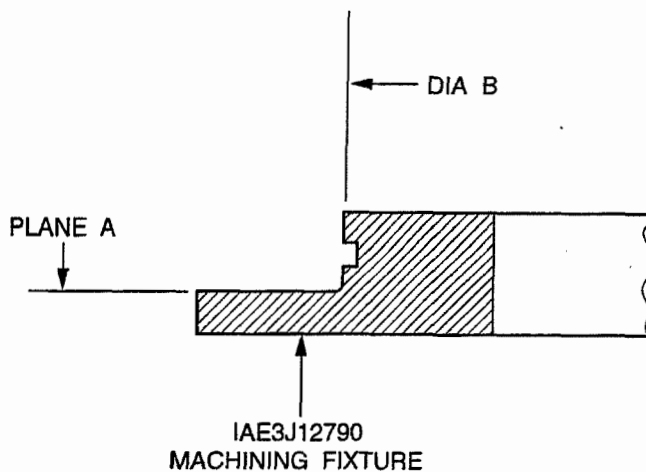
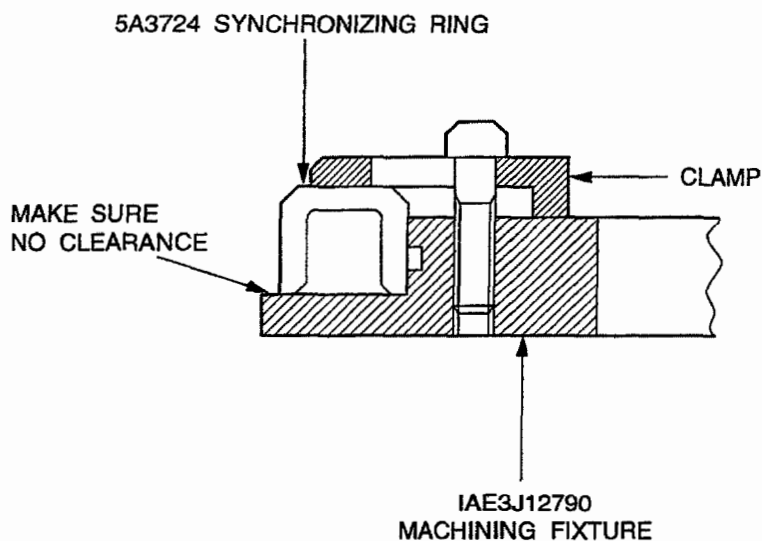
Figure 2 (Sheet 1 of 5)

Set the Synchronizing Ring onto the Machine Fixture

| <u>Procedures</u> | <u>Supplemental Information</u> |
|---|--|
| (c) Put the support equipment IAE3J12790, machining fixture onto the turn table. | Refer to the Facilities Equipment Manual Refer to Figure 2 (Sheet 1) |
| (d) Set the support equipment by the PLANE A and the Diameter B (DIA B). | Refer to Figure 2 (Sheet 1) |
| (e) Set and clamp the 5A3724, synchronizing ring with the open side down onto the IAE3J12790, machining fixture. Make sure that there is no clearance between the synchronizing ring and Plane A of machining fixture at each clamp position. | Refer to Figure 2 (Sheet 1) |

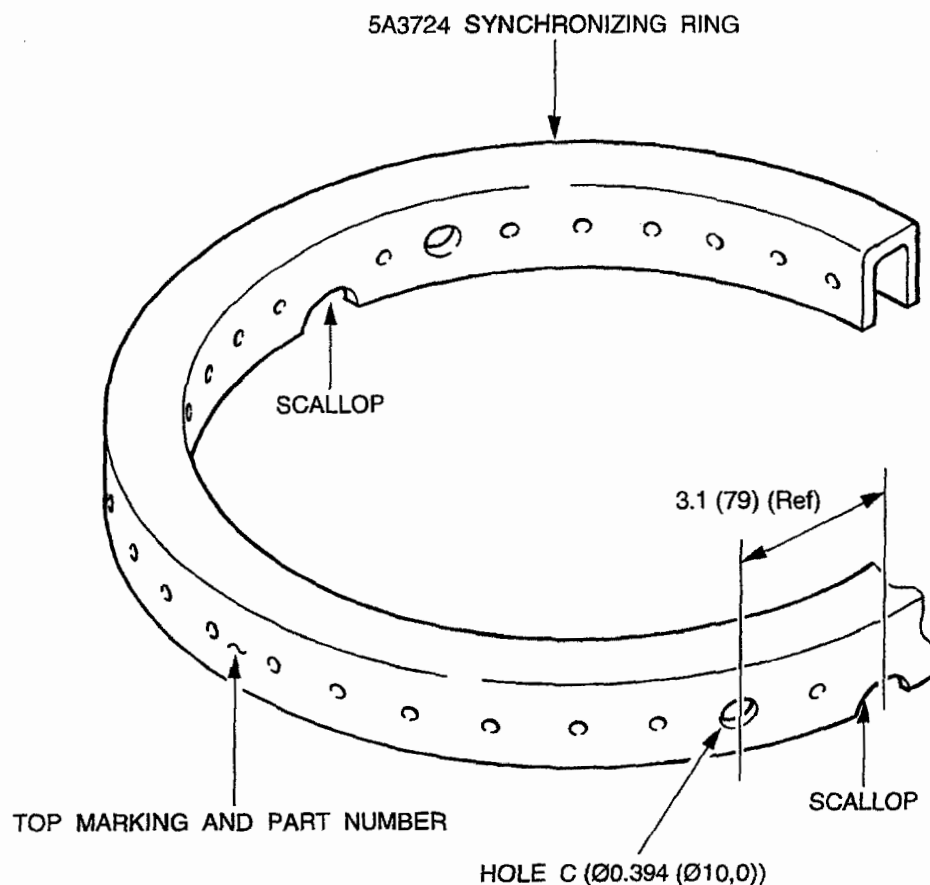
Figure 2 (Sheet 2 of 5)

Top Marking and Scallops on the Synchronizing Ring

| <u>Procedures</u> | <u>Supplemental Information</u> |
|---|--|
| (f) Find a 'Top' marking and two scallops on the synchronizing ring, and adjust the zero degree of the turn table to the center of hole 'C'. | Refer to Figure 2 (Sheet 2 and 3) |

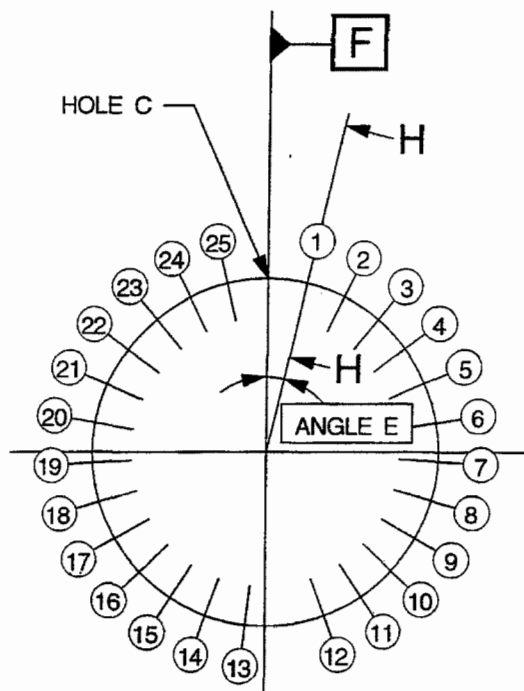
Figure 2 (Sheet 3 of 5)

Hole Positions on the Synchronizing Ring

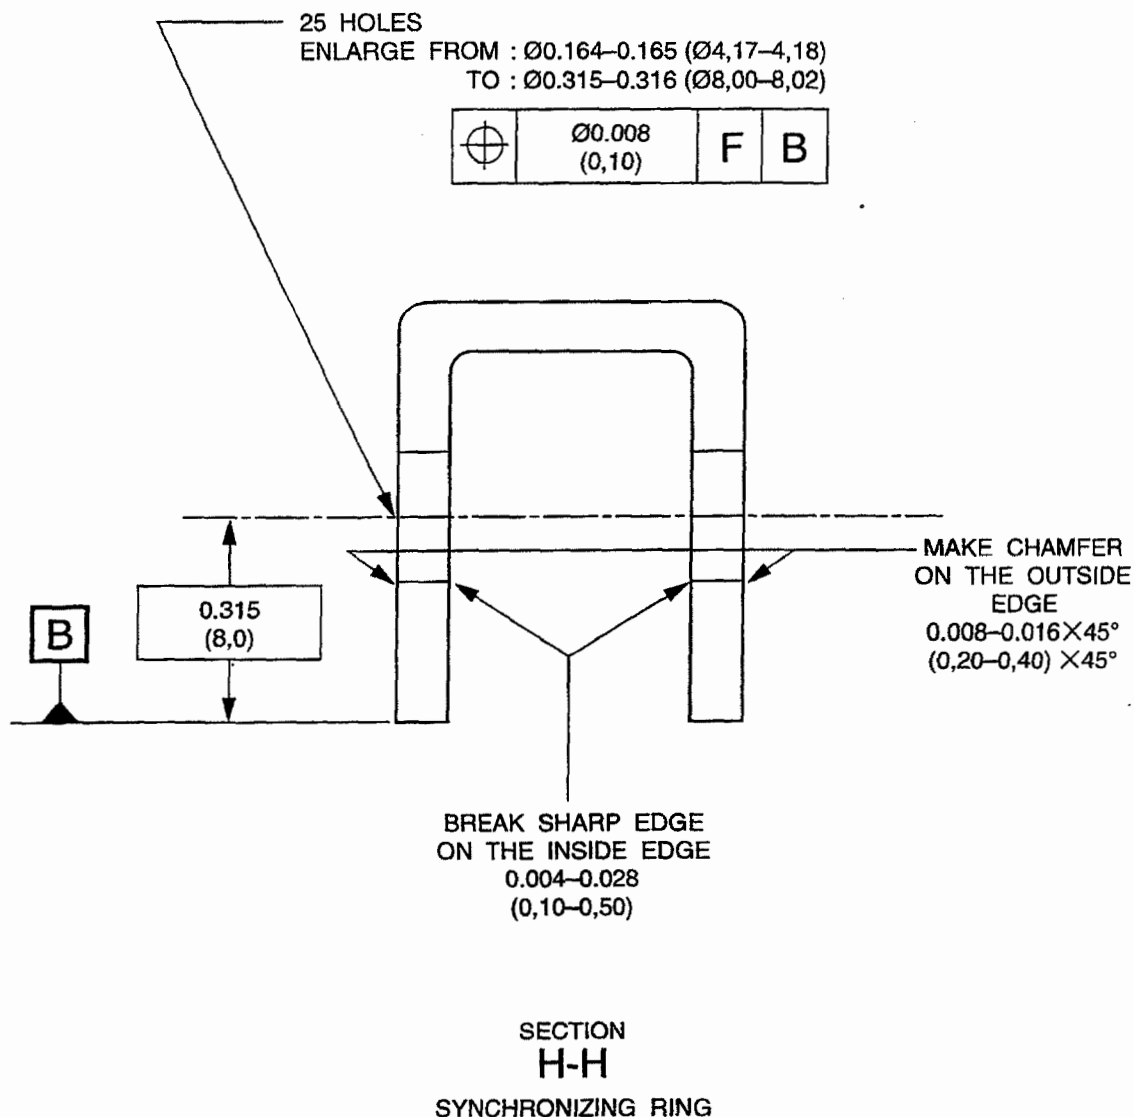
Figure 2 (Sheet 4 of 5)

Enlarge 25 Holes on the Synchronizing Ring

| <u>Procedures</u> | <u>Supplemental Information</u> |
|---|--|
| (g) Enlarge 25 holes on the synchronizing ring with a drill. Make sure that the drill center aligns with each existing hole. | Refer to Figure 2 (Sheet 4) |

- (h) Remove the synchronizing ring from the machining fixture.
- (i) Make chamfer on the outside edge of each hole. Break the sharp edge on the inside edge of each hole. Refer to Figure 2 (Sheet 4)

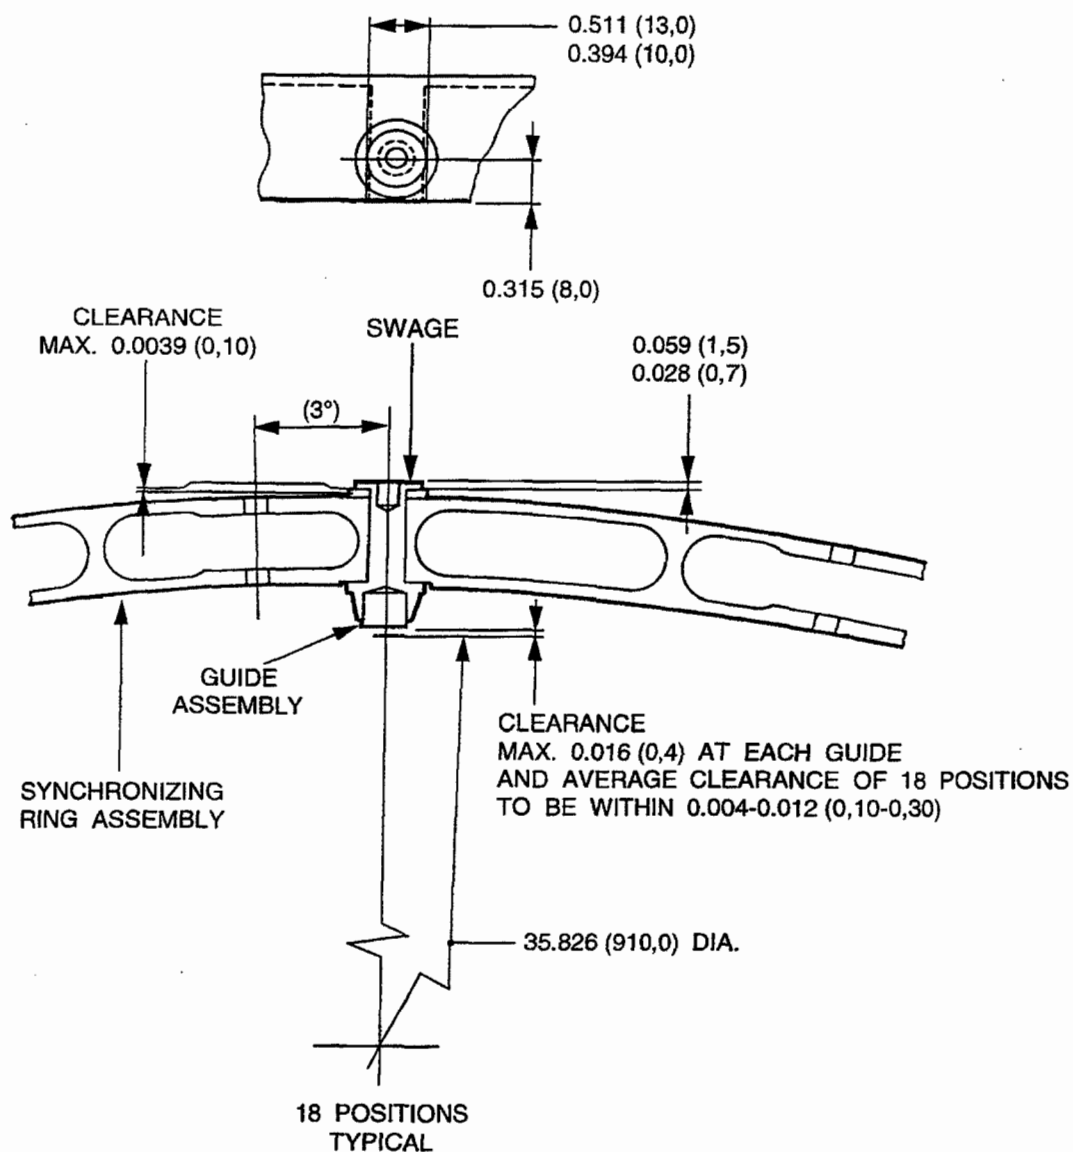
Figure 2 (Sheet 5 of 5)

Installation of the Guide onto the Synchronizing Ring

| <u>Procedures</u> | <u>Supplemental Information</u> |
|---|--|
| (a) Remove the 5A3699 guide assembly and MS15795, washer from the synchronizing ring. Discard the guide, but keep the washer. | Refer to the A1 Engine Manual Chapter/Section 72-32-73 Repair 002, VRS1336 Refer to Figure 2 (Sheet 5) |

- (k) Install the 5A0956, guide assembly and the MS15795-809, washer onto the synchronizing ring. Refer to Figure 2 (Sheet 5)
Refer to the A1 Engine Manual, Chapter/Section 72-32-73, Repair 002, VRS1336.
Use the IAE3J12850 peening tool

- (m) Visually and dimensionally examine the formed guide assembly. Refer to Figure 2 (Sheet 5)
