DATE ~~R~~ Sep.11/03**V2500-A1/A5/D5 SERIES PROPULSION SYSTEMS NON-MODIFICATION SERVICE BULLETIN**

This document transmits Revision 4 to Service Bulletin EV2500-72-0316

**V2500-ENG-72-0316**

ENGINE – LP COMPRESSOR FAN BLADES – ULTRASONIC INSPECTION OF FAN BLADE ROOTS –  
NON-MODIFICATION SERVICE BULLETIN

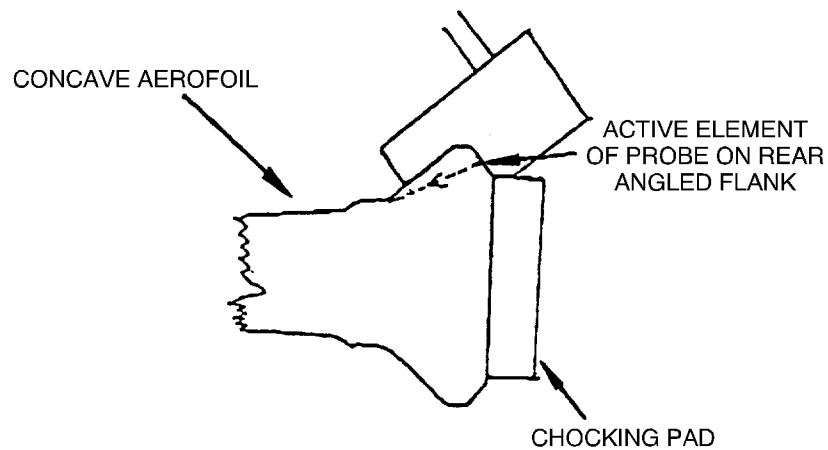
Calibration of the Ultrasonic Flaw Detector  
Figure 1

- (1) Set up the ultrasonic flaw detector for dual or through transmission operation with zero delay. Set the amplifier switch to 5–10 Mhz.
- (2) Apply couplant to the rear angled flank and position the probe on the test block (Refer to Figure 1).
- (3) Identify the signal produced by the large Slot–A. With the range control, position this signal at Division Line 5 on the time base and adjust the amplitude to approximately 50% screen height.
- (4) Increase the gain by 20dB. Move the probe over Slot–B and identify the signal produced. Adjust the amplifier to bring the signal to 60% screen height.
- (5) If a monitor gate is available, position it between the 4.5 and 5.5 Division Lines on the time base. Adjust any visual or audible alarms to trigger at 60% screen height. The calibration check is completed.

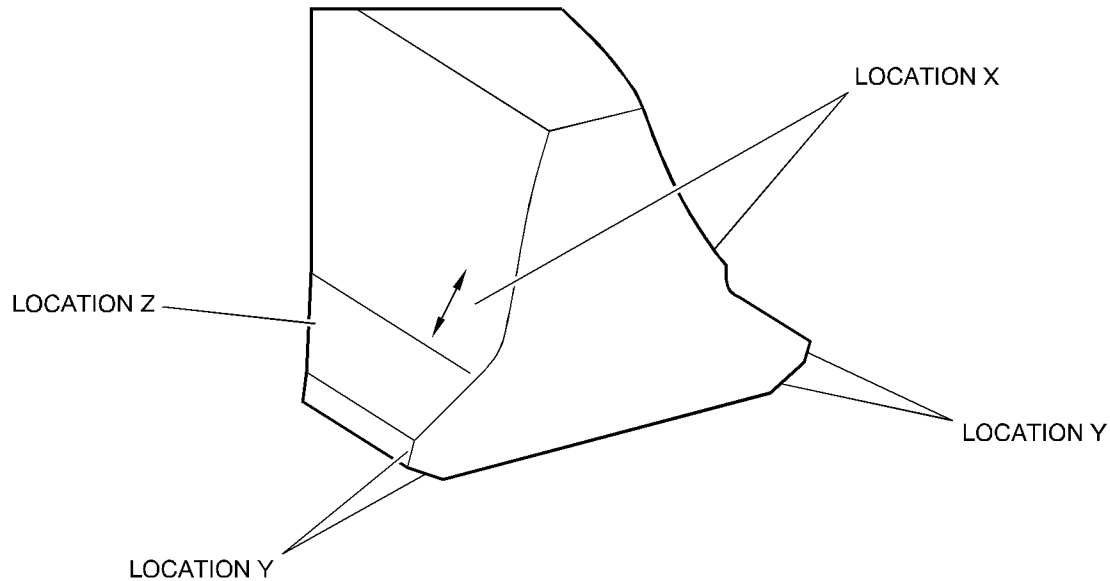
Removal of Excess Dry Film Lubricant  
Figure 2

- R (b) Reject the blade if a signal greater than 60% screen height is produced between the 4.5 and 5.5 Division Lines on the time base.
- R (c) Subsequently to the above, if excess dry film lubricant is still  
R present at the ultrasonic reject indication position on the blade root  
R flank in the areas X and Y defined in Figure 2, remove this by lightly  
R rubbing with Scotchbrite (using CoMat 05-125 to 05-127). Repeat the  
R ultrasonic check as in (a) and (b) above. Reject the blade if a signal  
R greater than 60% screen height is still present between the 4.5 and  
R 5.5 division lines on the time base.

- 1) At the ultrasonic reject indication locations, on either the concave or the convex flanks, remove any excess Dry Film Lubricant (DFL) by lightly rubbing with 'Scotchbrite' using CoMat No 05-125 to 05-127 in the following areas:
  - above the top edge of the bedding (location X)
  - at the lower corner of the root where the ultrasonic probe locates (location Y)

**CAUTION 1:** On post SB 72-0375 and post SB72-0384 (Metco 58 coated root) fan blades it is essential not to "scotchbrite" the fan blade bedding surface (Location Z) as this will have a detrimental effect to the coating.

- 2) If excessive DFL is present, at location X and/or Y that cannot be removed by lightly rubbing with 'Scotchbrite' it is permissible to remove this using a non metallic scraper and then remove any loose residual DFL using 'Scotchbrite'

**CAUTION 2:** On post SB 72-0375 and post SB72-0384 (Metco 58 coated root) fan blades it is important not to damage the fan blade bedding surface (Location Z) when using a scraper
