ENGINE - HP COMPRESSOR SPLIT CASES - INTRODUCTION OF REVISED STAGE 5 AND 6 BOROSCOPE
BLANKING PLUG WITH ADDITIONAL ATTACHING BOLT - CATEGORY CODE 6 - MOD.ENG-72-0317

V2500-ENG-72-0317

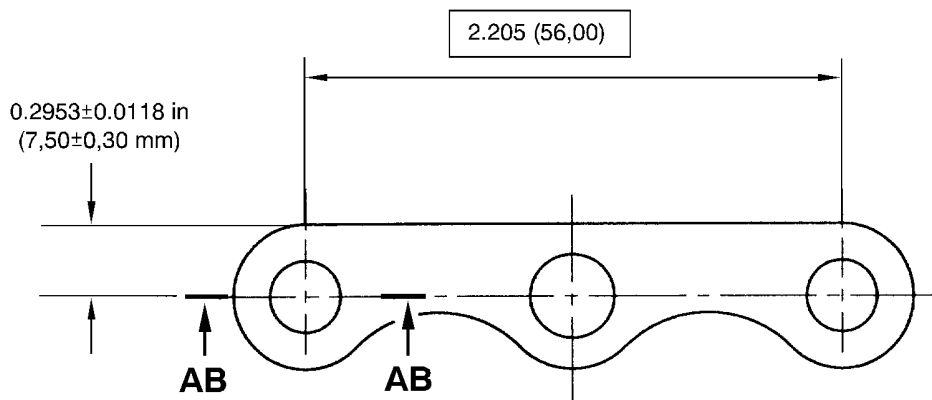
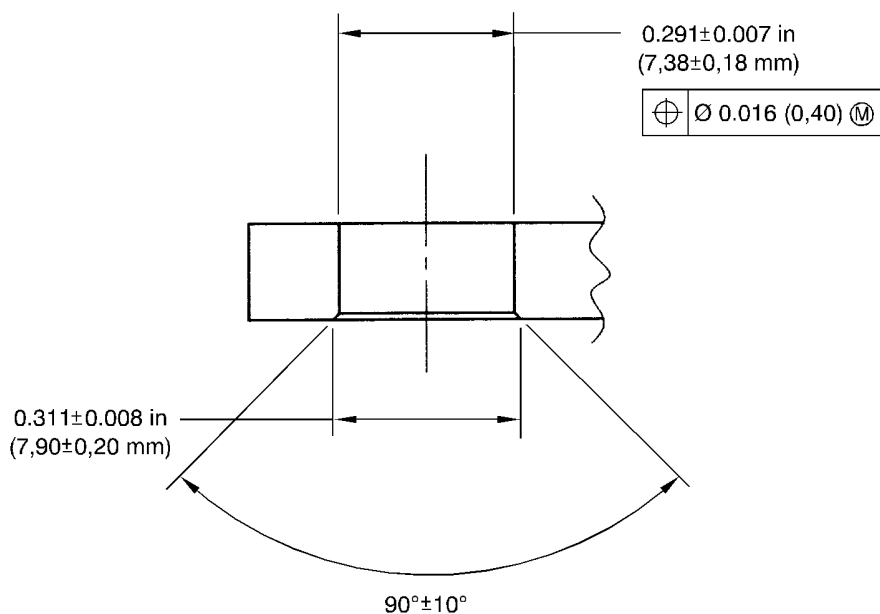
Rework of the Stage-5 and 6 Boroscope blanking-plug
Fig.1

IAE V2500 Service Bulletin ENG 72-0265 introduced a revised boroscope blanking plug for Stages 5 and 6 of the HP Compressor, secured with a single bi-hexagonal bolt. It has been found that this standard of blanking plug can deteriorate quickly. In extreme conditions the stem of the plug can break off.

The problem is caused by an air leak through the non-bolted side of the blank. This causes the stem to vibrate which causes High Cyclic Fatigue (HCF). In addition, because there is only one point of attachment, there is a higher probability of static stress being introduced to the component.

(2) The existing Stage-5 and 6 boroscope blanking-plugs can be reworked. (Refer to Section 2. and Figure 1).

With the scribing tool and a locally manufactured template, mark off the position of the new bolt hole.

With a drilling machine with standard workshop equipment, drill the new bolt hole.

With standard workshop equipment, remove any burrs and break off any sharp edges.

With CoMat 06-022 fluorescent penetrant and penetrant crack test equipment, do a local penetrant crack test of the reworked area.

Reject the blanking plug if any cracks are found.
