## SERVICE BULLETIN

ENGINE - INLET CONE - INTRODUCTION OF SEALS ON THE INLET CONE FAIRING - [C]CATEGORY  
CODE 8 - CATEGORY CODE 5 - MOD.ENG-72-0318

# V2500-ENG-72-0318

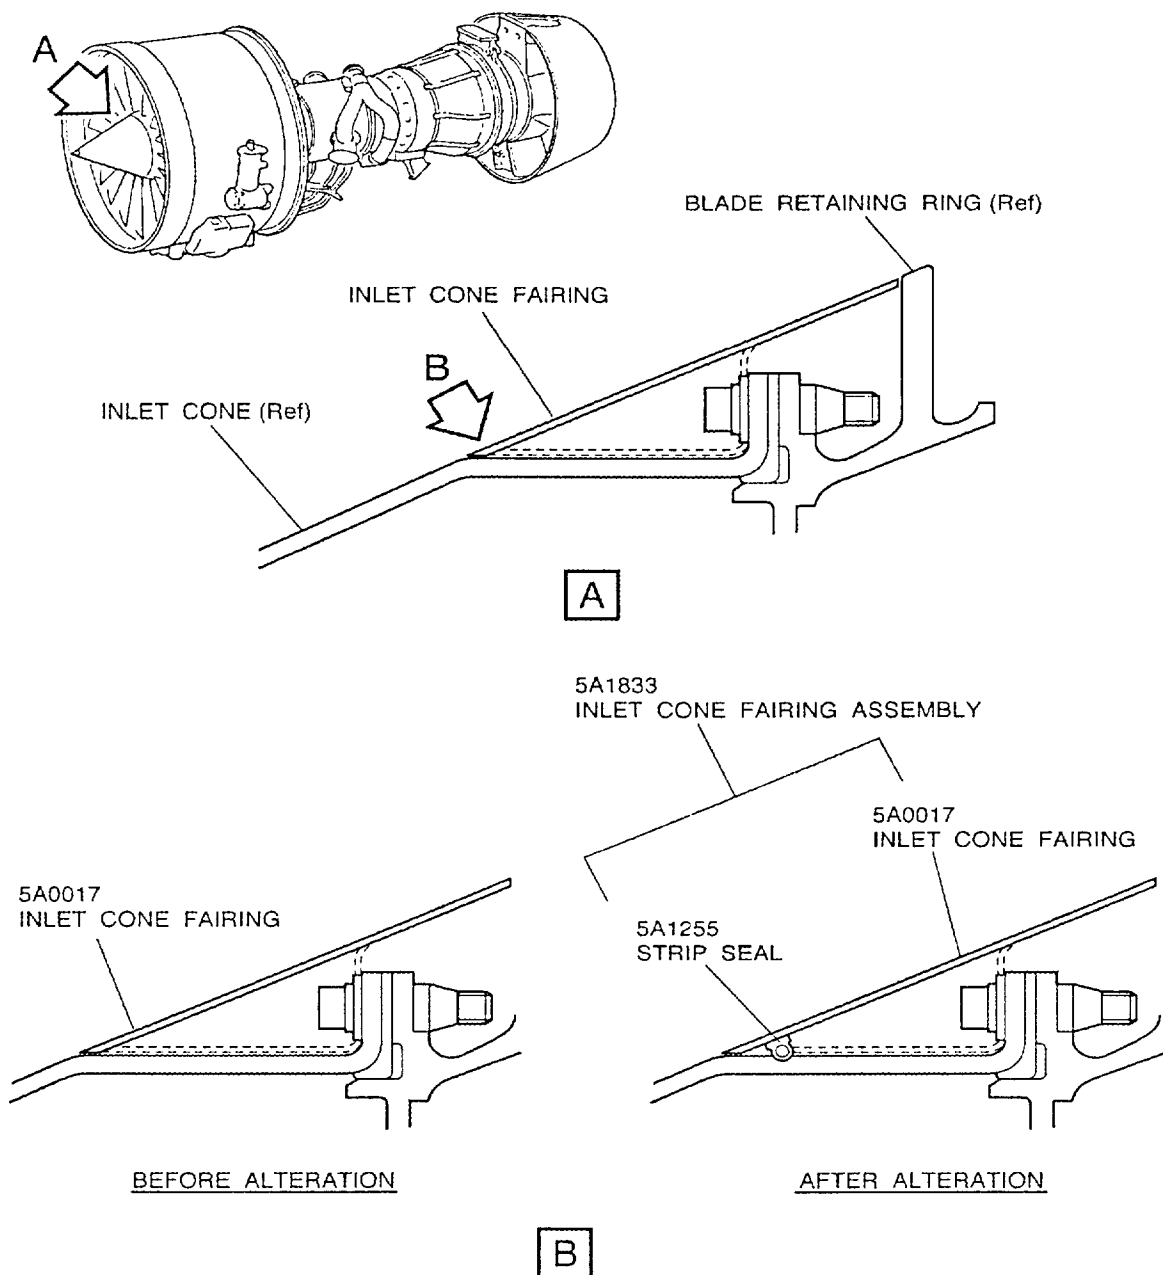
Modification of the Inlet Cone Fairing  
Fig.1

Operators have reported cracking around the bolt hole location on the inlet cone fairing (Part Number 5A0017). In the majority of instances, the fairing has been assembled to a post Service Bulletin No.V2500-ENG-70-0484 inlet cone (Part Number 5A1733).

Analysis shows that the cracking is high cycle fatigue in nature and is caused by the fairing vibrating against the inlet cone flange seating. The driving force for the vibration is airflow entering under the forward lip and exiting through the rear of the fairing causing excitation (Flow patterns have been seen on the fairing underside).

A new inlet cone fairing which has strip seals is introduced.

(2) The modification is accomplished when the six strip seals are installed at the forward lip of the inlet cone fairing. The existing inlet cone fairing can be reworked, see Figure 2. The 5A1255 strip seal is necessary to do the modification.
