Subject: Transmittal of Revision 1 To Service Bulletin Number
V25000-ENG-72-0321

ENGINE - HP TURBINE ROTOR AND STATOR ASSEMBLY - INTRODUCE NEW FIRST AND SECOND
STAGE TURBINE BLADES WITH UNDER PLATFORM COATING

MODEL APPLICATION

V2500-ENG-72-0321

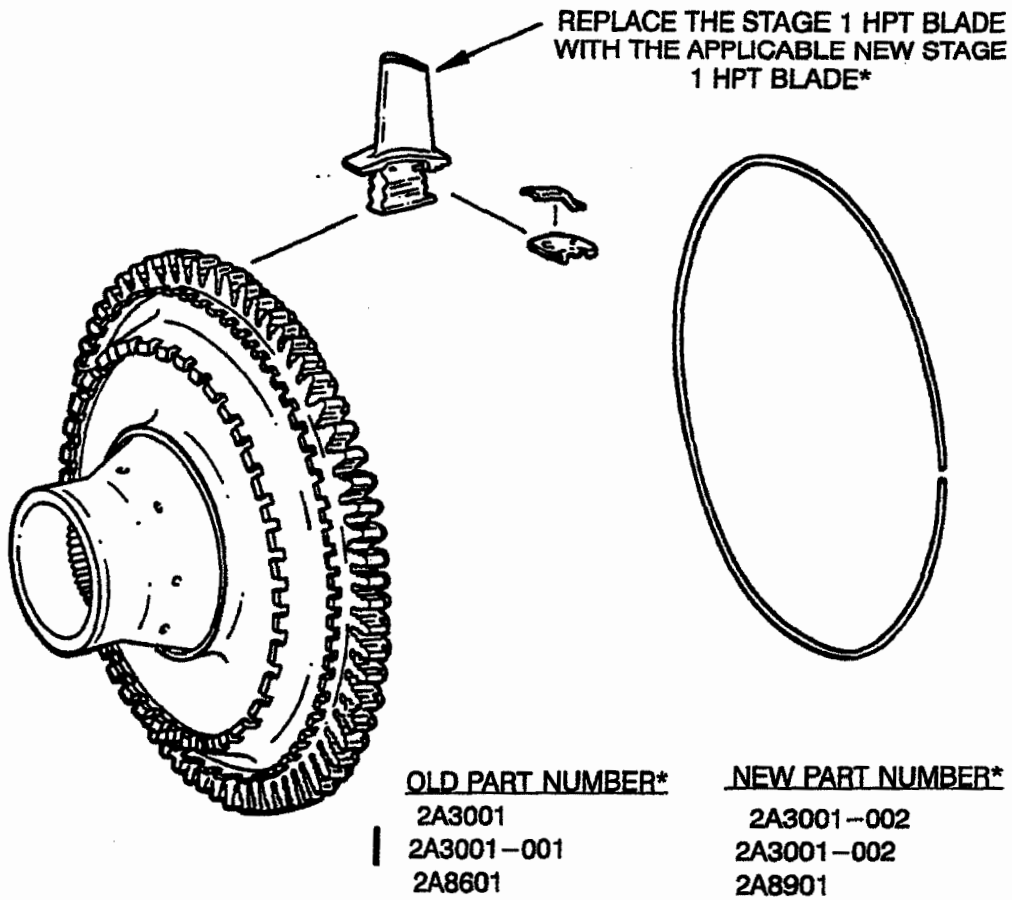
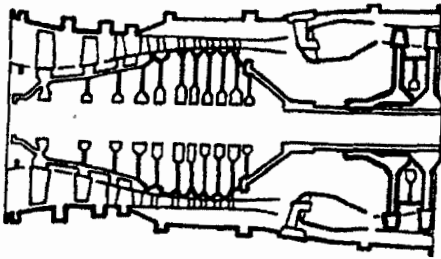
Location of the Stage 1 High Pressure Turbine Blade
Figure 1

- (1) Do a modification of the Stage 1 High Pressure Turbine Blades 2A3001, 2A3001-001 and 2A8601 (64 off). See Reference (2), Chapter/Section 72-45-14. See Figures 1 and 2.

D. Replace the Stage 1 HPT Blades (64 off) by the approved procedure given in Reference (4), Chapter/Section 72-45-10, Assembly-01 and Figure 1.

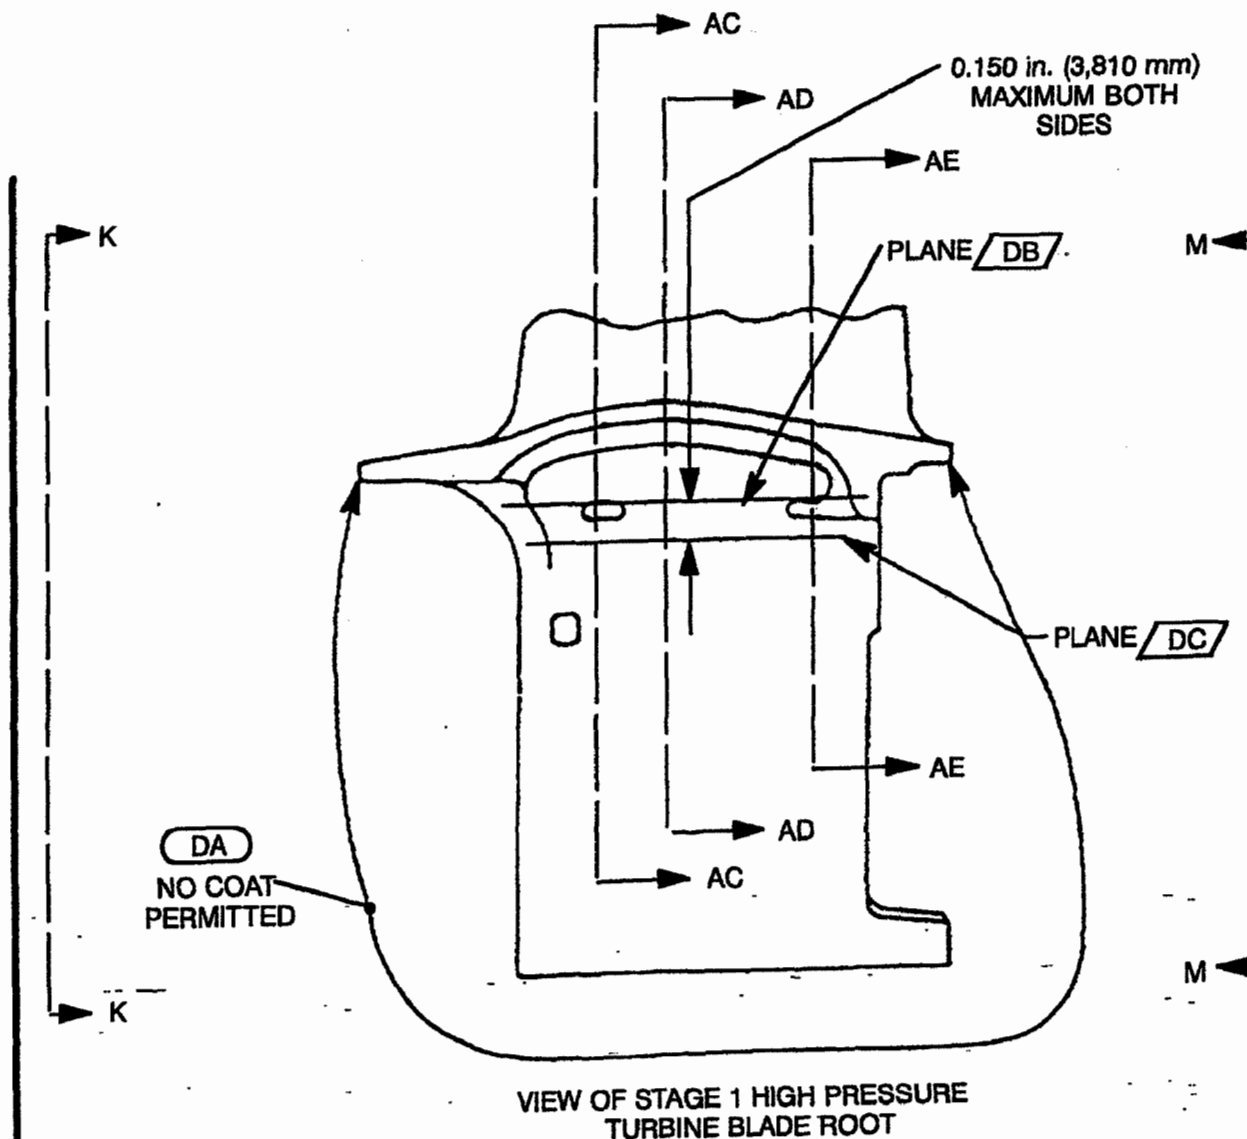
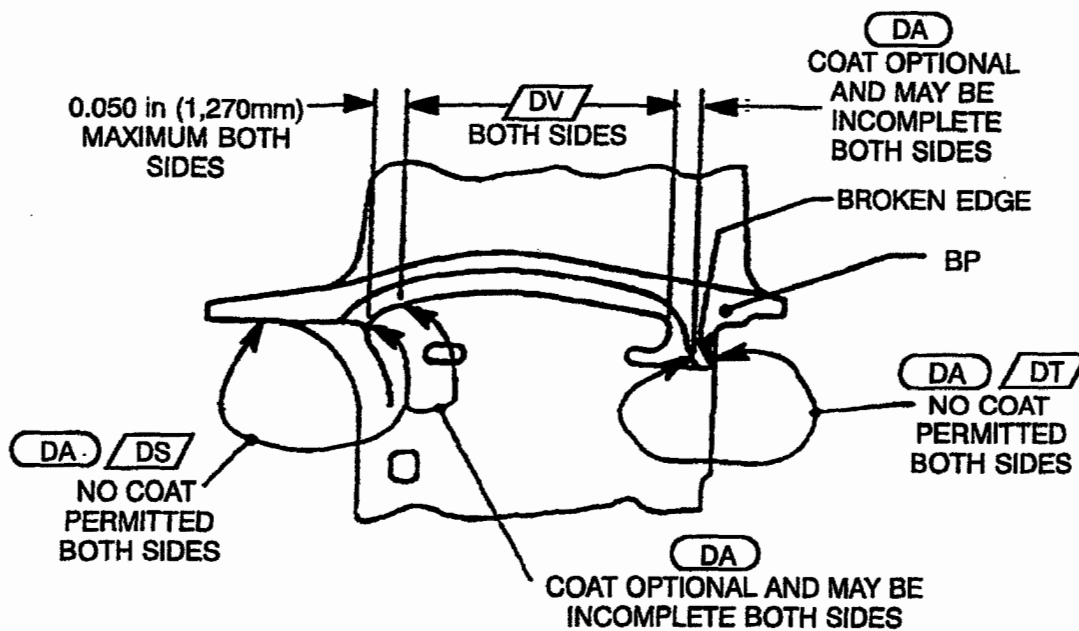
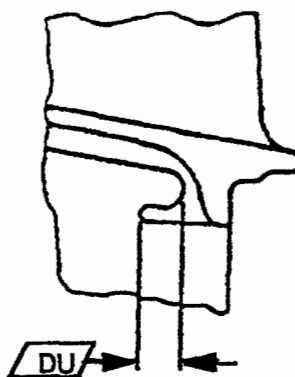
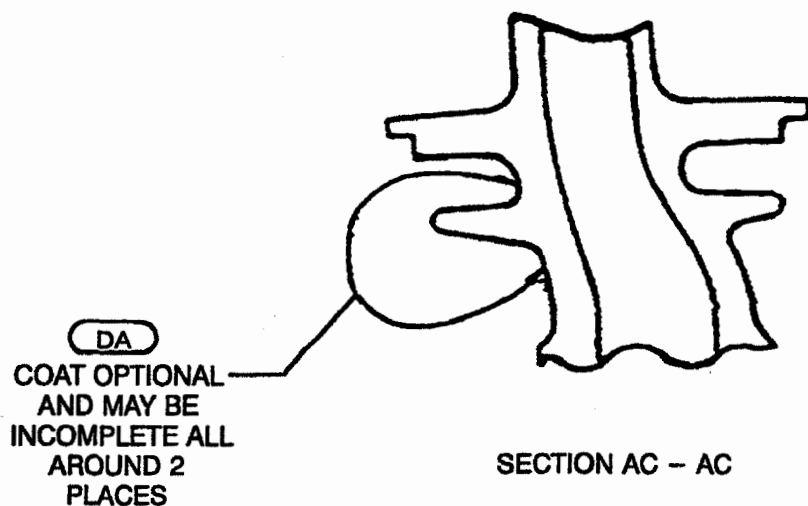
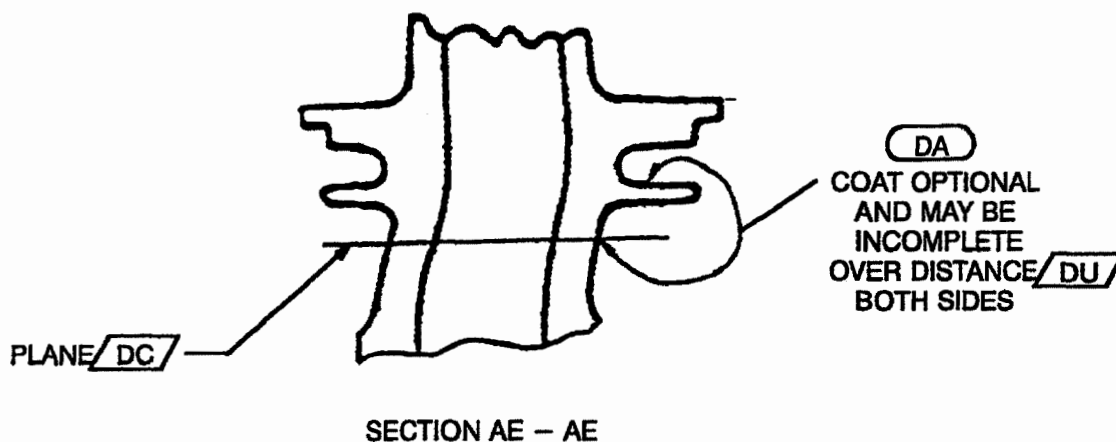
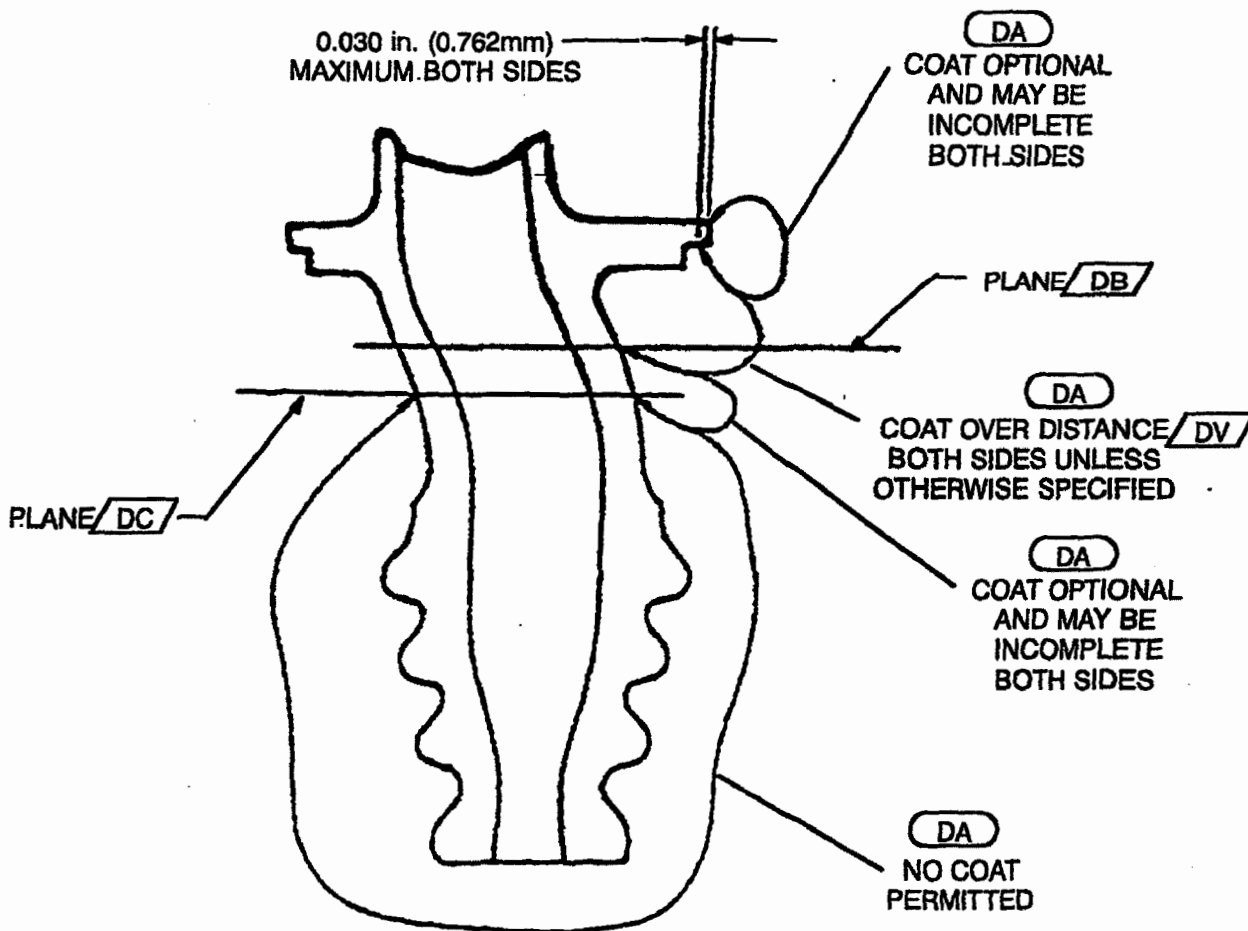
Modification of the Stage 1 High Pressure Turbine Blade Assembly
Figure 2 (Sheet 1)

Experience with High Pressure Turbine Blades in other engine models suggests that the HP Turbine Blades in the V2500-A1 model are susceptible to under platform corrosion in the damper pocket area. Under platform corrosion has been shown to have the potential of causing base material cracking.

| (f) | Dry abrasive blast the under platform area by the procedure specified. Make sure that the areas which need protection are properly masked (root serrations, root openings and coated areas). | Refer to Reference (3), Chapter/Section 70-12-09, Abrasive Cleaning. See Figure 2. |

- (h) Do a check of the under platform area for the presence of coating by the procedure specified.
- Refer to Reference (3), Chapter/Section 70-28-01, Special Inspection. See Figure 2.
- (i) Touch-up under platform areas that have insufficient coating by the procedure specified.
- Refer to Reference (3), Chapter/Section 70-38-26, Surface Treating. See Figure 2.
- (j) Diffusion heat treat for 1 to 4 hours at 1950 - 2000° F (1065.6 - 1093.6° C) in a dry argon atmosphere.
- Refer to Reference (3), Chapter/Section 70-37-03, Heat Treating. See Figure 2.
- 1 The cooling rate must be 10° F/minutes minimum average to 1200° F (648.9° C) and cooling at any convenient rate thereafter.

DA COAT IN THE APPLICABLE AREA BY THE PROCEDURE SPECIFIED IN THE TEXT

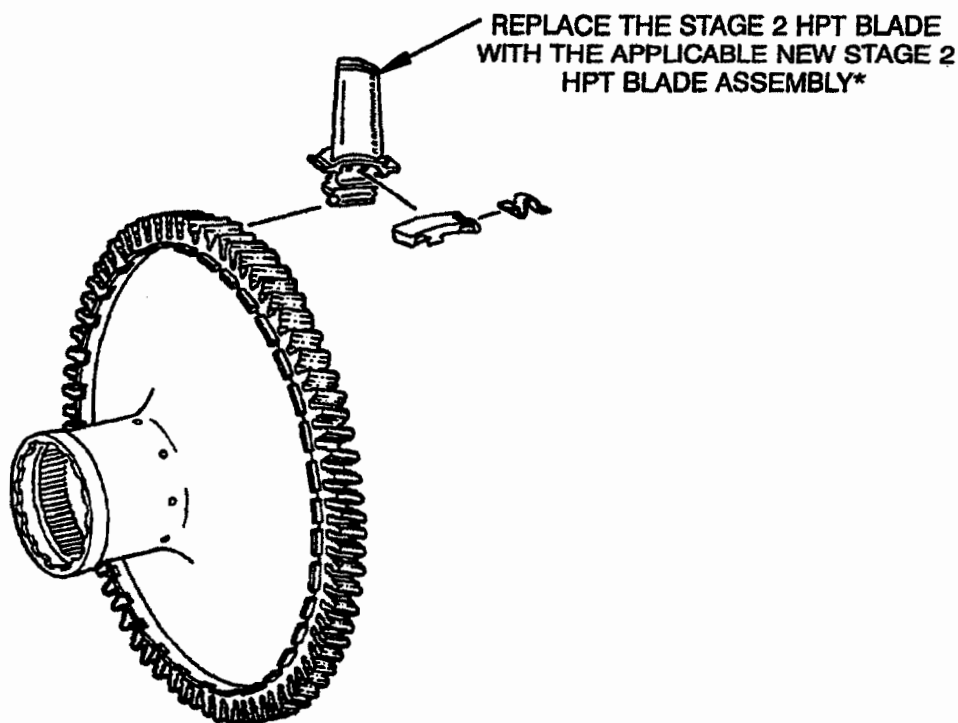
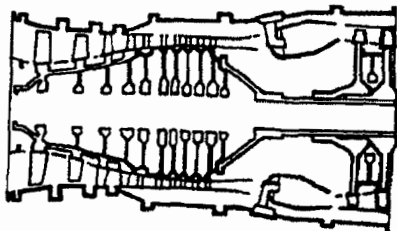
Location of the Stage 2 High Pressure Turbine Blade Assembly
Figure 3

- (1) Do a modification of the Stage 2 High Pressure Turbine Blades 2A1102, 2A1102-001 and 2A8602 (72 off). See Reference (2), Chapter/Section 72-45-32 for the applicable engine model. See Figures 3 and 4.

E. Replace the Stage 2 HPT Blades (72 off) by the approved procedure given in Reference (4), Chapter/Section 72-45-30, Assembly-01 and Figure 3.
