V2500-A5/D5 PROPULSION SYSTEMS SERVICE BULLETIN

ENGINE – HIGH PRESSURE TURBINE ROTOR AND STATOR ASSEMBLY – INTRODUCE A NEW STAGE 2
HIGH PRESSURE TURBINE BLADE RETAINING PLATE

V2500-ENG-72-0328

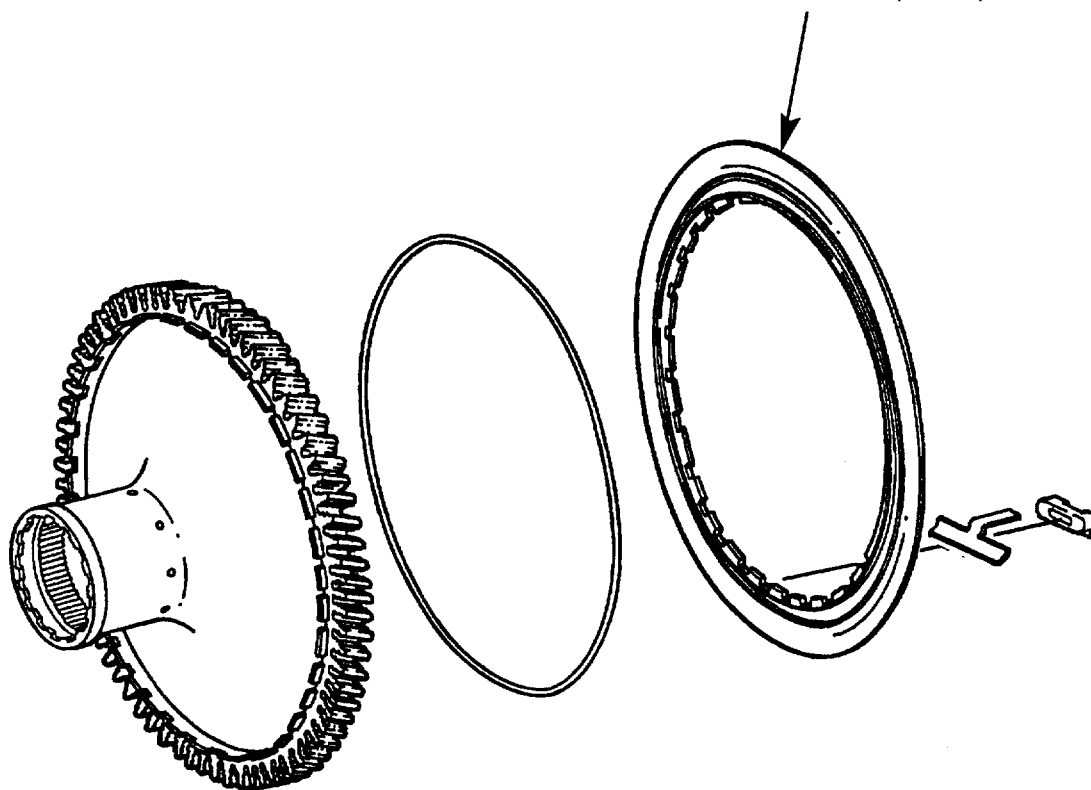
Location of the Stage 2 High Pressure Turbine Blade Retaining Plate
Figure 1

(1) Condition: High operational stresses in the HP Turbine Stage 2 Blade Retaining Plate limit the potential life of the part.

INSTALL THE 2A3437 STAGE 2
HIGH PRESSURE TURBINE BLADE
RETAINING PLATE (1 OFF)

- (1) Install the 2A3437 Stage 2 HPT Retaining Plate (1 off) by the procedure specified in Reference (3) or (4), Engine Manual, Chapter/Section 72-45-30, Assembly. See Figure 1.
- (2) Recording Instructions
 - (a) A record of accomplishment is required.
