V2500-A1/A5 SERIES PROPULSION SYSTEMS SERVICE BULLETIN

V2500-ENG-72-0329

ENGINE – ATTACHING PARTS AND FITTINGS – HP SYSTEM – INTRODUCTION OF REVISED BRACKETS
TO PROVIDE INCREASED CLEARANCE WITH FUEL MANIFOLDS

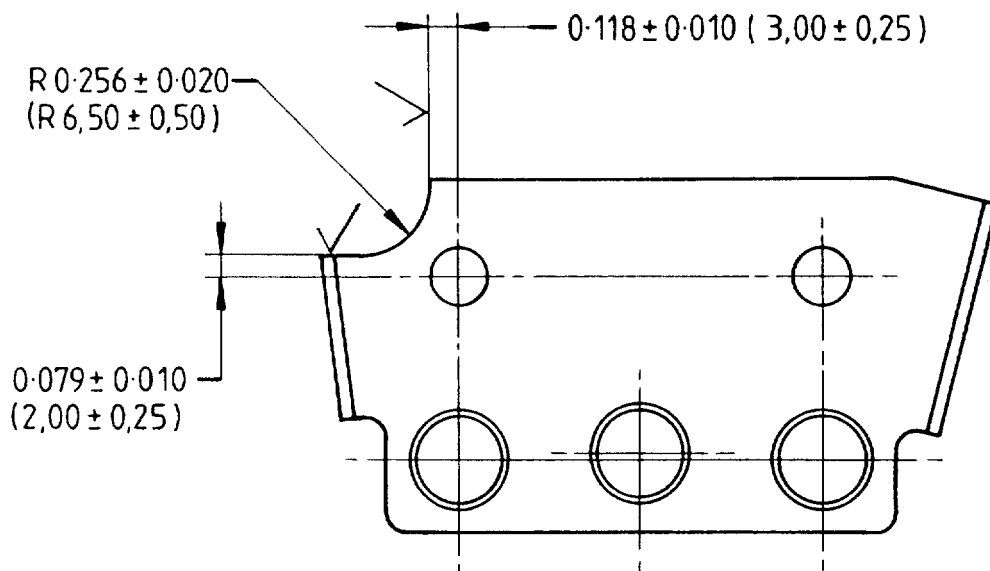
Rework bracket 6A5911
Figure 3

(b) Attaching bracket 6A5911 has been revised, a corner has been removed.

| (d) Rework the brackets in the area(s) shown | Use standard workshop equipment.

Refer to Figures 3 and 4. |

VIEW SHOWING REWORK OF 6A5911

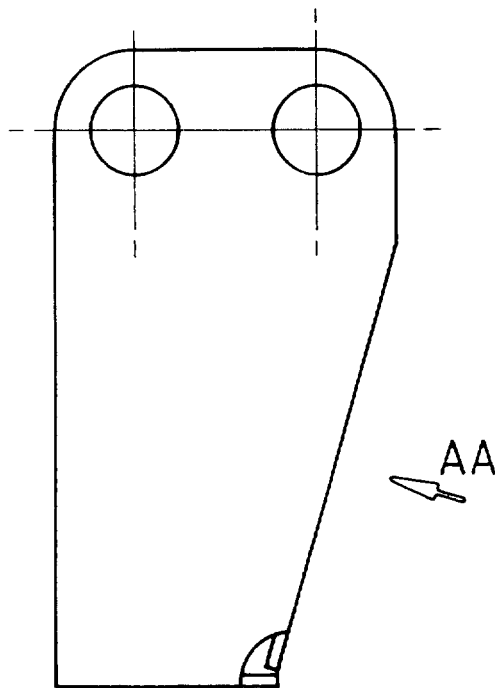
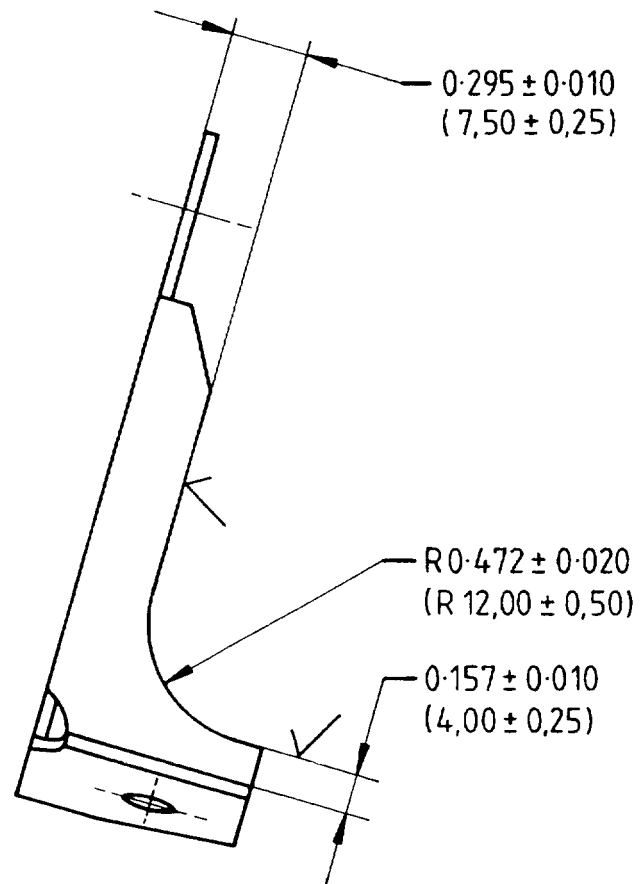
Rework bracket 5W8363
Figure 4

(a) Clipping bracket 5W8363 has been revised, the profile of the folded edge has been relieved.

AA
SHOWING REWORK OF BRACKET

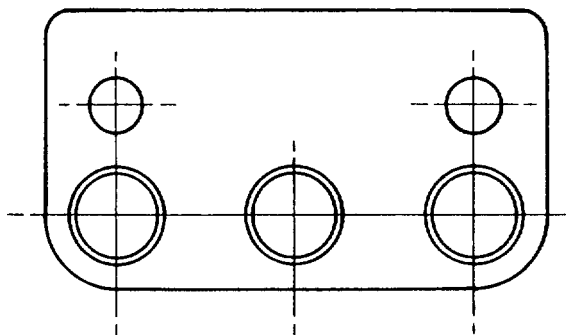
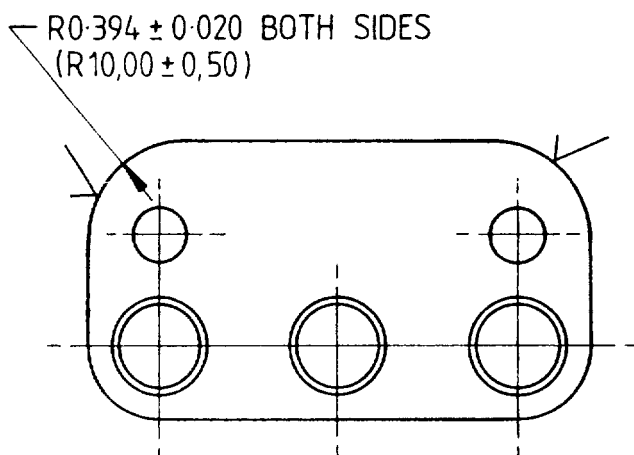
Bracket 6A3992 – Before and after alteration
Figure 5

(i) A rework standard of attaching bracket 6A3992 is introduced with an increase in size of the top corner radii.

PROCEDURE	RELATED DATA
(a) Chemically clean the bracket	Use chemical cleaning equipment. Refer to the Standard Practices Manual (SPM), TASK 70-11-03-300-503.
(b) Apply marking ink to the area(s) to be reworked	Use standard workshop equipment. Refer to Figure 5.
(c) Mark-off the area(s) of the bracket to be removed	Use standard workshop equipment. Refer to Figure 5.
(d) Rework the bracket in the area(s) shown	Use standard workshop equipment. Refer to Figure 5.
(e) Remove any sharp edges	Use standard workshop equipment. Refer to Figure 5.
(f) Chemically clean the bracket	Use chemical cleaning equipment. Refer to the Standard Practices Manual (SPM), TASK 70-11-03-300-503.

- (h) Visually examine and measure the dimensions of the reworked area(s)
- Refer to Figure 5.
