International Aero Engines SERVICE BULLETIN

**ENGINE - LP COMPRESSOR - INCORPORATION OF STRONGER
BOLTS FOR THE LPC BLEED DUCT TO FAN FRAME**

V2500-A1

V2500-ENG-72-0333

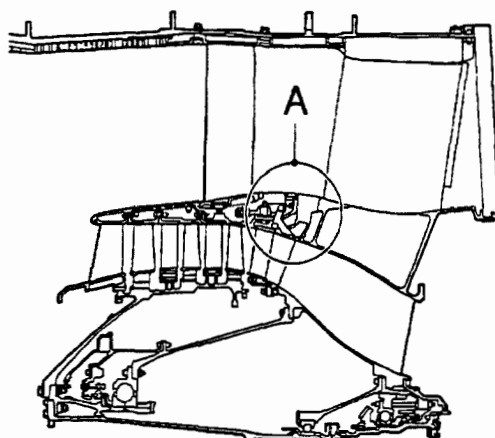
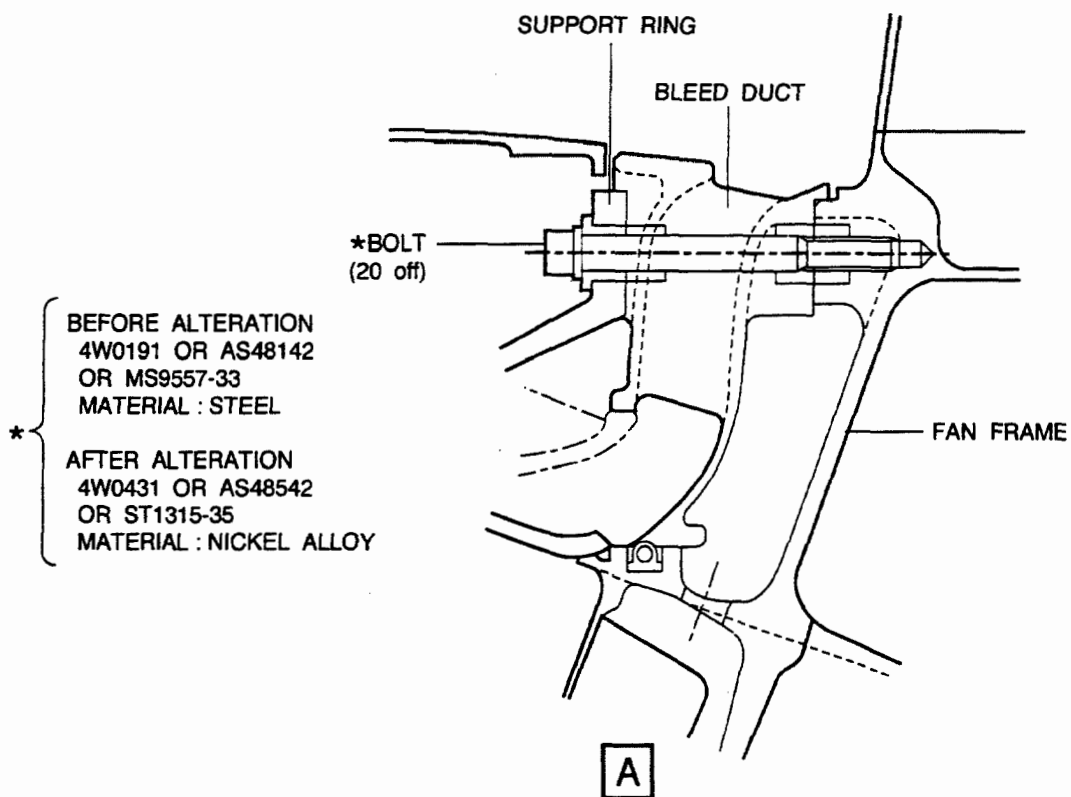
The extension of bolts which join the LPC bleed duct and the fan frame was experienced on a V2500-A1 engine that had a Fan blade-off.

Analysis shows that the fan blade-off load causes the extension of the bolt.

Location of the bolts that connect
the LP bleed duct to the fan frame
Figure 1

The material of bolts that connect the LP bleed duct to the fan frame has been changed from steel to nickel alloy.

Install new 4W0431 (20 off) bolts, in place of 4W0191 (20 off) bolts.
Install parts per V2500 Engine Manual. (Ref. Chapter/Section, 72-32-00,
Assembly-08, Config-1 or Config-2)
