International Aero Engines

ENGINE - LP COMPRESSOR - INTRODUCE THE NEW NO.6  
STRUT FAIRING PANEL WITH ROUNDED CORNERS

V2500-A1  
V2522-A5  
V2524-A5  
V2527-A5  
V2527E-A5  
V2530-A5  
V2533-A5

**V2500-ENG-72-0346**

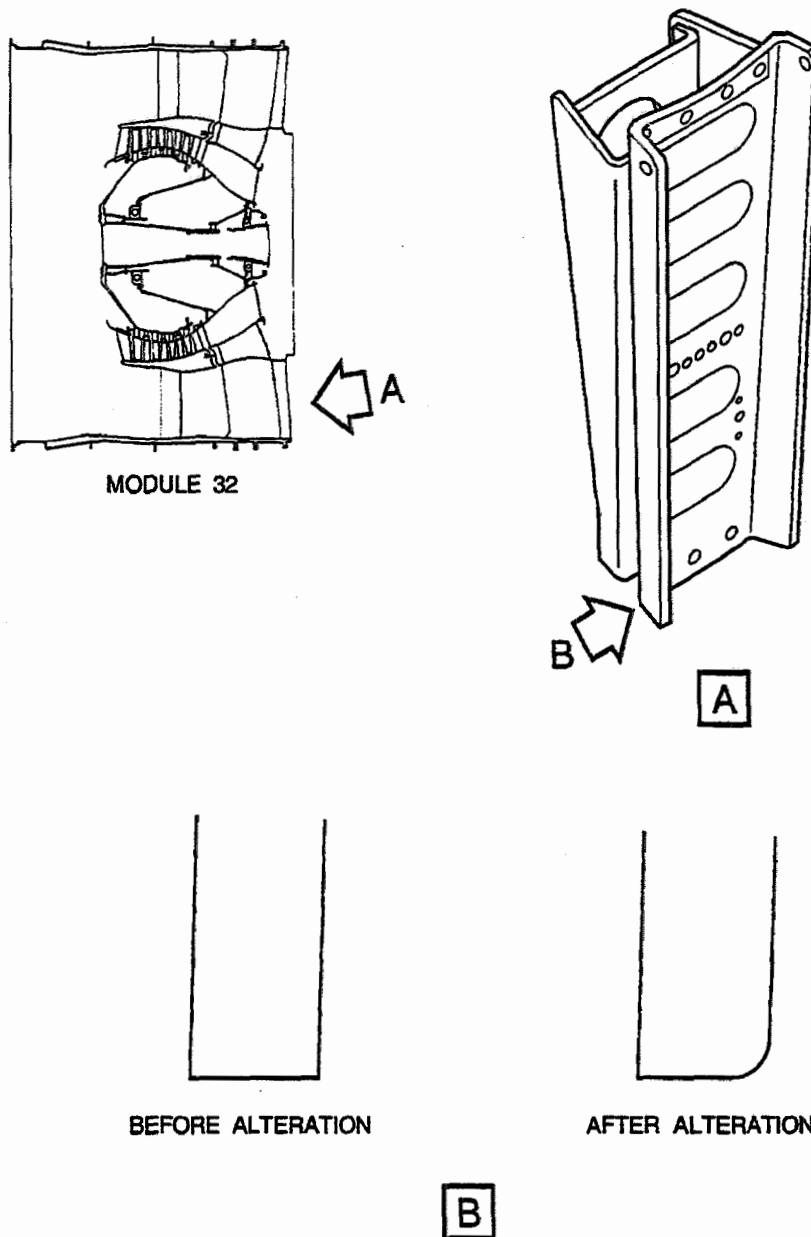
**Before and after alteration of  
the No.6 strut fairing panel  
Figure 1**

The existing No.6 fairing panel has sharp corners. The sharp corners may cause injury to persons.

(a) The corners of the No.6 strut fairing panel are changed to the round ones (See Figure 1).
